The map above shows the west end of the village of Woodborough with the surface drain locations.

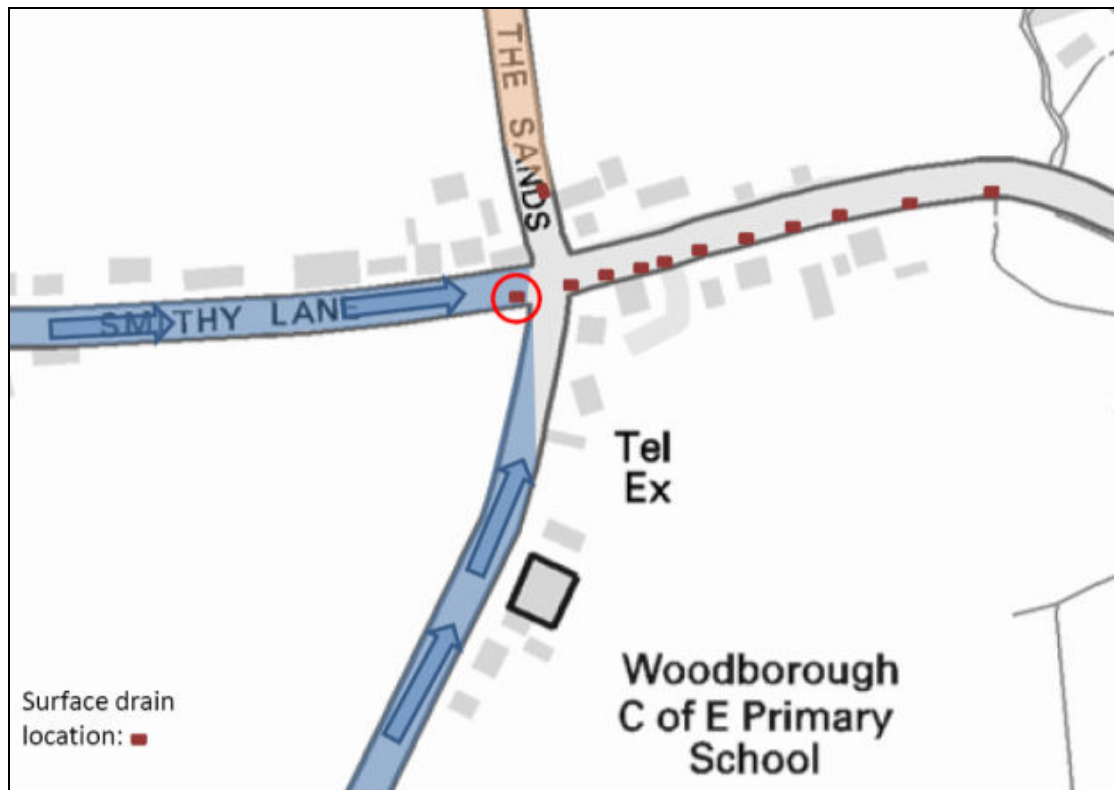
The issues with the drain located in Smithy Lane (circled) are:

- The volume of water that it is expected to accommodate.
- The design of the drain results in frequent blockages. The road water from the south and west run to the drain (indicated as the blue zone), this is greater volume of water when compared with the surrounding drains. The drain is located lower than the road surface and acts as a sump connecting all the rubbish which then blocks the drain. The photographs were taken after only a few hours of rain. The collection of rubbish is evident and without constant maintenance causes flooding.
