TRAFFIC ENGINEERING TEAM

BRIEFING NOTE

Subject	A3102 Mile Elm	Date:	July 2016
Circulation			
Prepared by	David Thomas – Traffic Engineering Manager

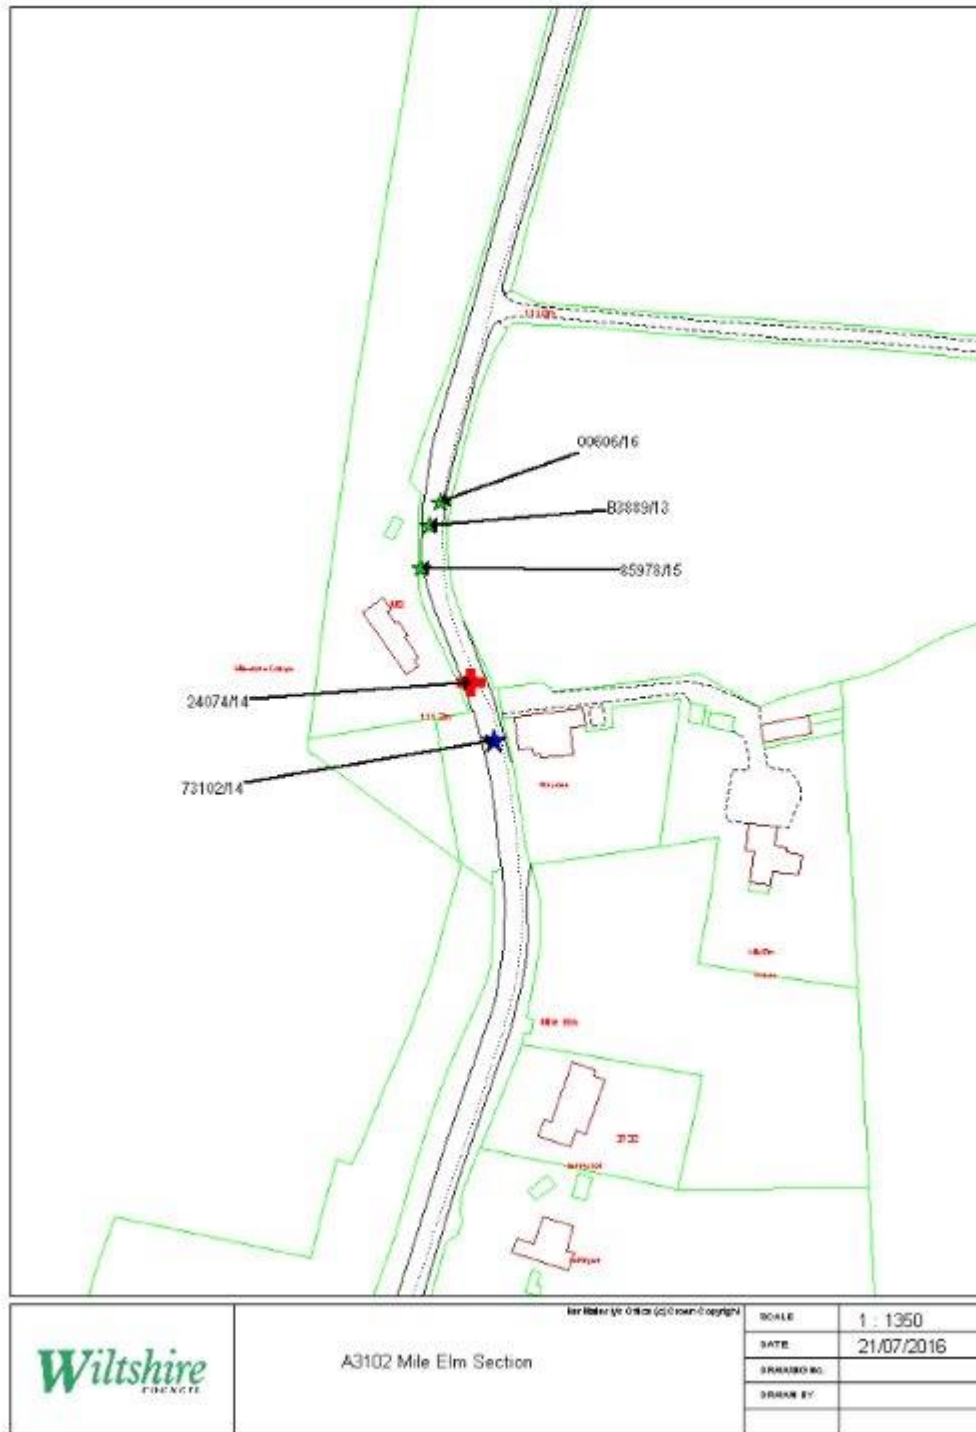
3	<p>Collision history The annual average daily traffic usage of the A3102 at Mile Elm is 6700 vehicles per day (2,445,500 per annum). The collision rate for the length from the junction with the A342 to the 30mph terminal point at Calne is 18.2 per million vehicle kilometres. This compares to the national average for an A class road of 18.3.</p> <p>In the last 3 years to 31/03/2016 there have been 5 recorded injury collisions within the section of road at Mile Elm. 3 being categorised as slight, 1 as serious and 1 fatal. During this same period approximately 7,336,495 vehicles have therefore travelled safely along this length of the A3102 so it is important to concentrate on the circumstances around the specific collisions as it is clear that the majority of drivers are travelling safely along this stretch of road.</p> <p>All three of the most recent collisions are recorded as southbound loss of control at or on the approach to a left hand bend, with the primary contributory factors to these collisions being listed as – Oil or Diesel on road, wet / slippery road surface, and swerving to avoid an animal in the carriageway. All occurred in wet road conditions around the same location. This level of collision history around a specific area will always trigger further action under the annual collision cluster site programme.</p> <p>It is understood that a further collision took place on the 13th June but as yet this has not been added to the Police collision database. For information the database usually runs 3 to 4 months behind actual events.</p>
