**Summary Review of Issues Raised in Bishopdown Estate Report**

# Bishopdown Residents Association

## Survey of Bishopdown Estate – 2019

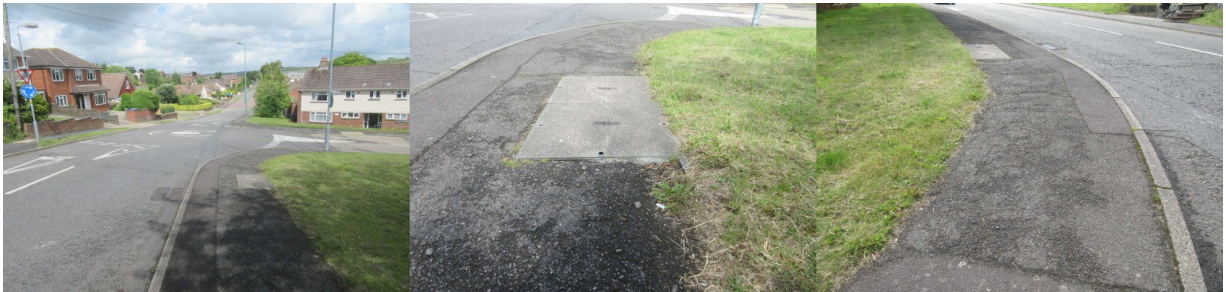
6a

Junction of Bishopdown Road and Denison Rise (right). This steep section of footway is bumpy and degraded, especially where the inspection cover is, part of the inspection cover frame stands clear and is a tripping hazard. This whole section needs relaying.

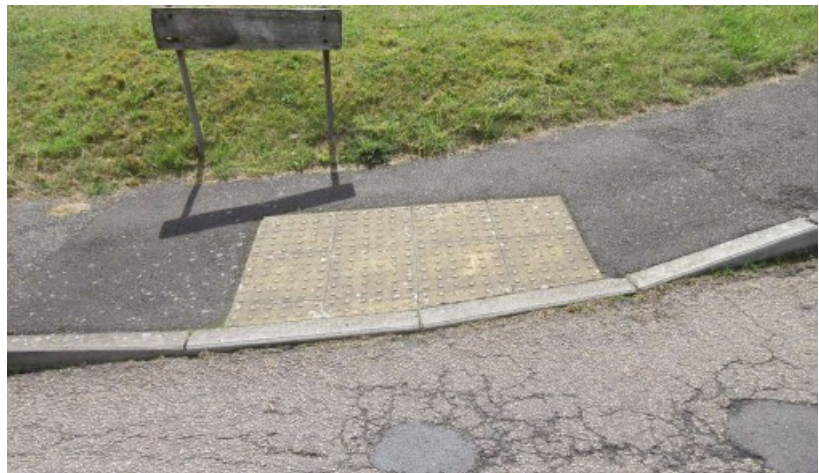
6b Crossing point of Denison Rise, drop-kerbs are not flush – which must exacerbate the steep slope for wheelchair users. Road surface is somewhat degraded too at this point. The street sign for Denison Rise is missing.

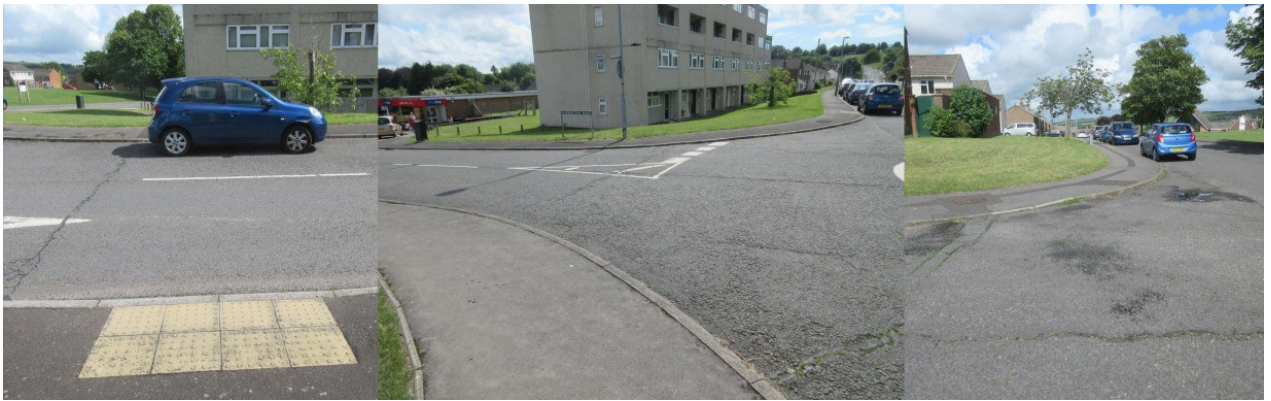
12

Drop-kerb crossing point of Bishopdown Road by Bishop's Court flats – a car is impeding the crossing point, therefore thought should be given to marking this as a proper crossing point. Similarly, at the junction of Barrington Road with Bishopdown Road there is no crossing point at all for wheelchair and other less able users. Thirdly, the entrance of Gilbert Way has no drop kerb crossing point at all.

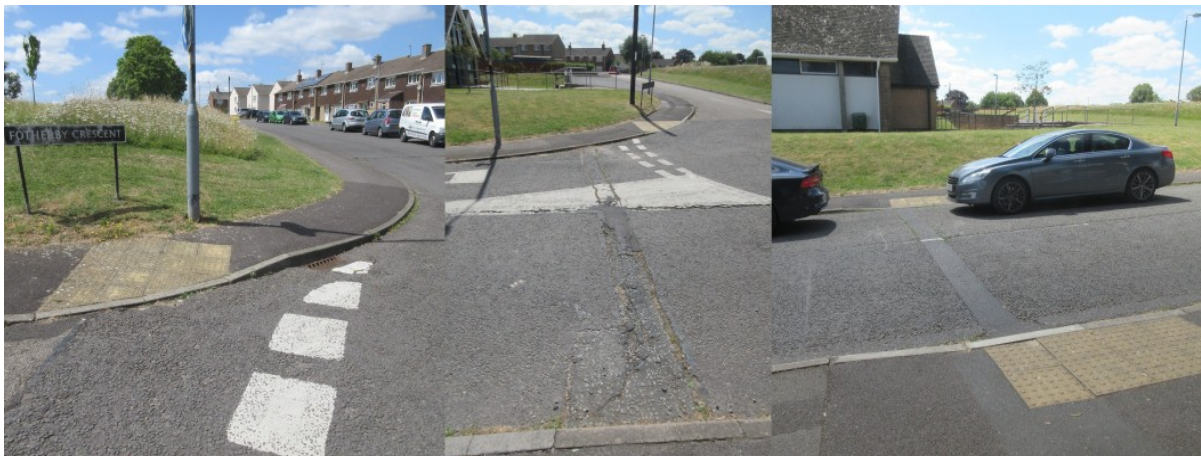
Drop-kerb at entrance of Fotherby Crescent from Bishopdown Road, surface missing and drop-kerb is raised, very difficult for a wheelchair. Poor road surface on Bishopdown Road by Catholic Church. Drop-kerb crossing point of Bishopdown Road by Catholic Church – a vehicle parked on it, thought should be given to designating such crossing places against parking.

13	<a href="#">Bishopdown Road (In Vicinity of Junction with Fotherby Crescent)</a>	Dropped kerb is not flush with the road surface	Highways Maintenance	Dropped kerbs don't have to be flush with the road surface and would typically have up to a 6mm upstand but can have up to a 25mm upstand before becoming a significant trip hazard. Existing dropped kerb is generally within these tolerances. However, there is small amount of carriageway delamination which could be fill with tarmac to improve use of the crossing point for wheelchair/mobility scooter users.
		Poor carriageway surface	Highways Maintenance	The carriageway surface is not a hazard to users. The only way to address it would be for the road to be resurfaced.
		Dropped kerb crossing point by Bishops Court obstructed by parked vehicles	Traffic Engineering CATG	Provide white bar marking in front of dropped kerbs.

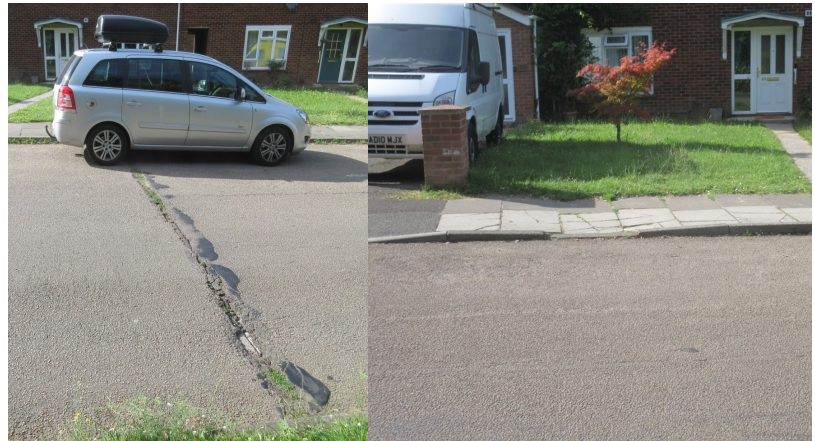
17 - Outside No.49 Denison Rise a join in the road becoming a trench. And, a kerb stone and paving which has dropped.

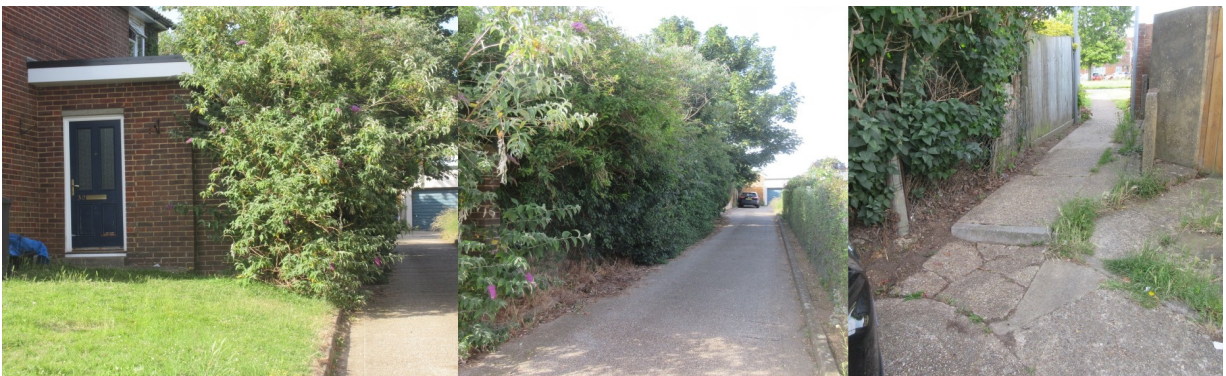
26-

Tenant at 30 Lovett Green has allowed a buddleia to get out of hand on front steps of property. Also the garden is so overgrown that it impinges the access road to the upper garages of Lovett Green. Can WC assist tenant with this problem?  
Pathway from upper garages of Lovett Green to Neville Close – drop kerb needed here and correction of dip in road surface.

Drop-kerbs need improvement over entrance of upper garages in Lovett Green.

Location	Road Name	Issue(s)	Responsibility	Potential Action Required
26	<a href="#">Lovett Green</a>	General condition of access road to upper garage area	Housing Department	Housing Department to advise on potential remedial actions at this location.
		Damaged footway surface Footway leading to Neville Close		The only way to address it would be for the footway to be resurfaced. Housing Department to advise on potential remedial actions at this location.
		No dropped kerb on footway leading to Neville Close		No specific evidence that dropped kerb is require at this location. Potential to provide a ramp at this location which would address the damaged footway at this location. Housing Department to advise on potential remedial actions at this location.
27	<a href="#">Blyth Way</a>	General condition of access road to garage area	Housing Department	Housing Department to advise on potential remedial actions at this location.

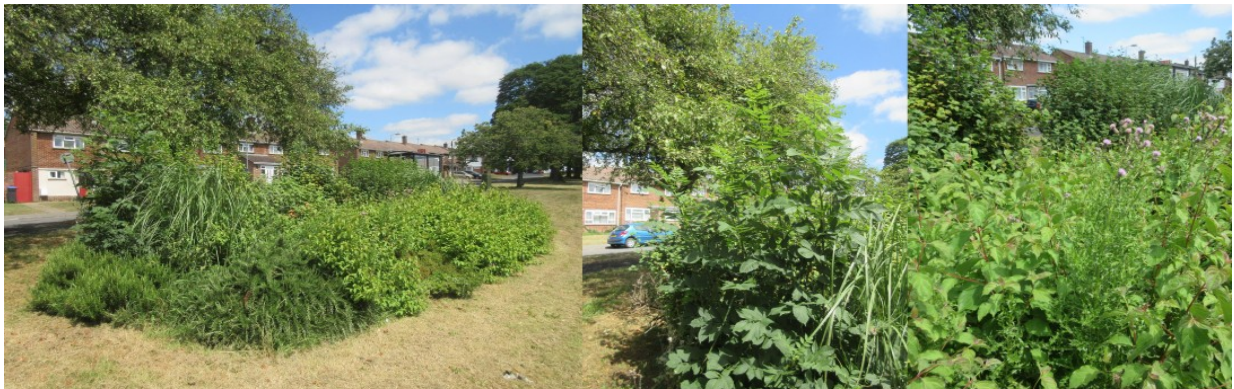
38-

Bus Stop bottom of Seth Ward Drive – this shrubbery has not been maintained, and has been infiltrated by tree-saplings, blackthorn, thistles etc. Can someone who understands gardening – ie: NOT idverde who are completely incompetent – please maintain this shrubbery properly.

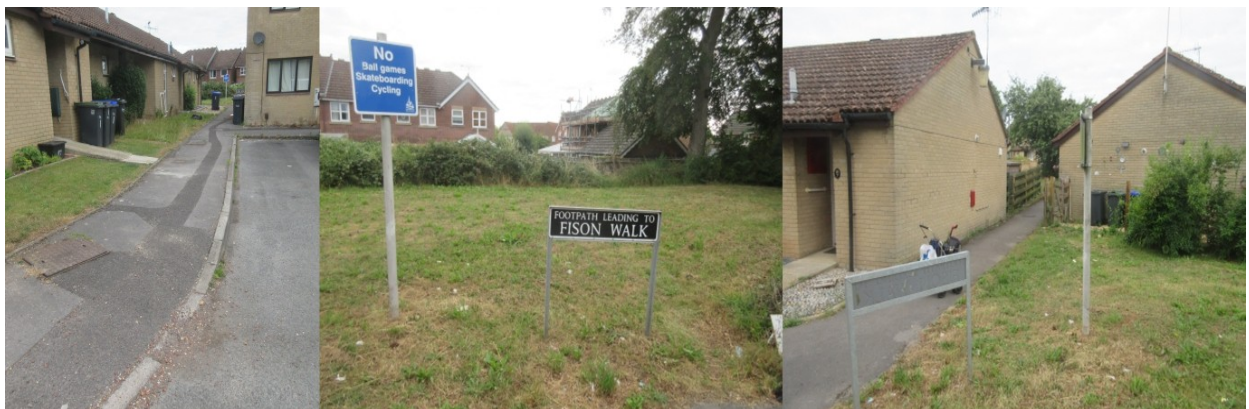
42

Footway in Hallum Close leading to Fison Walk. Many of the residents of Fison Walk are elderly and less-abled, several appear to use wheelchairs. This drop-kerb and footway are alike in poor condition, and are representative of general conditions.

It leads initially to this corner of land at the lower end of Fison Walk. This was a planning anomaly and has just been left blank and untended, it is not overlooked by the front of any property and often becomes a dumping ground.

Uneven footway surface	Highways Maintenance	The only way to address the issue would be for the footway to be resurfaced.
43	<a href="#">Hallum Close / Jewell Close</a>	General weed growth and debris in the kerb channel.	Salisbury City Council	Weed killing and road sweeping required. Salisbury City Council to advise on potential remedial actions at this location.
44	<a href="#">Fison Walk (Area between No. 27 and 29)</a>	Area overgrown and covered in garden waste	Housing Department	Housing Department to advise on potential remedial actions at this location. Salisbury City Council may need to address garden waste issue if this is considered a fly-tipping issue.
45	<a href="#">Fison Walk</a>	Gully blocked with vegetation (Outside of Nos. 31 and 33).	Highways Maintenance	Gully needs to be cleared.

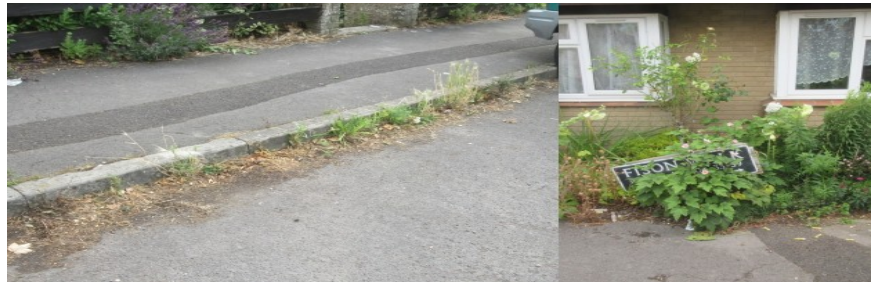
43- General state of kerbs and gutters – debris and weeds.

Sign for lower part of Fison Walk needs reinstating.

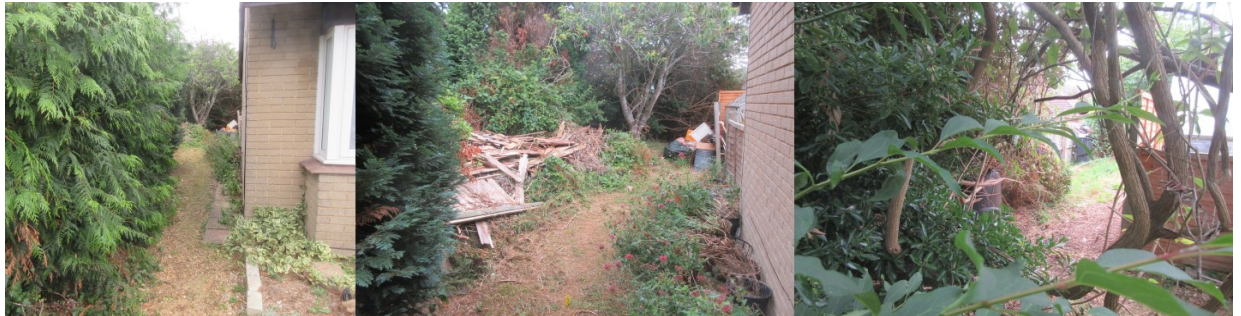
44

Between Nos. 29 & 31 Fison Walk an access path was left when built to allow residents to get to and from rear gardens. This has now become overgrown with trees and shrubs and a haven for litter and overflow of people's gardens. The elderly residents are unable to bring bins out from the rear – this has apparently been seen by Mostyn Coombes in June 27<sup>th</sup> 2019. What is being done?

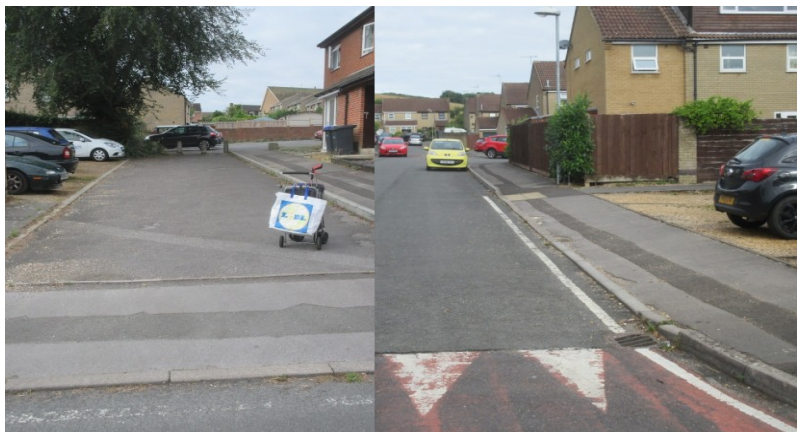
A main route from Bingham Road (and the rest of the Estate) to Jewell Close, and thereby on to Bishopdown Farm Estate, this garage space and parking place is used by many walkers, cyclists and the less able. The drop-kerbs and bollards are a problem to this, and should be improved.

Drop-kerb from Jewell Close into footpath through to Bishopdown Farm estate. The kerbs here are typical of the area generally.

<b>Location</b>	<b>Road Name</b>	<b>Issue(s)</b>	<b>Responsibility</b>	<b>Comments / Potential Action Required</b>
46	<a href="#">Jewell Close</a>	Poorly installed dropped kerbs on pedestrian route from Bingham Road to Bishopdown Farm	Highways Maintenance Housing Department	Existing dropped kerbs are generally okay and within acceptable tolerances. The only exception being the dropped kerb that provides the access to the off-street parking area in front of Nos. 37-41 Jewell Close where the kerb upstand is on the threshold for intervention. However, this dropped kerb is not essential to the pedestrian route and shouldn't be considered a priority for replacing/improving. No further action required.
47	<a href="#">Fison Walk</a>	Improved street nameplates required	Traffic Engineering CATG	Provided replacement and additional street nameplates. Proposals to provide improved street nameplates in Fison Walk have been designed and costed
