Summary Review of Issues Raised in Bishopdown Estate Report

Bishopdown Residents Association

Survey of Bishopdown Estate – 2019

Walk 01- Bishopdown Road- from hill-top to lower end of estate.

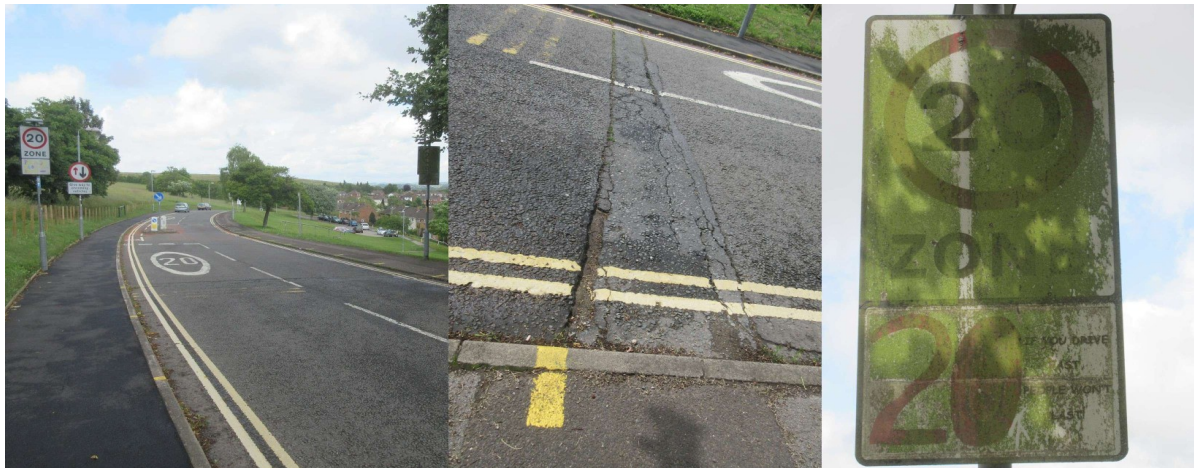
2-

Entry of 20mph zone, top of Bishopdown Hill. The 20mph sign is filthy, mostly due to being close to tree overhang. Adjacent to it a trench in the road needs filling again.

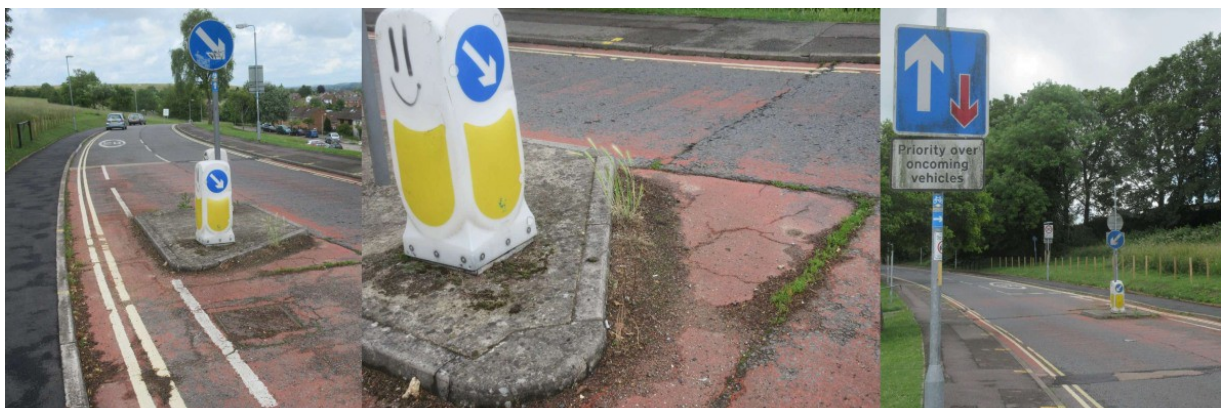
3

Entry of 20mph zone, top of Bishopdown Hill. Cycle bypass is filthy, the signs are filthy, the island is surrounded by scree which has vegetation growing in it.

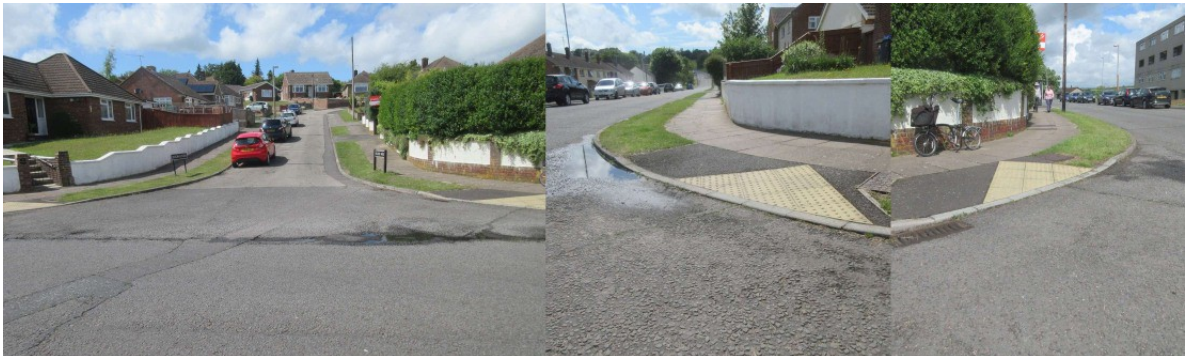
10

Entry of Bingham Road from Bishopdown Road. Poor road surface and drop kerbs not flush with road surface.

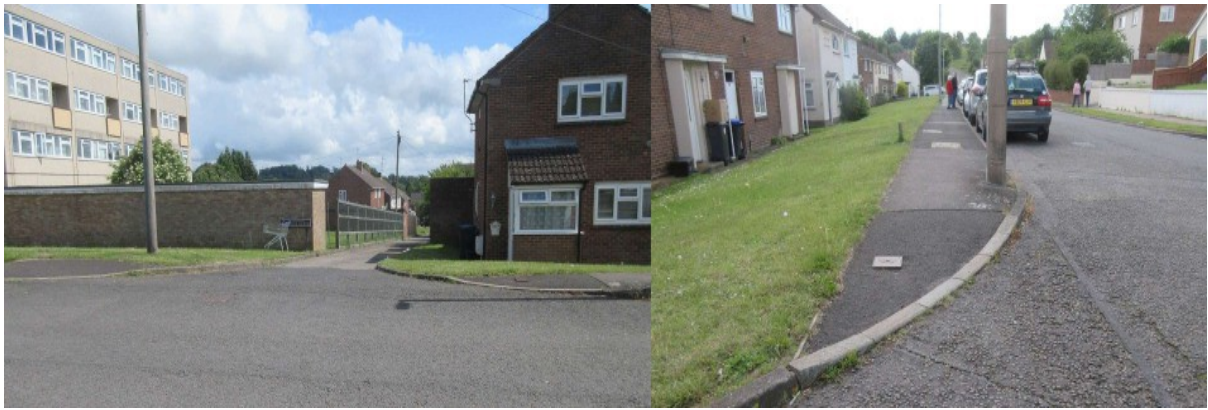
Junction of Bishopdown Road with lane/garages to Burgess Green. The drop kerb here is again poor and not flush with the road surface.

Location	Road Name	Issue(s)	Responsibility	Potential Action Required
11	Bishopdown Road (Junction with Footpath to Burgess Green)	Dropped kerb is not flush with the road surface	Highways Maintenance	Dropped kerbs don't have to be flush with the road surface and would typically have up to a 6mm upstand but can have up to a 25mm upstand before becoming a significant trip hazard. Existing dropped kerb is within these tolerances. No further action required.
12	Bishopdown Road (In Vicinity of Junction with Barrington Road)	Dropped kerb crossing point by Bishops Court obstructed by parked vehicles	Traffic Engineering LHFIFG	Provide white bar marking in front of dropped kerbs.
		No dropped kerb crossing point across Barrington Road	Traffic Engineering LHFIFG	Provide dropped kerb crossing point.
		No dropped kerb crossing point across Gilbert Way	Traffic Engineering LHFIFG	Dropped kerb crossing point already exists at this location. No further action required.

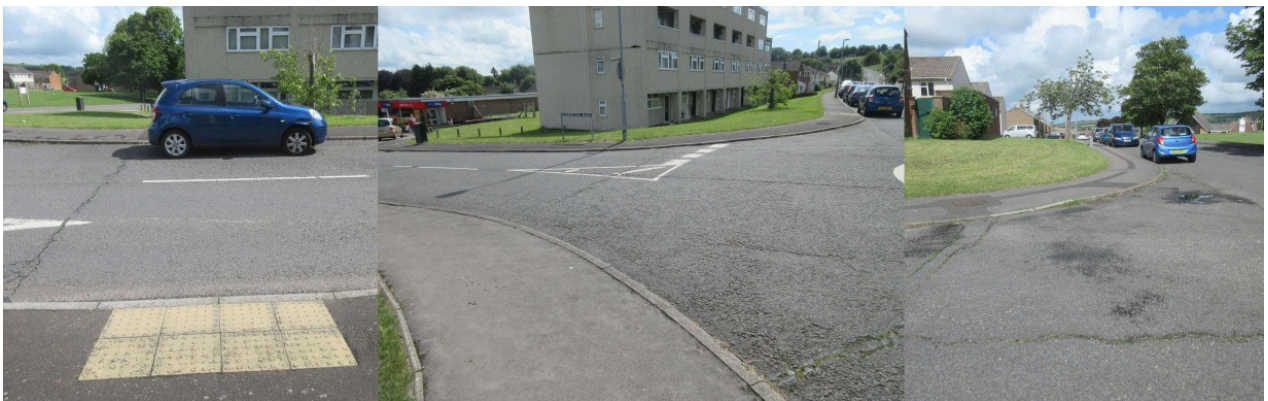
12

Drop-kerb crossing point of Bishopdown Road by Bishop's Court flats – a car is impeding the crossing point, therefore thought should be given to marking this as a proper crossing point. Similarly, at the junction of Barrington Road with Bishopdown Road there is no crossing point at all for wheelchair and other less able users. Thirdly, the entrance of Gilbert Way has no drop kerb crossing point at all.

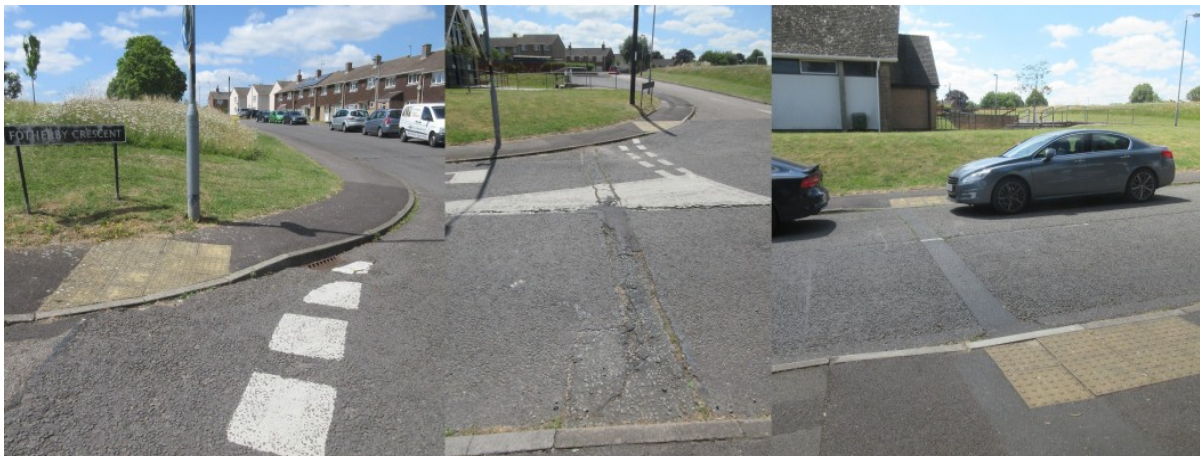
Drop-kerb at entrance of Fotherby Crescent from Bishopdown Road, surface missing and drop-kerb is raised, very difficult for a wheelchair. Poor road surface on Bishopdown Road by Catholic Church. Drop-kerb crossing point of Bishopdown Road by Catholic Church – a vehicle parked on it, thought should be given to designating such crossing places against parking.

13	Bishopdown Road (In Vicinity of Junction with Fotherby Crescent)	Dropped kerb is not flush with the road surface	Highways Maintenance	Dropped kerbs don't have to be flush with the road surface and would typically have up to a 6mm upstand but can have up to a 25mm upstand before becoming a significant trip hazard. Existing dropped kerb is generally within these tolerances. However, there is small amount of carriageway delamination which could be filled with tarmac to improve use of the crossing point for wheelchair/mobility scooter users.
		Poor carriageway surface	Highways Maintenance	The carriageway surface is not a hazard to users. The only way to address it would be for the road to be resurfaced.
		Dropped kerb crossing point by Church obstructed by parked vehicles	Traffic Engineering LHFIFG	Provide white bar marking in front of dropped kerbs.

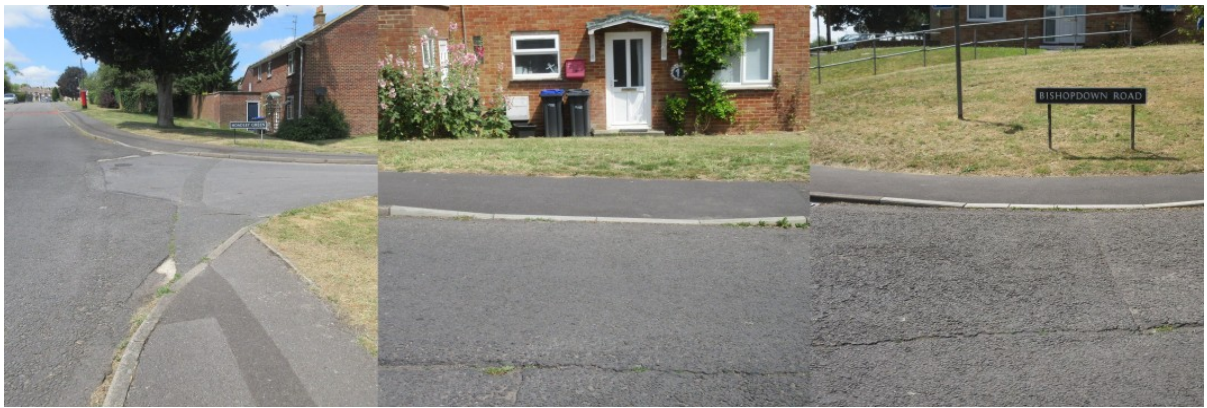
Drop-kerbs. First is lower entry to Hoadley Green, again really poorly done with degraded road surface, proud stones and uneven and narrow paving. Second and Third are drop-kerb crossing point at bottom of Bishopdown Road, the kerb stones again proud.

15	Bishopdown Road (In Vicinity of Junctions with Hoadley Green and Seth Ward Drive)	Hoadley Green dropped kerb has been poorly done (Bottom Junction)	Traffic Engineering LHFIG	The existing dropped kerbs are very narrow and have been poorly installed. Existing dropped kerbs should be improved. However, should be considered a lower priority for action than locations where no dropped kerbs exist.
		Poor carriageway and footway surface (Hoadley Green Bottom Junction)	Highways Maintenance	Neither the carriageway nor the footway is a hazard to users. The only way to address this issue would be for the road and footway to be resurfaced.
		Dropped kerb is not flush with the road surface	Highways Maintenance	Dropped kerbs don't have to be flush with the road surface and would typically have up to a 6mm upstand but can have up to a 25mm upstand before becoming a significant trip hazard. Existing dropped kerb is within these tolerances. No further action required.

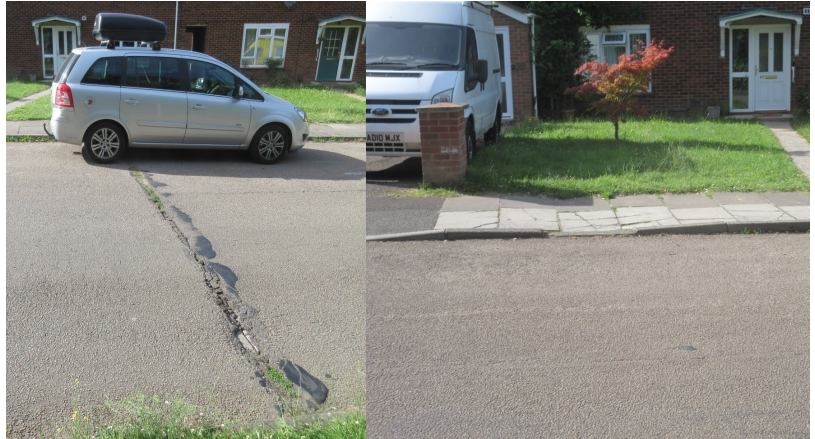
17 - Outside No.49 Denison Rise a join in the road becoming a trench. And, a kerb stone and paving which has dropped.

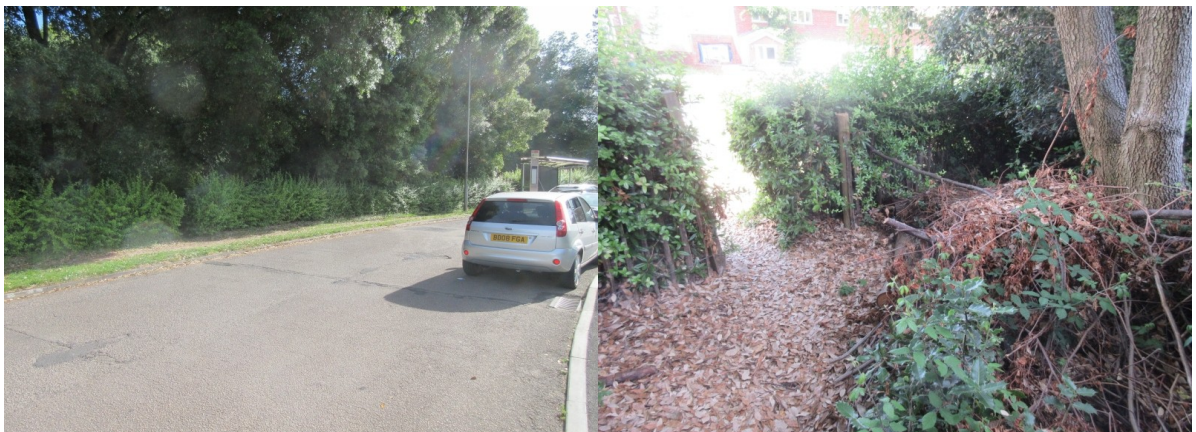
Further up Denison Rise a gap in the hedge forming the boundary of the Crematorium Garden of Remembrance, has been repeatedly forced by a local dog-walker. A recent repair with wire fencing and a pile of logs and brushwood was taken apart within a day by the offending person.

18	Denison Rise	Gap in hedge between Crematorium Grounds and Denison Rise being created by dog walkers	Salisbury City Council	Salisbury City Council to advise on potential remedial actions at this location.
19	Denison Rise	Gully blocked with vegetation	Highways Maintenance	Gully needs to be cleared.
20	Linkway	Missing street nameplate	Highways Maintenance	Street nameplate replaced in 2020. No further action required.
21	Linkway	Dead/dying cherry blossom tree	Salisbury City Council	Salisbury City Council to advise on potential remedial actions at this location.
22	Linkway	Raised slabs on steps/footway leading to Bishopdown Road	Highways Maintenance	No issues that required remedial action were noted with this footway during most recent highway inspection. Footway to be monitored as part of regular highways maintenance activities.

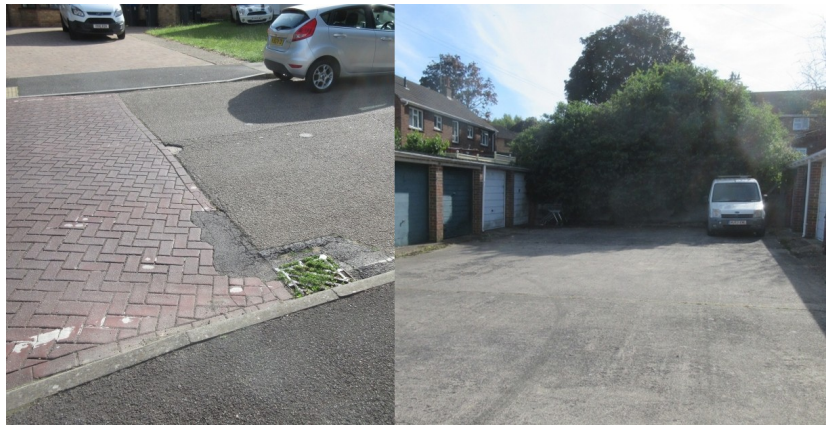
19- This drain, just above the junction of Denison Rise and Link Way, and outside No. 16 Denison Rise, is blocked with grass.

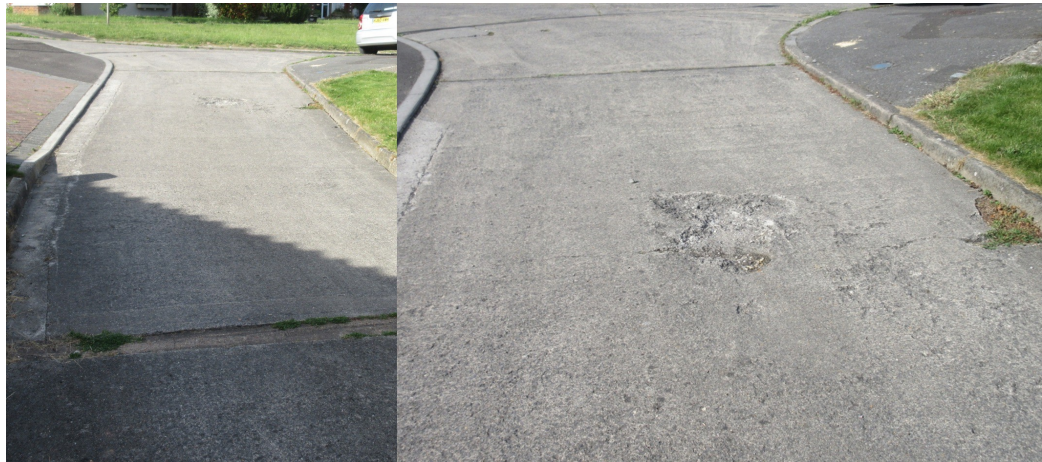
23-

A trench left across the road at entry to garages. A hole left at entry of garages - a child on a scooter caught a wheel on it and fell as I crossed the road.

Location	Road Name	Issue(s)	Responsibility	Potential Action Required
23	Talbot Close	Trench in road (broken carriageway surface)	Housing Department	Trench is a joint in the carriageway surfacing and is a consequence of how the carriageway surfacing was laid. The only way to address it would be for the road to be resurfaced. Housing Department to advise on potential remedial actions at this location.
		Pothole in road		Minor damage to concrete road surface. Damage appears to have been in place for a minimum of 12 years so, whilst needing to be addressed, is a relatively minor issue. Issue could be addressed by filling the pothole or resurfacing the road. Housing Department to advise on potential remedial actions at this location
		Are all the garages used to park cars		Whilst ideally the garages should be used to store vehicles, they can be used to store anything by the person hiring them. No further action required.

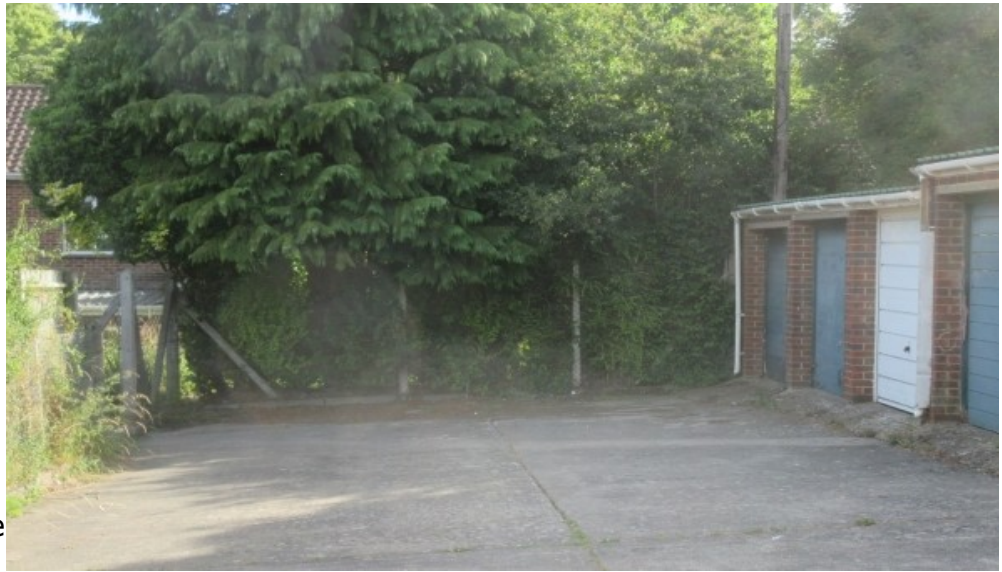
25- The lower garages in Lovett Green, being close to the main entry to the Estate, is often a dumping ground of litter.

There is a spread of scree/litter dropped from the fir trees.

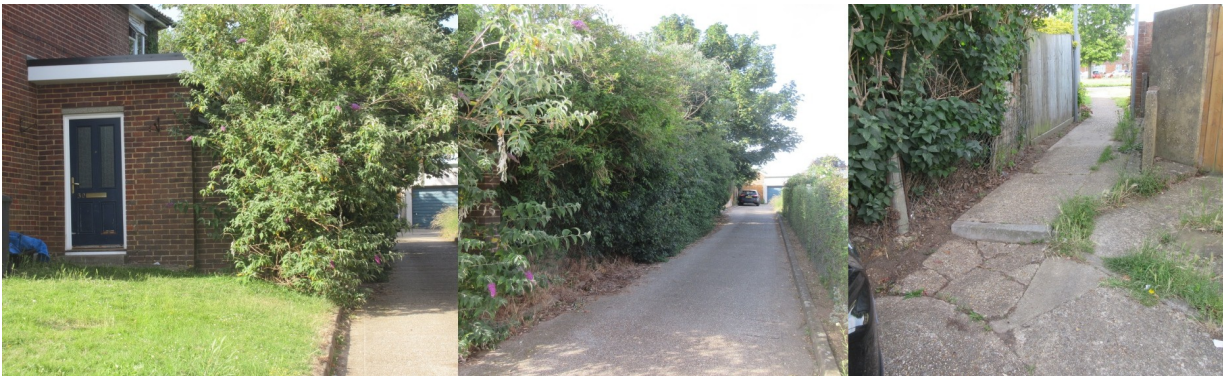
26-

Tenant at 30 Lovett Green has allowed a buddleia to get out of hand on front steps of property. Also the garden is so overgrown that it impinges the access road to the upper garages of Lovett Green. Can WC assist tenant with this problem?
Pathway from upper garages of Lovett Green to Neville Close – drop kerb needed here and correction of dip in road surface.

Location	Road Name	Issue(s)	Responsibility	Potential Action Required
26	Lovett Green	General condition of access road to upper garage area	Housing Department	Housing Department to advise on potential remedial actions at this location.
		Damaged footway surface Footway leading to Neville Close		The only way to address it would be for the footway to be resurfaced. Housing Department to advise on potential remedial actions at this location.
		No dropped kerb on footway leading to Neville Close		No specific evidence that dropped kerb is require at this location. Potential to provide a ramp at this location which would address the damaged footway at this location. Housing Department to advise on potential remedial actions at this location.
27	Blyth Way	General condition of access road to garage area	Housing Department	Housing Department to advise on potential remedial actions at this location.
		No dropped kerb crossing point across access road to the garages	Traffic Engineering LHFIG	Provide dropped kerb crossing point.

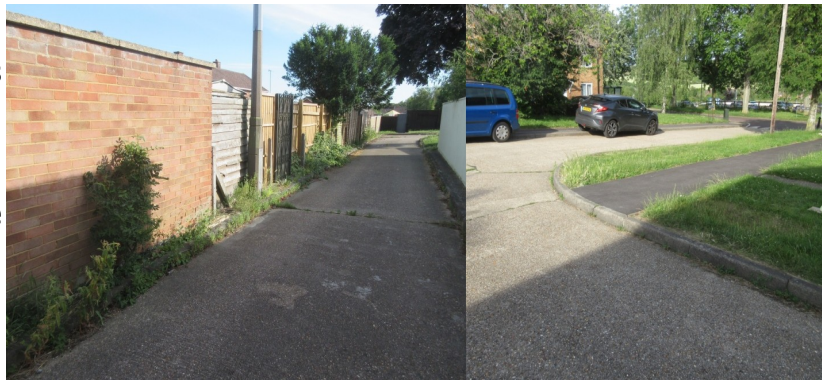
27b- Drop-kerb needed outside 2 Blyth Way to match the one outside 3 Blyth Way.

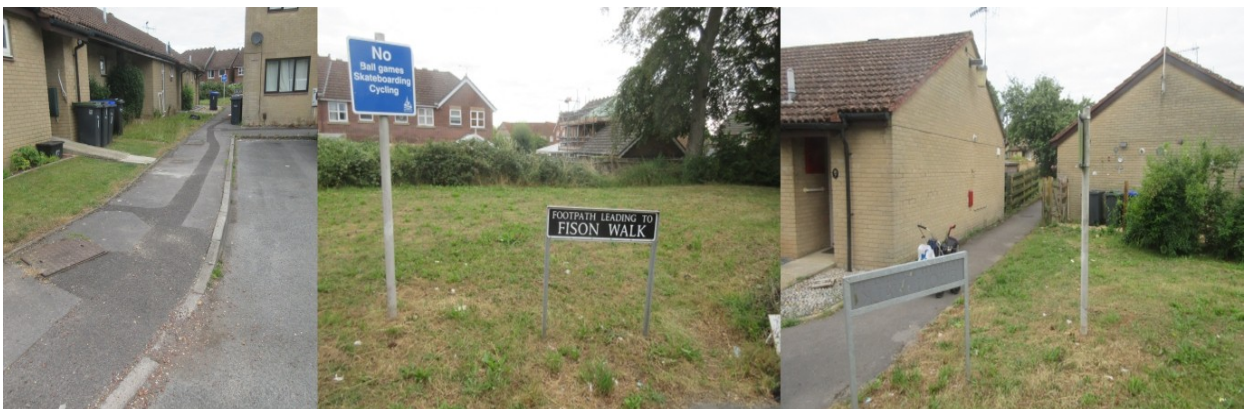
42

Footway in Hallum Close leading to Fison Walk. Many of the residents of Fison Walk are elderly and less-abled, several appear to use wheelchairs. This drop-kerb and footway are alike in poor condition, and are representative of general conditions.

Uneven footway surface	Highways Maintenance	The only way to address the issue would be for the footway to be resurfaced.
43	Hallum Close / Jewell Close	General weed growth and debris in the kerb channel.	Salisbury City Council	Weed killing and road sweeping required. Salisbury City Council to advise on potential remedial actions at this location.
44	Fison Walk (Area between No. 27 and 29)	Area overgrown and covered in garden waste	Housing Department	Housing Department to advise on potential remedial actions at this location. Salisbury City Council may need to address garden waste issue if this is considered a fly-tipping issue.
45	Fison Walk	Gully blocked with vegetation (Outside of Nos. 31 and 33).	Highways Maintenance	Gully needs to be cleared.

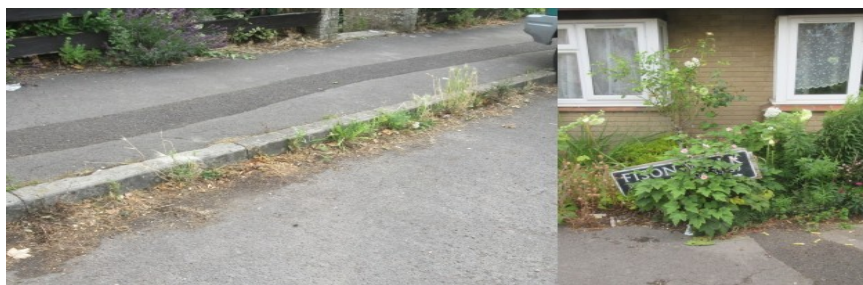
43- General state of kerbs and gutters – debris and weeds.

Sign for lower part of Fison Walk needs reinstating.

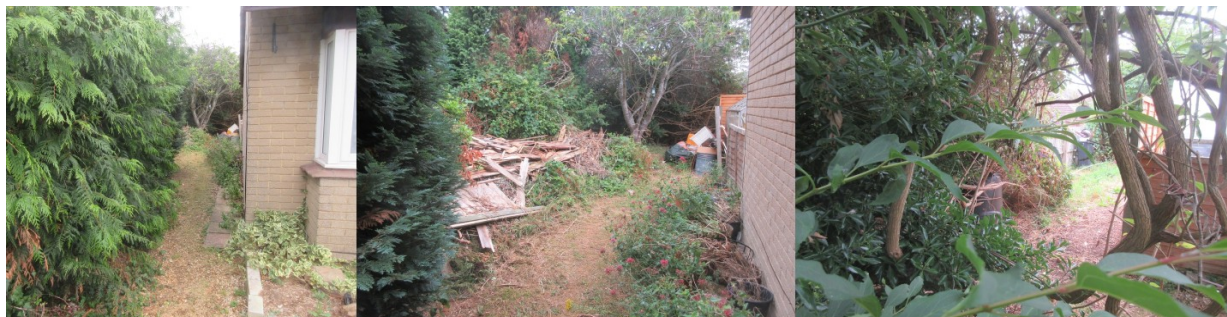
44

Between Nos. 29 & 31 Fison Walk an access path was left when built to allow residents to get to and from rear gardens. This has now become overgrown with trees and shrubs and a haven for litter and overflow of people's gardens. The elderly residents are unable to bring bins out from the rear – this has apparently been seen by Mostyn Coombes in June 27th 2019. What is being done?

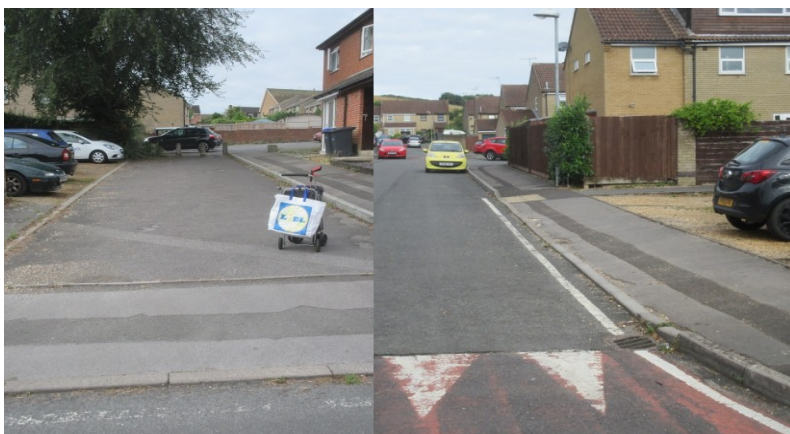
Drop-kerb from Jewell Close into footpath through to Bishopdown Farm estate. The kerbs here are typical of the area generally.

Location	Road Name	Issue(s)	Responsibility	Comments / Potential Action Required
46	Jewell Close	Poorly installed dropped kerbs on pedestrian route from Bingham Road to Bishopdown Farm	Highways Maintenance Housing Department	Existing dropped kerbs are generally okay and within acceptable tolerances. The only exception being the dropped kerb that provides the access to the off-street parking area in front of Nos. 37-41 Jewell Close where the kerb upstand is on the threshold for intervention. However, this dropped kerb is not essential to the pedestrian route and shouldn't be considered a priority for replacing/improving. No further action required.
47	Fison Walk	Improved street nameplates required	Traffic Engineering LHFIG	Provided replacement and additional street nameplates. Proposals to provide improved street nameplates in Fison Walk have been designed and costed
