**Summary Review of Issues Raised in Bishopdown Estate Report**

# Bishopdown Residents Association

## Survey of Bishopdown Estate – 2019

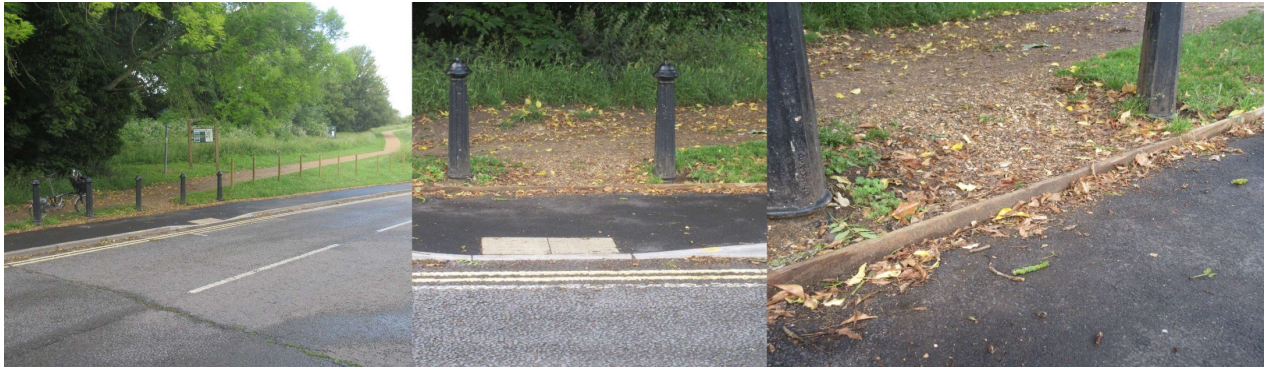
1-

Where cycleway over hill meets Bishopdown Rd by school, the contractors who tarmac-surfaced the footway left their framing timber all the way up the road. For most of the way there is a gap between the timber and the grass beyond, which acts as a litter trap. Here, the timber stands proud by 2inches, impeding cycle and wheelchair access to the cycleway over Bishopdown Hill.

Location	Road Name	Issue(s)	Responsibility	Potential Action Required
1	<a href="#">Bishopdown Road</a>	Trip hazard	Highways Maintenance	Trip hazard created through the provision of the new tarmac footway as part of maintenance resurfacing works. Level difference needs to be removed.
		Overgrown path	Salisbury City Council	Path needs to be cleared.
2	<a href="#">Bishopdown Road</a>	Dirty signs	Highways Maintenance	Signs need to be cleaned
		Pothole		Pothole is a joint in the carriageway surfacing and is a consequence of how the carriageway surfacing was laid. The only way to address it would be for the road to be resurfaced.
3	<a href="#">Bishopdown Road</a>	Dirty signs	Highways Maintenance	Signs need to be cleaned.
		Detritus around splitter island	Salisbury City Council	Area around the splitter island needs to be cleaned.
4	<a href="#">Bishopdown Road</a>	Trenches in road (broken carriageway surface)	Highways Maintenance	Trenches are actually joints in the carriageway surfacing and are a consequence of how the carriageway surfacing was laid. The only way to address them would be for the road to be resurfaced.

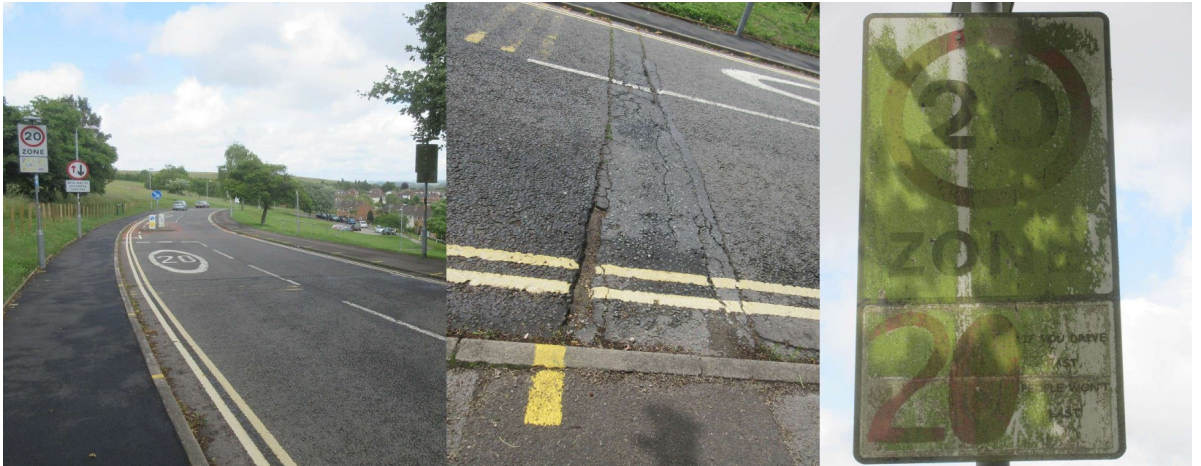
2-

Entry of 20mph zone, top of Bishopdown Hill. The 20mph sign is filthy, mostly due to being close to tree overhang. Adjacent to it a trench in the road needs filling again.

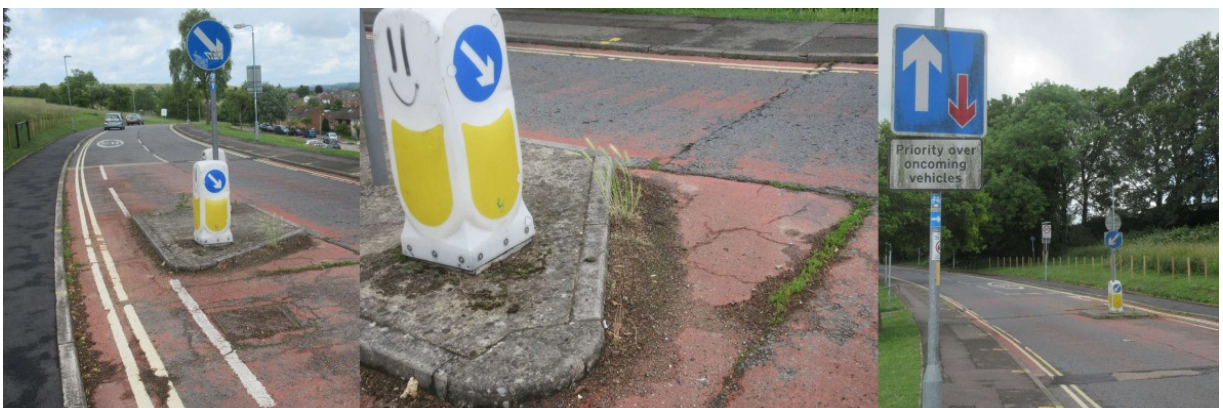
3

Entry of 20mph zone, top of Bishopdown Hill. Cycle bypass is filthy, the signs are filthy, the island is surrounded by scree which has vegetation growing in it.

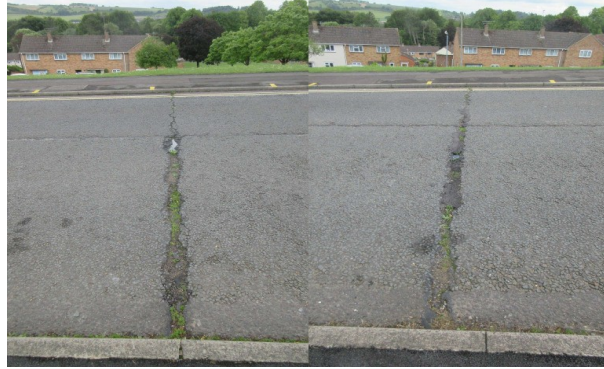
4  
Bishopdown Hill, two trenches that require filling, both overlooking houses below Bishopdown Road. They both held water when I was there.

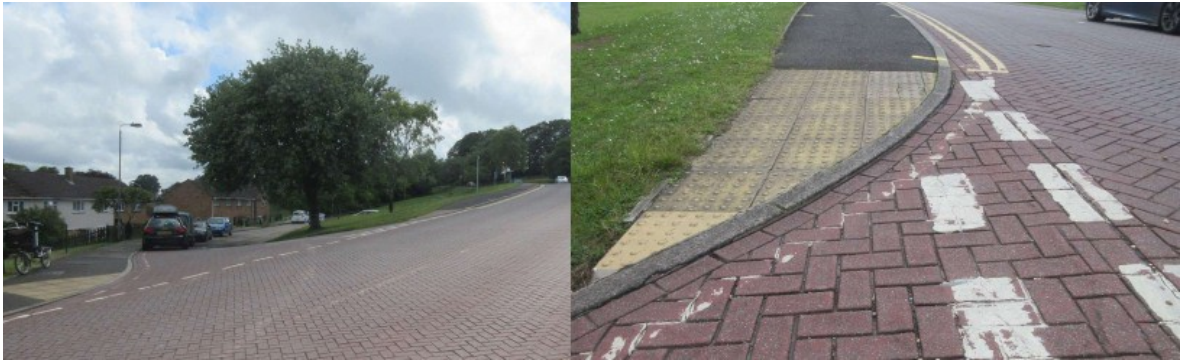
Entry road of houses below Bishopdown Road. This drop-kerb is steep and angled and the kerb-stones are not flush with the road.

5	<a href="#">Bishopdown Road</a>	Dropped kerb is not flush with the road surface	Highways Maintenance	Dropped kerbs don't have to be flush with the road surface and would typically have up to a 6mm upstand but can have up to a 25mm upstand before becoming a significant trip hazard. Existing dropped kerb is within these tolerances. No further action required.
6	<a href="#">Bishopdown Road (Junction with Denison Rise)</a>	Dropped kerb is not flush with the road surface	Highways Maintenance	Dropped kerbs don't have to be flush with the road surface and would typically have up to a 6mm upstand but can have up to a 25mm upstand before becoming a significant trip hazard. Existing dropped kerb is within these tolerances. No further action required.
		Uneven footway surface		The only way to address the issue would be for the footway to be resurfaced.
		Missing street nameplate (Denison Rise)		Street nameplate replaced in 2020. No further action required.

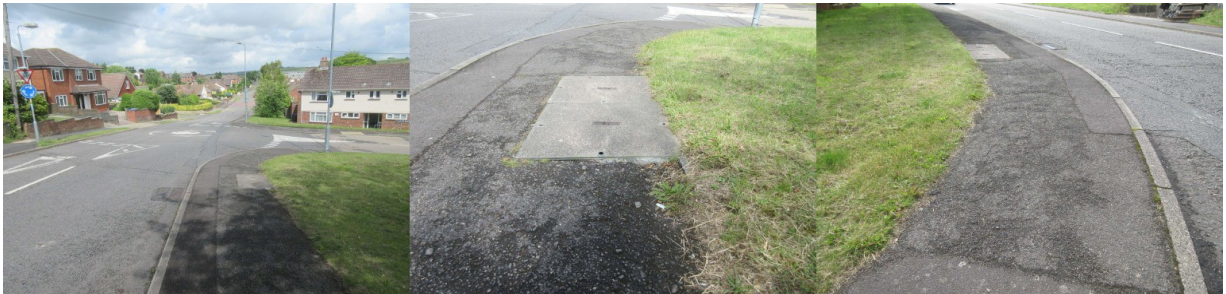
6a

Junction of Bishopdown Road and Denison Rise (right). This steep section of footway is bumpy and degraded, especially where the inspection cover is, part of the inspection cover frame stands clear and is a tripping hazard. This whole section needs relaying.

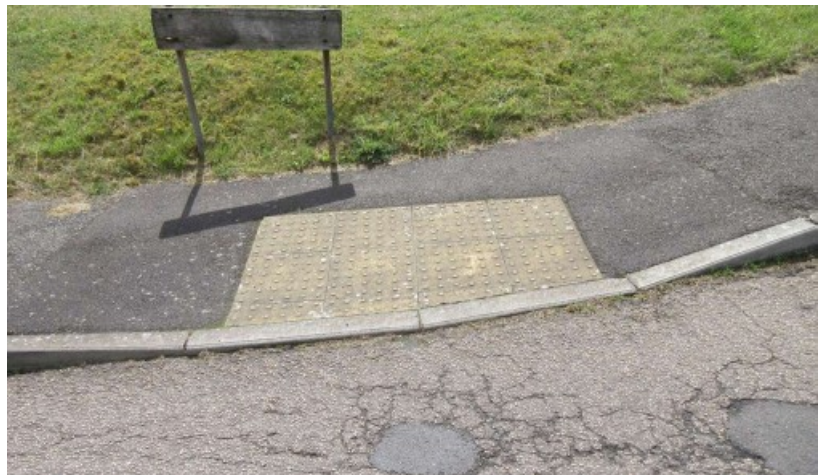
6b Crossing point of Denison Rise, drop-kerbs are not flush – which must exacerbate the steep slope for wheelchair users. Road surface is somewhat degraded too at this point. The street sign for Denison Rise is missing.

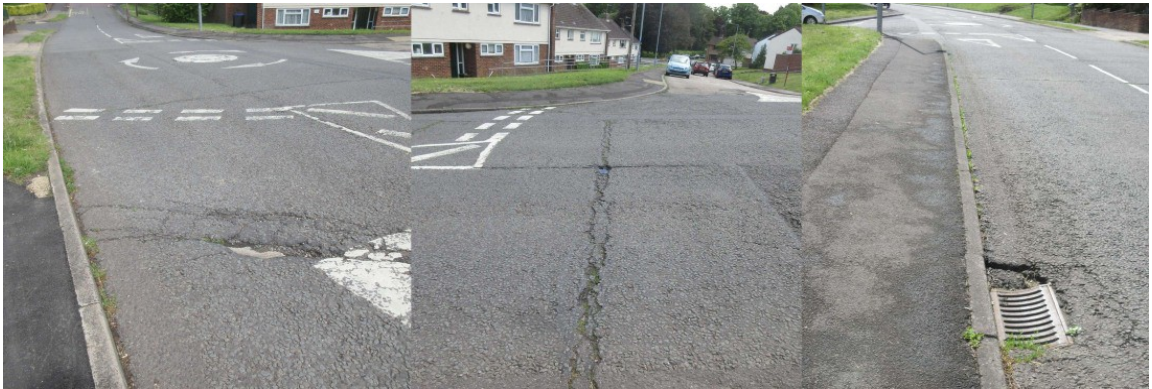
Broken road surfaces above, and below, the roundabout junction of Bishopdown Road and Denison Rise. Below the junction, this drain has sunken hazardously.

Location	Road Name	Issue(s)	Responsibility	Potential Action Required
7	<a href="#">Bishopdown Road (Junction with Denison Rise)</a>	Broken carriageway surface	Highways Maintenance	The broken carriageway surface is a consequence of how the carriageway surfacing was laid. The only way to address it would be for the road to be resurfaced.
		Sunken gully		Tarmac around gully frame is slightly cracked. Gully doesn't appear to have sunken significantly. Gully to be monitored as part of regular highways maintenance activities.
8	<a href="#">Bishopdown Road (Junction with Denison Rise)</a>	Broken carriageway surface	Highways Maintenance	The broken carriageway surface is a consequence of how the carriageway surfacing was laid. The only way to address it would be for the road to be resurfaced.
		Gully is in poor condition		Tarmac around gully frame is slightly cracked. Gully hasn't sunken and is satisfactory condition. Gully to be monitored as part of regular highways maintenance activities.

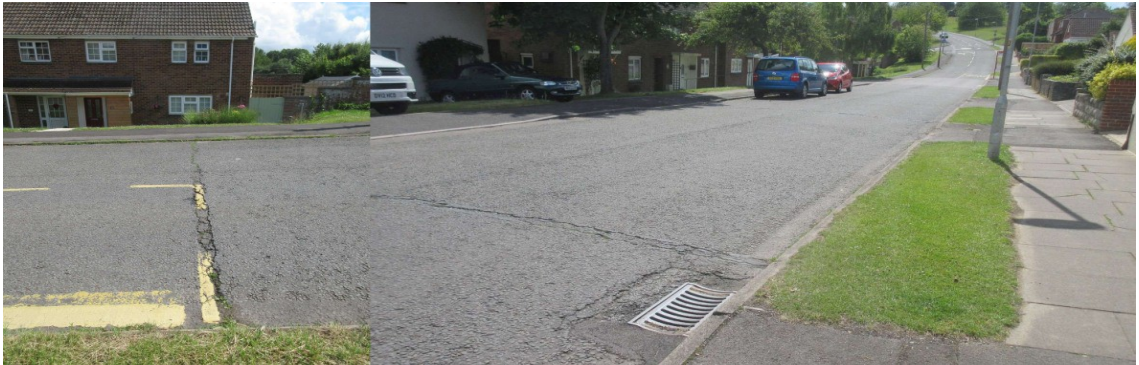
8

Trench opposite 32 Bishopdown Road. Further down the road a poor Drain Cover.

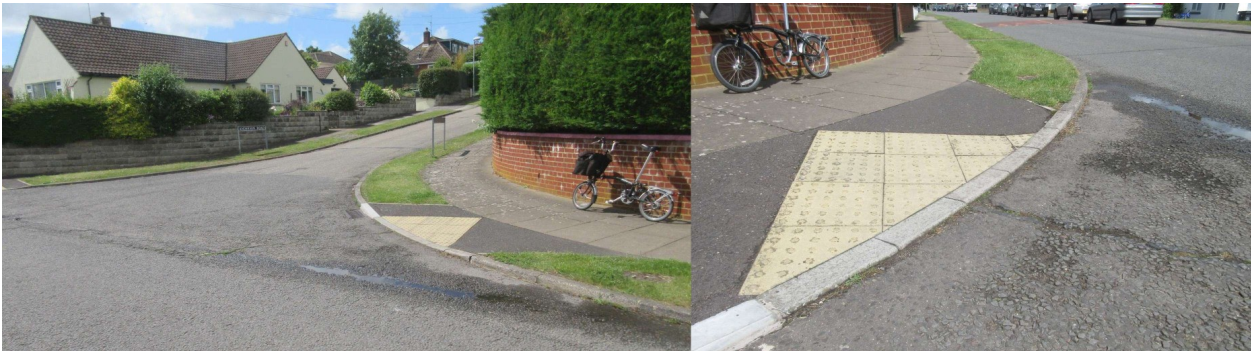
Footway crossing entrance from Bishopdown Road from Anderson Road. The road surface is poor, and the drop kerb is not flush with the road surface.

9	<a href="#">Bishopdown Road (Junction with Anderson Road)</a>	Dropped kerb is not flush with the road surface	Highways Maintenance	Dropped kerbs don't have to be flush with the road surface and would typically have up to a 6mm upstand but can have up to a 25mm upstand before becoming a significant trip hazard. Existing dropped kerb is within these tolerances. No further action required.
		Poor carriageway surface		The carriageway surface is not a hazard to users. The only way to address it would be for the road to be resurfaced.
10	<a href="#">Bishopdown Road (Junction with Bingham Road)</a>	Dropped kerb is not flush with the road surface	Highways Maintenance	Dropped kerbs don't have to be flush with the road surface and would typically have up to a 6mm upstand but can have up to a 25mm upstand before becoming a significant trip hazard. Existing dropped kerb is within these tolerances. No further action required.

Poor carriageway surface		The carriageway surface is not a hazard to users. The only way to address it would be for the road to be resurfaced.

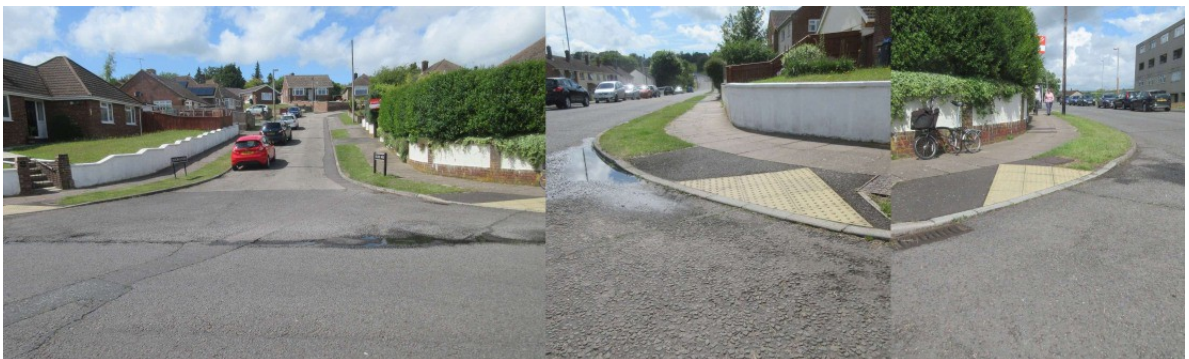
10

Entry of Bingham Road from Bishopdown Road. Poor road surface and drop kerbs not flush with road surface.

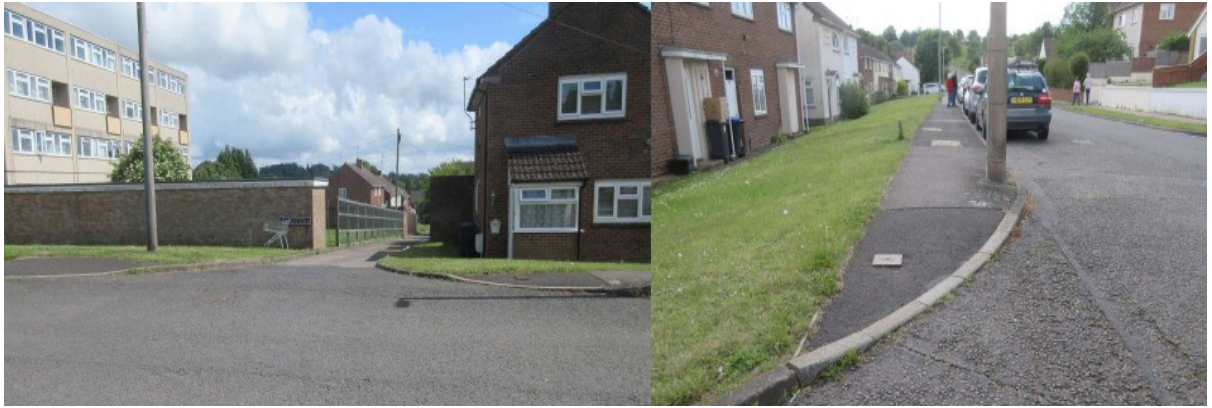
Junction of Bishopdown Road with lane/garages to Burgess Green. The drop kerb here is again poor and not flush with the road surface.

<b>Location</b>	<b>Road Name</b>	<b>Issue(s)</b>	<b>Responsibility</b>	<b>Potential Action Required</b>
11	<a href="#">Bishopdown Road (Junction with Footpath to Burgess Green)</a>	Dropped kerb is not flush with the road surface	Highways Maintenance	Dropped kerbs don't have to be flush with the road surface and would typically have up to a 6mm upstand but can have up to a 25mm upstand before becoming a significant trip hazard. Existing dropped kerb is within these tolerances. No further action required.
12	<a href="#">Bishopdown Road (In Vicinity of Junction with Barrington Road)</a>	Dropped kerb crossing point by Bishops Court obstructed by parked vehicles	Traffic Engineering CATG	Provide white bar marking in front of dropped kerbs.
		No dropped kerb crossing point across Barrington Road	Traffic Engineering CATG	Provide dropped kerb crossing point.
		No dropped kerb crossing point across Gilbert Way	Traffic Engineering CATG	Dropped kerb crossing point already exists at this location. No further action required.

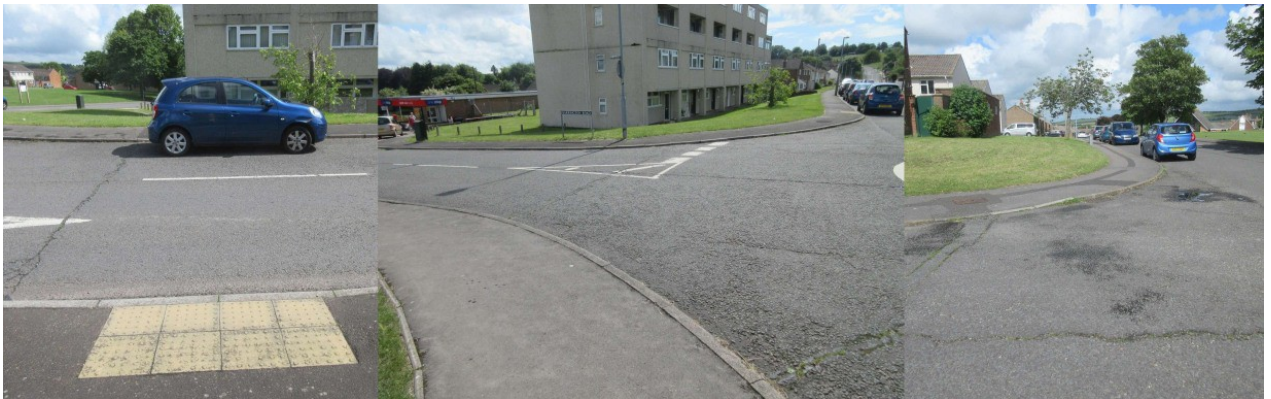
12

Drop-kerb crossing point of Bishopdown Road by Bishop's Court flats – a car is impeding the crossing point, therefore thought should be given to marking this as a proper crossing point. Similarly, at the junction of Barrington Road with Bishopdown Road there is no crossing point at all for wheelchair and other less able users. Thirdly, the entrance of Gilbert Way has no drop kerb crossing point at all.

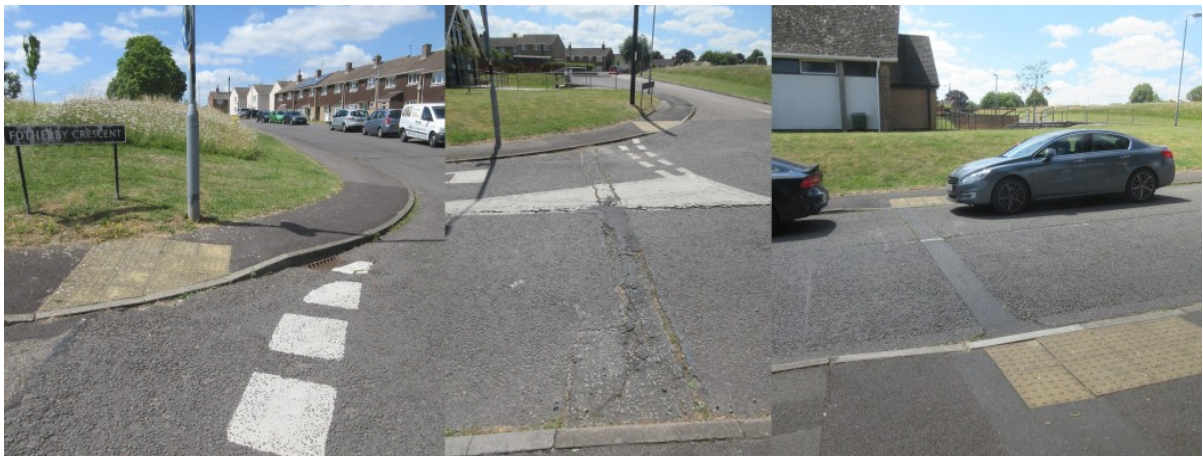
Drop-kerb at entrance of Fotherby Crescent from Bishopdown Road, surface missing and drop-kerb is raised, very difficult for a wheelchair. Poor road surface on Bishopdown Road by Catholic Church. Drop-kerb crossing point of Bishopdown Road by Catholic Church – a vehicle parked on it, thought should be given to designating such crossing places against parking.

13	<a href="#">Bishopdown Road (In Vicinity of Junction with Fotherby Crescent)</a>	Dropped kerb is not flush with the road surface	Highways Maintenance	Dropped kerbs don't have to be flush with the road surface and would typically have up to a 6mm upstand but can have up to a 25mm upstand before becoming a significant trip hazard. Existing dropped kerb is generally within these tolerances. However, there is small amount of carriageway delamination which could be fill with tarmac to improve use of the crossing point for wheelchair/mobility scooter users.
		Poor carriageway surface	Highways Maintenance	The carriageway surface is not a hazard to users. The only way to address it would be for the road to be resurfaced.
		Dropped kerb crossing point by Bishops Court obstructed by parked vehicles	Traffic Engineering CATG	Provide white bar marking in front of dropped kerbs.

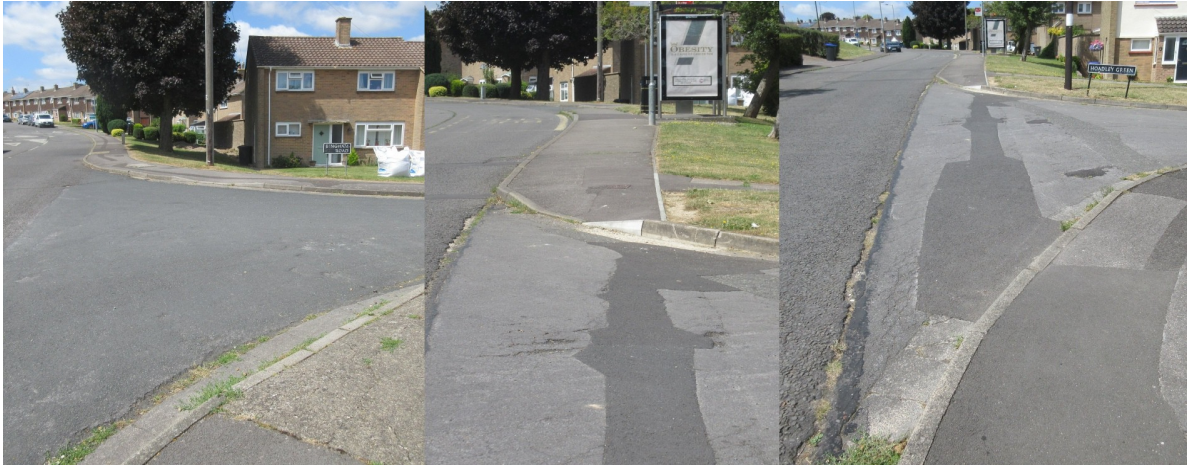
Drop-kerbs. First image is Bingham Road and Bishopdown Road by Catholic Church, very poorly done. Second & Third are upper entry of Hoadley Green, the drop-kerb is only applied to one-third width of the pavement, it stands proud of the road, the surface of which is poor.

<b>Location</b>	<b>Road Name</b>	<b>Issue(s)</b>	<b>Responsibility</b>	<b>Potential Action Required</b>
14	<a href="#">Bishopdown Road (In Vicinity of Junctions with Bingham Road and Hoadley Green)</a>	Bingham Road dropped kerb has been poorly done	Highways Maintenance Traffic Engineering CATG	The existing dropped kerbs have been poorly installed. However, the presence of nearby dropped kerbs driveway accesses which could be used to cross Bingham Road means that they shouldn't be considered a priority for replacing/improving. No further action required.
		Hoadley Green dropped kerb has been poorly done (Top Junction)	Traffic Engineering CATG	The existing dropped kerbs are very narrow. have been poorly installed. Existing dropped kerbs should be improved. However, should be considered a lower priority for action than locations where no dropped kerbs exist.
		Poor carriageway surface (Hoadley Green Top Junction)	Highways Maintenance	The carriageway surface is not a hazard to users. The only way to address it would be for the road to be resurfaced.

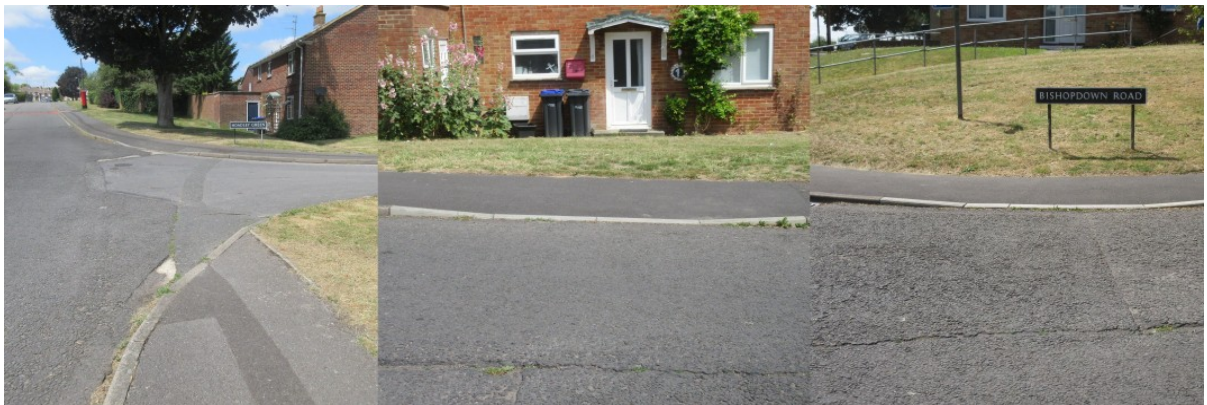
Drop-kerbs. First is lower entry to Hoadley Green, again really poorly done with degraded road surface, proud stones and uneven and narrow paving. Second and Third are drop-kerb crossing point at bottom of Bishopdown Road, the kerb stones again proud.

15	<a href="#">Bishopdown Road (In Vicinity of Junctions with Hoadley Green and Seth Ward Drive)</a>	Hoadley Green dropped kerb has been poorly done (Bottom Junction)	Traffic Engineering CATG	The existing dropped kerbs are very narrow. have been poorly installed. Existing dropped kerbs should be improved. However, should be considered a lower priority for action than locations where no dropped kerbs exist.
		Poor carriageway and footway surface (Hoadley Green Bottom Junction)	Highways Maintenance	Neither the carriageway nor the footway is a hazard to users. The only way to address this issue would be for the road and footway to be resurfaced.
		Dropped kerb is not flush with the road surface	Highways Maintenance	Dropped kerbs don't have to be flush with the road surface and would typically have up to a 6mm upstand but can have up to a 25mm upstand before becoming a significant trip hazard. Existing dropped kerb is within these tolerances. No further action required.

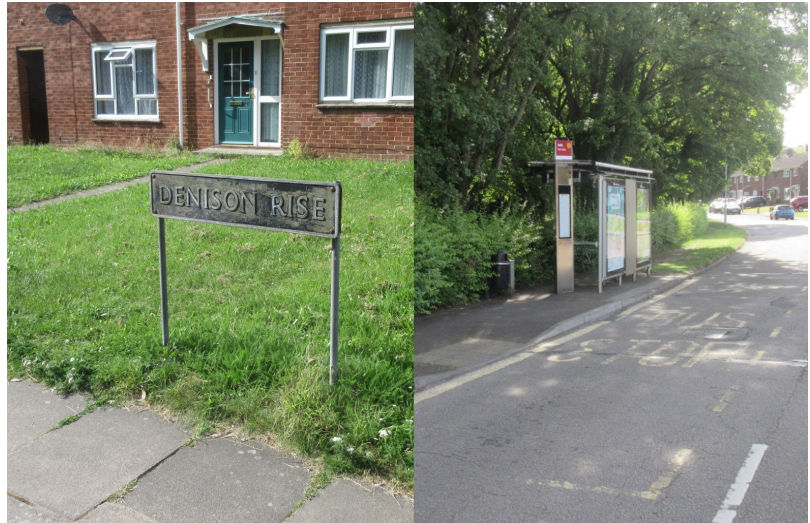
16a- Bus Stop in Denison Rise by entry to Burgess Green. This bus stop, placed on a narrow green verge, has its back to the road, and is often daubed with graffiti. The enclosed nature of it, often with overhanging greenery, makes it a potentially threatening environment.

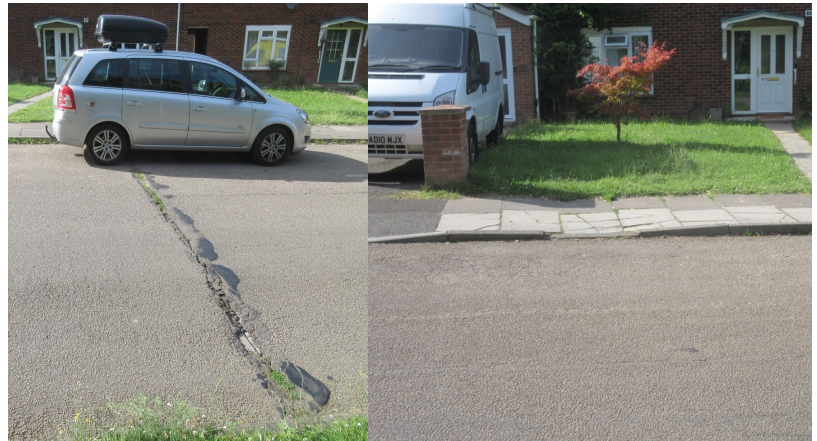
17 - Outside No.49 Denison Rise a join in the road becoming a trench. And, a kerb stone and paving which has dropped.

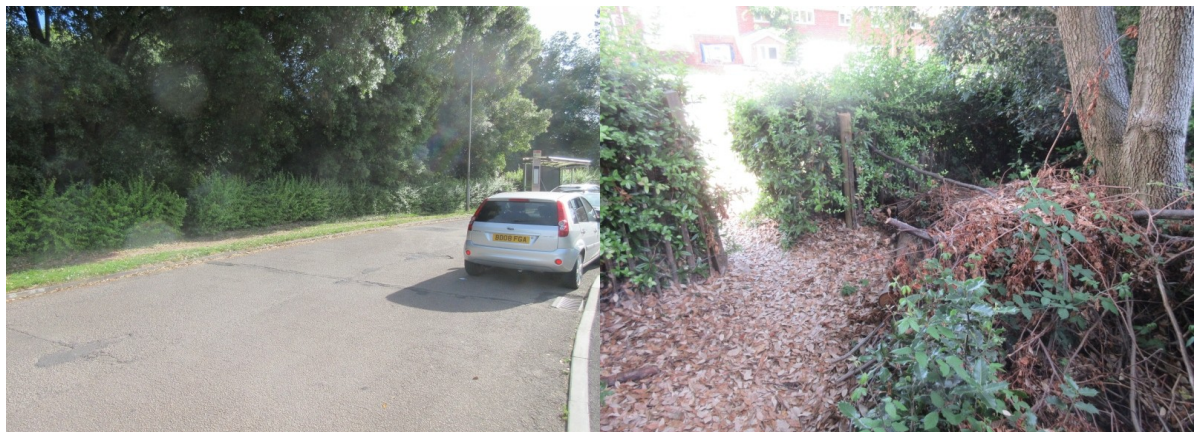
Further up Denison Rise a gap in the hedge forming the boundary of the Crematorium Garden of Remembrance, has been repeatedly forced by a local dog-walker. A recent repair with wire fencing and a pile of logs and brushwood was taken apart within a day by the offending person.

18	<a href="#">Denison Rise</a>	Gap in hedge between Crematorium Grounds and Denison Rise being created by dog walkers	Salisbury City Council	Salisbury City Council to advise on potential remedial actions at this location.
19	<a href="#">Denison Rise</a>	Gully blocked with vegetation	Highways Maintenance	Gully needs to be cleared.
20	<a href="#">Linkway</a>	Missing street nameplate	Highways Maintenance	Street nameplate replaced in 2020. No further action required.
21	<a href="#">Linkway</a>	Dead/dying cherry blossom tree	Salisbury City Council	Salisbury City Council to advise on potential remedial actions at this location.
22	<a href="#">Linkway</a>	Raised slabs on steps/footway leading to Bishopdown Road	Highways Maintenance	No issues that required remedial action were noted with this footway during most recent highway inspection. Footway to be monitored as part of regular highways maintenance activities.

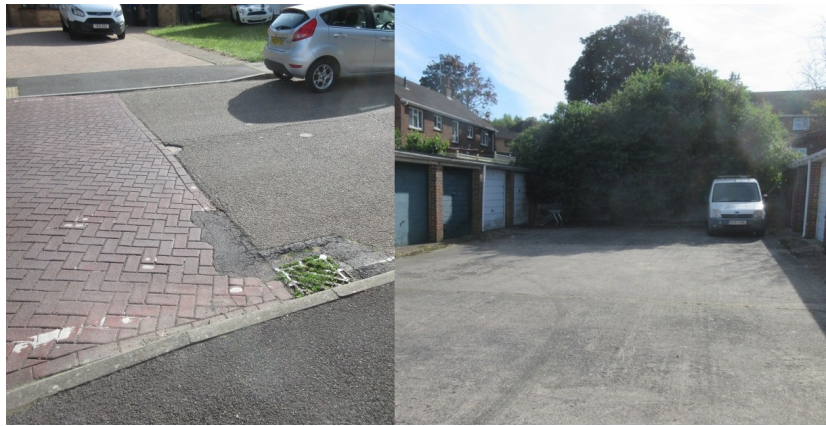
19- This drain, just above the junction of Denison Rise and Link Way, and outside No. 16 Denison Rise, is blocked with grass.

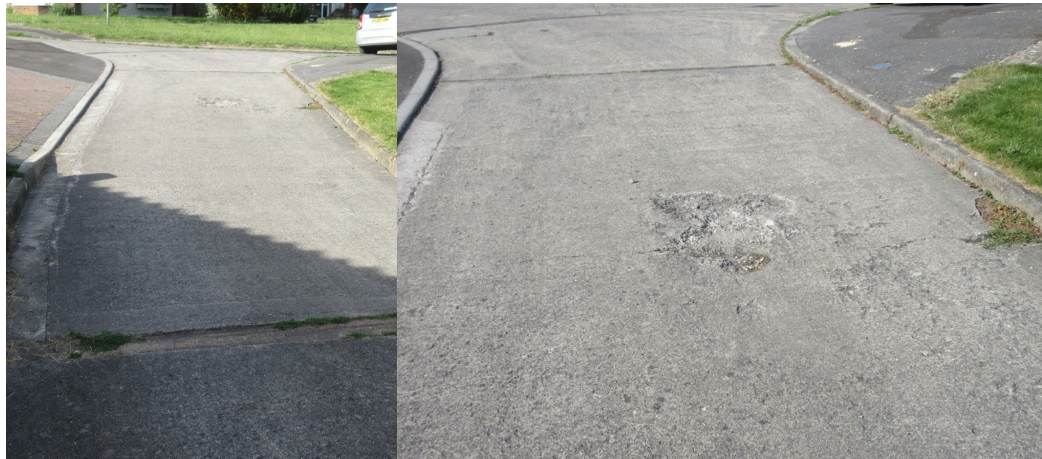
23-

A trench left across the road at entry to garages. A hole left at entry of garages - a child on a scooter caught a wheel on it and fell as I crossed the road.

Location	Road Name	Issue(s)	Responsibility	Potential Action Required
23	<a href="#">Talbot Close</a>	Trench in road (broken carriageway surface)	Housing Department	Trench is a joint in the carriageway surfacing and is a consequence of how the carriageway surfacing was laid. The only way to address it would be for the road to be resurfaced. Housing Department to advise on potential remedial actions at this location.
		Pothole in road		Minor damage to concrete road surface. Damage appears to have been in place for a minimum of 12 years so, whilst needing to be addressed, is a relatively minor issue. Issue could be addressed by filling the pothole or resurfacing the road. Housing Department to advise on potential remedial actions at this location
		Are all the garages used to park cars		Whilst ideally the garages should be used to store vehicles, they can be used to be store anything by the person hiring them. No further action required.

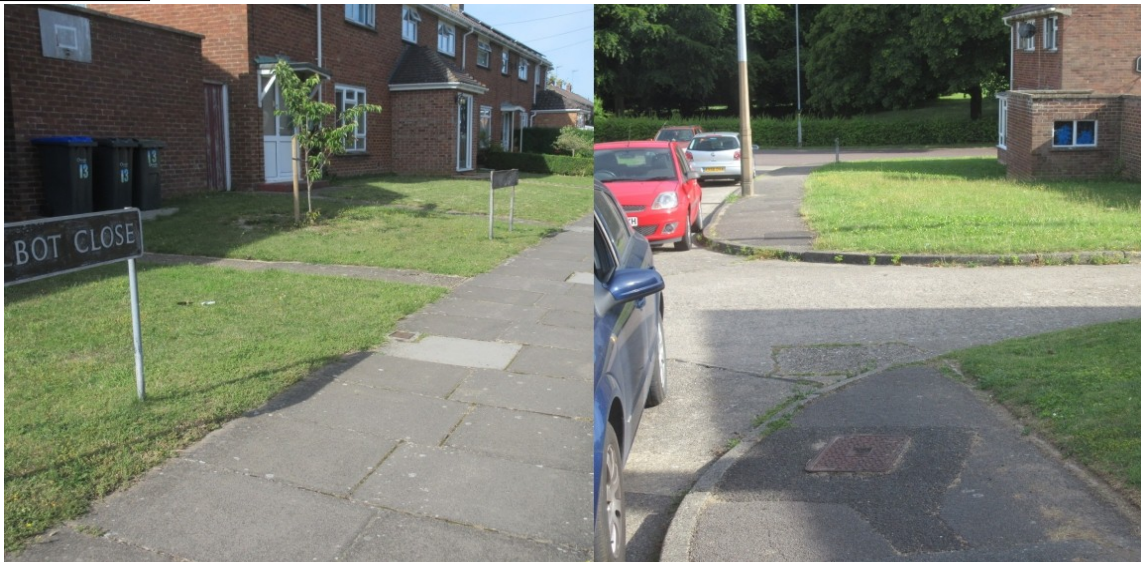
24-

Sign for Burgess Green missing between Burgess Green and Talbot Close. Drop-kerbs are required at the entrance of the garages in Burgess Green.

24	<a href="#">Burgess Green</a>	Missing street nameplate	Highways Maintenance	Street nameplate replaced in 2020. No further action required.
		No dropped kerb crossing point across access road to the garages	Traffic Engineering CATG	Provide dropped kerb crossing point.
25	<a href="#">Lovett Green</a>	General condition of lower garage area	Housing Department	Housing Department to advise on potential remedial actions at this location.

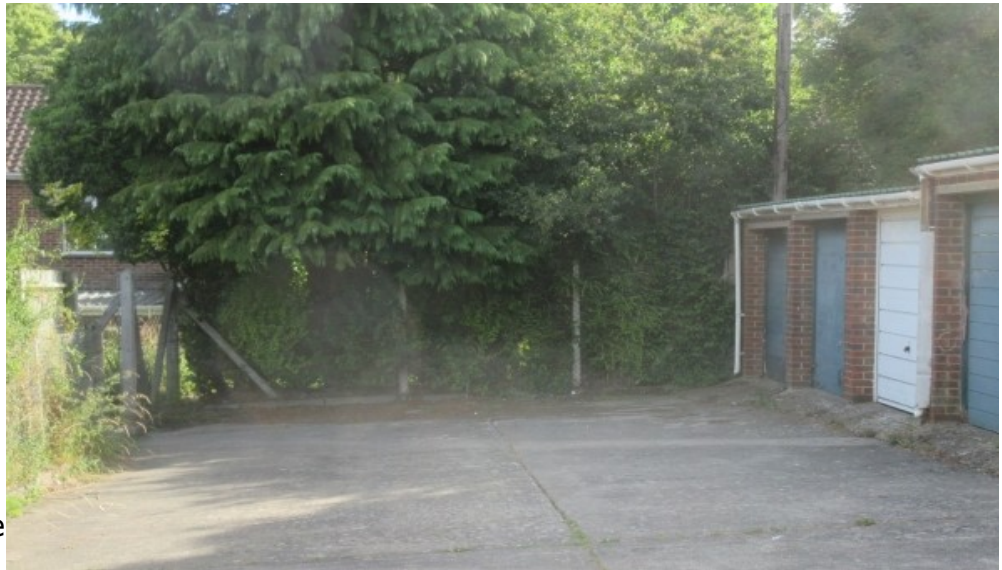
25- The lower garages in Lovett Green, being close to the main entry to the Estate, is often a dumping ground of litter.

There is a spread of scree/litter dropped from the fir trees.

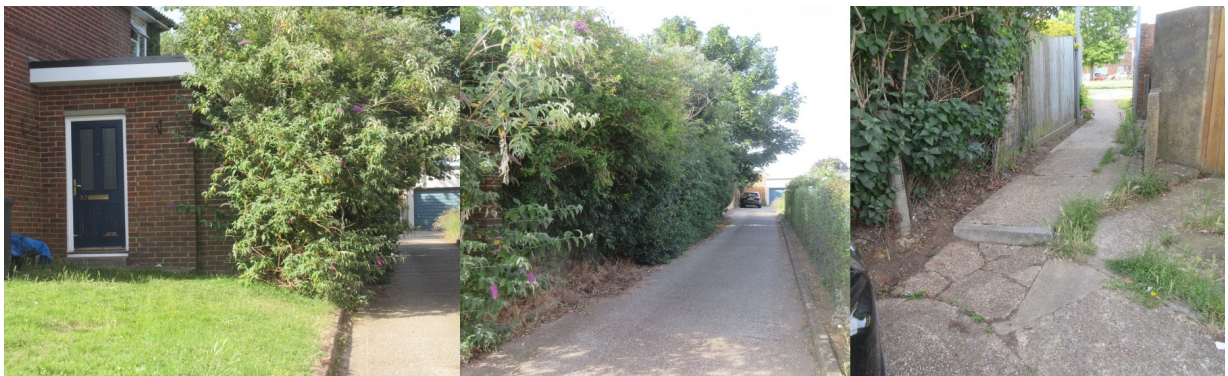
26-

Tenant at 30 Lovett Green has allowed a buddleia to get out of hand on front steps of property. Also the garden is so overgrown that it impinges the access road to the upper garages of Lovett Green. Can WC assist tenant with this problem?  
Pathway from upper garages of Lovett Green to Neville Close – drop kerb needed here and correction of dip in road surface.

Drop-kerbs need improvement over entrance of upper garages in Lovett Green.

<b>Location</b>	<b>Road Name</b>	<b>Issue(s)</b>	<b>Responsibility</b>	<b>Potential Action Required</b>
26	<a href="#">Lovett Green</a>	General condition of access road to upper garage area	Housing Department	Housing Department to advise on potential remedial actions at this location.
		Damaged footway surface Footway leading to Neville Close		The only way to address it would be for the footway to be resurfaced. Housing Department to advise on potential remedial actions at this location.
		No dropped kerb on footway leading to Neville Close		No specific evidence that dropped kerb is require at this location. Potential to provide a ramp at this location which would address the damaged footway at this location. Housing Department to advise on potential remedial actions at this location.
27	<a href="#">Blyth Way</a>	General condition of access road to garage area	Housing Department	Housing Department to advise on potential remedial actions at this location.

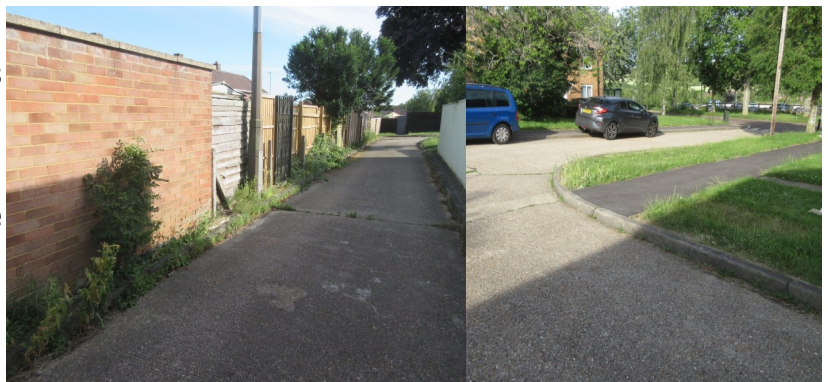
27b- Drop-kerb needed outside 2 Blyth Way to match the one outside 3 Blyth Way.

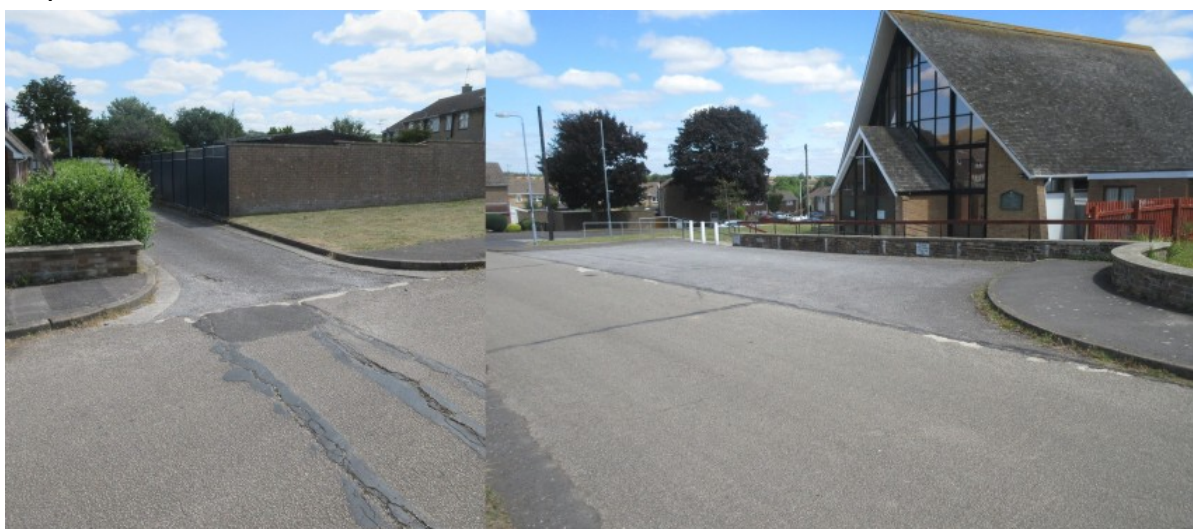
29-

There are no drop-kerbs across the entrance of the garages by the Catholic Church, and, indeed, crossing the forecourt of the Catholic Church. Wheelchair users are forced currently to go on the roads here, which is unacceptable.

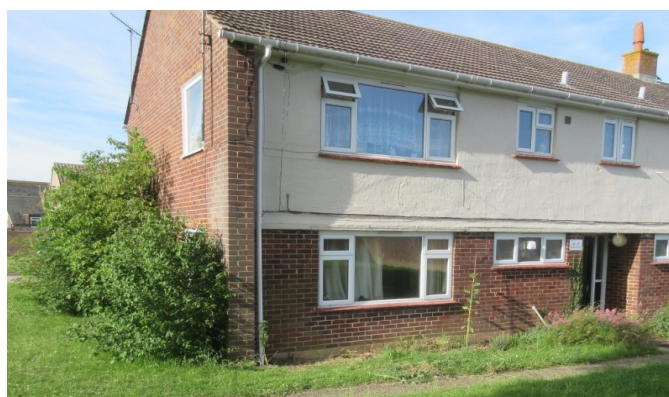
30 -

Flats 16-19 Fotherby Crescent have overgrown elder and other shrubs along the side wall, which clearly should not be there and must be removed.

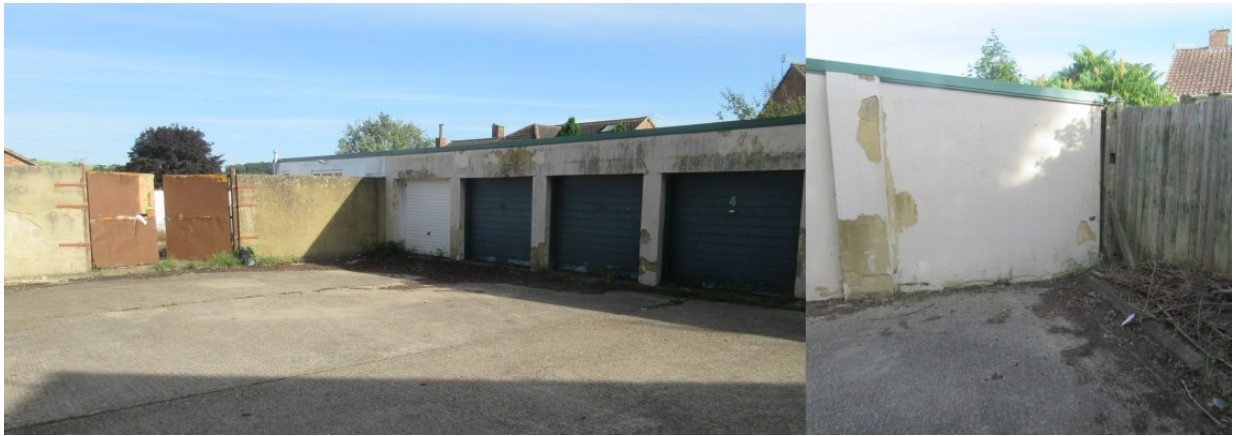
Garage Space between Burnett Way and Neville Close. We have had recent trouble here with youths climbing across the garage buildings, using the fence-bar seen on the right to mount on to the roofs. They are clearly into par-cours and have trespassed in several properties local to these garages, causing damage to one resident's garden shed. The garage space has a spread of mud and debris, suggestive that the garages have few if any cars within them.

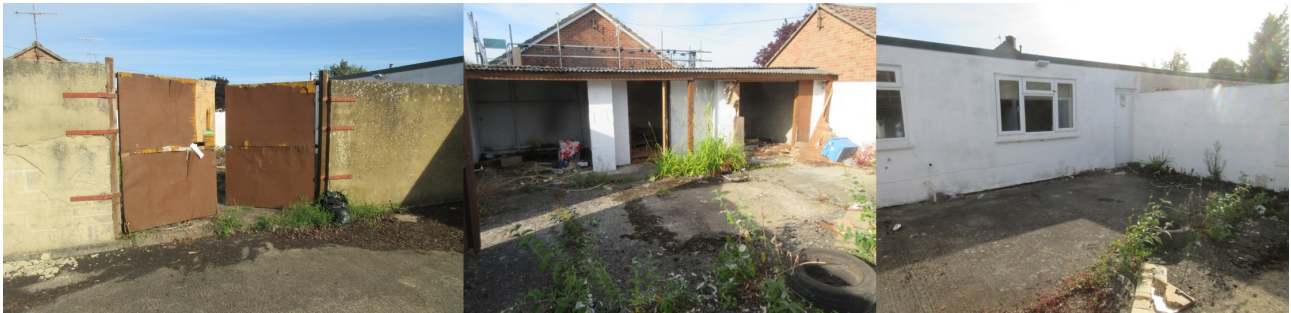
Within the garage spaces is a former Council yard and workshop buildings, sixty years ago it was a local base for maintenance men on the new estate, until recently British Gas operated an office from here. Now, it is defunct and has been abandoned with an open gate – an open invitation to troublesome youth.

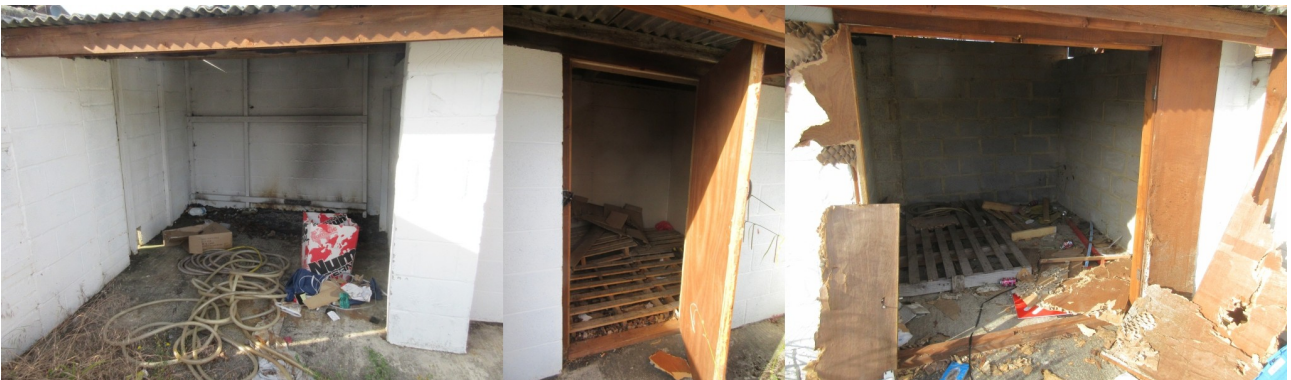
Youth have been drinking, smoking, and generally gathered here on recent summer evenings. The three *rooms* at the left have, debris which has clearly been lit and burnt, wooden pallets asking to be burnt, and various debris. This neighbours directly the bungalows at Nos. 8 & 9 Blyth Way, and must be a concern to both them and other neighbouring properties.

**Can Wiltshire Council take responsibility for the security and safety of this property please.**

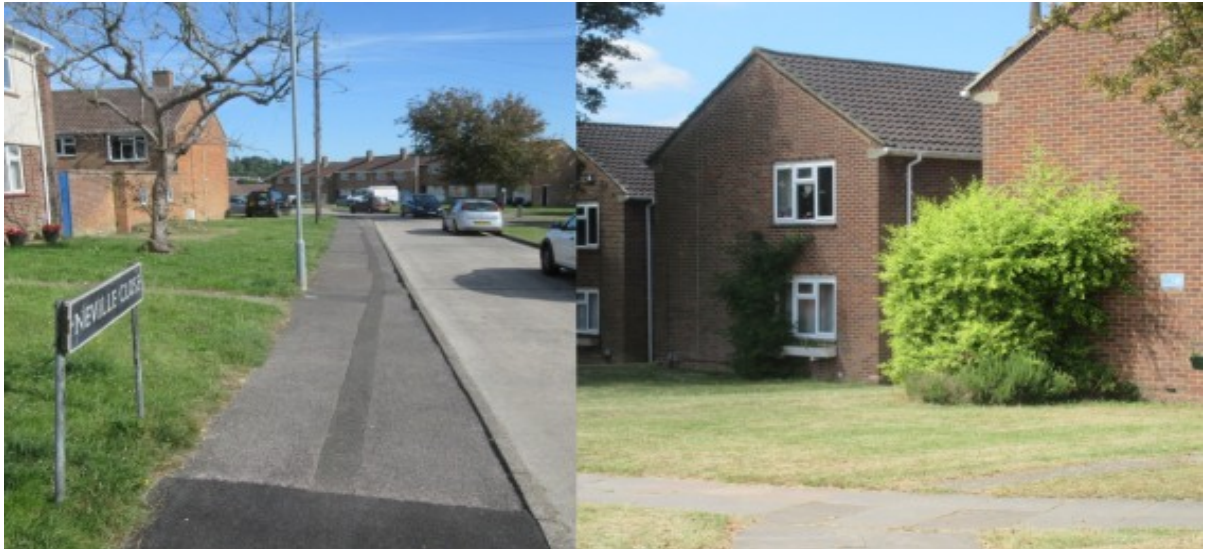
32-

This cherry blossom tree is virtually dead and may need removal at 34-37 Neville Close.

Location	Road Name	Issue(s)	Responsibility	Potential Action Required
32	Neville Close	Dead/dying cherry blossom tree	Salisbury City Council	Salisbury City Council to advise on potential remedial actions at this location.
		Uneven footway surface	Highways Maintenance	The only way to address the issue would be for the footway to be resurfaced.
		Overgrown foliage outside Nos. 8 to 10	Housing Department	Housing Department to advise on potential remedial actions at this location.
		Improved dropped kerb required on footway leading to Blyth Way garages	Housing Department	Housing Department to advise on potential remedial actions at this location.
33	<a href="#">Barrington Road</a>	Lack of dropped kerbs crossing points in vicinity of local shop	Traffic Engineering CATG Housing Department	Provide dropped kerb crossing points.
		Uneven footway surface in vicinity of local shop	Highways Maintenance Housing Department	The only way to address the issue would be for the footway to be resurfaced.

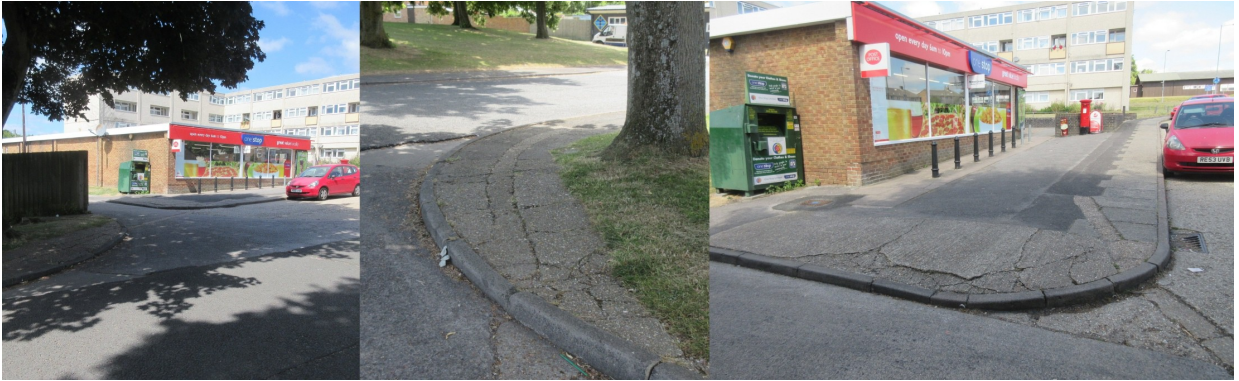
33-

The shop in Barrington Road. There is no drop-kerb anywhere in the vicinity to allow wheelchair users to cross Barrington Road close to the shop. The corner nearest the shop has no drop-kerb, and the pavement is much degraded, both by tree disruption and by delivery vehicles turning on the corner. The shop forecourt may be accessed in wheelchair by a poor degraded drop-kerb just beyond the left front corner of the shop, but the forecourt of the shop has degraded paving, and wheelchair users are forced to travel along the road to get there. This is unacceptable.

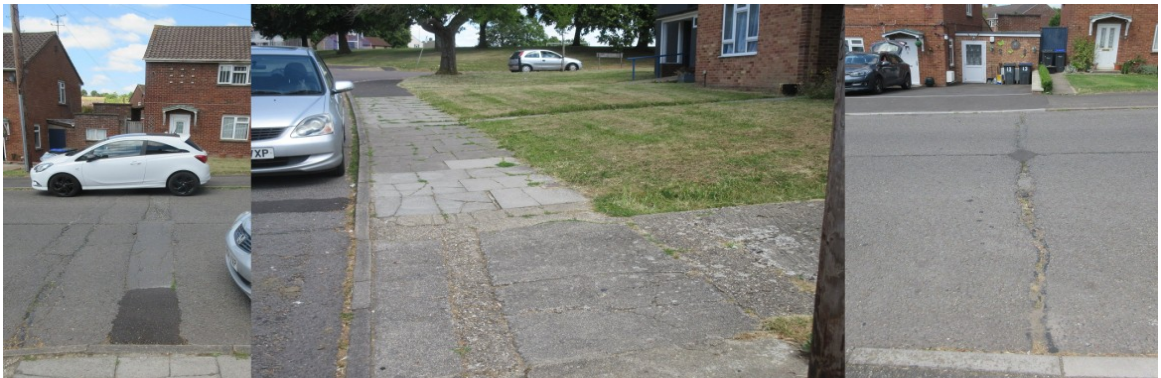
34-

Opposite the Vicarage, possibly the most avoided trench in the roads of the estate. Poor paving in front of the Vicarage. Opposite 13 Barrington Road, poor road surface.

34	<a href="#">Barrington Road (In vicinity of No. 19)</a>	Trench in road	Highways Maintenance	The trench is from utility company works previously undertaken in the road and appears to have been in place for a minimum of 12 years so, is a relatively minor issue. Issue could be addressed by filling the pothole or resurfacing the road. The only way to address this issue would be to resurface the road.
		Uneven footway surface	Highways Maintenance	The only way to address the issue would be for the footway to be resurfaced.
35	<a href="#">Barrington Road (Junction with Denison Rise)</a>	Uneven footway surface	Highways Maintenance	The only way to address the issue would be for the footway to be resurfaced.
		Dropped kerb crossing points in vicinity of junction obstructed by parked vehicles	Traffic Engineering CATG	Provide white bar marking in front of dropped kerbs.
		Gully blocked with vegetation (Outside of No. 24).	Highways Maintenance	Gully needs to be cleared.

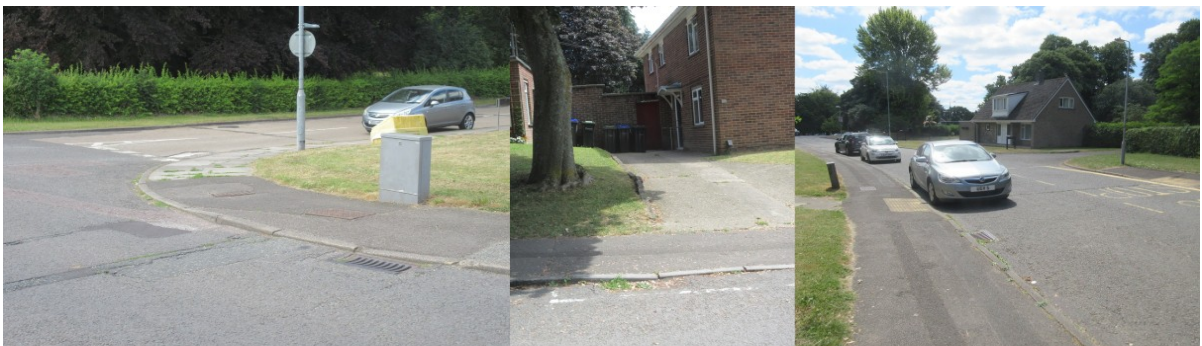
35-

Poor paving by entrance of Denison Rise, the drop-kerb crossing is often impeded here by parked cars. Blocked drain by 24 Barrington Road. Lower end of Barrington Road another drop-kerb crossing, this time to the bus-stop, here blocked. Again, can some scheme to enforce these points be worked up?

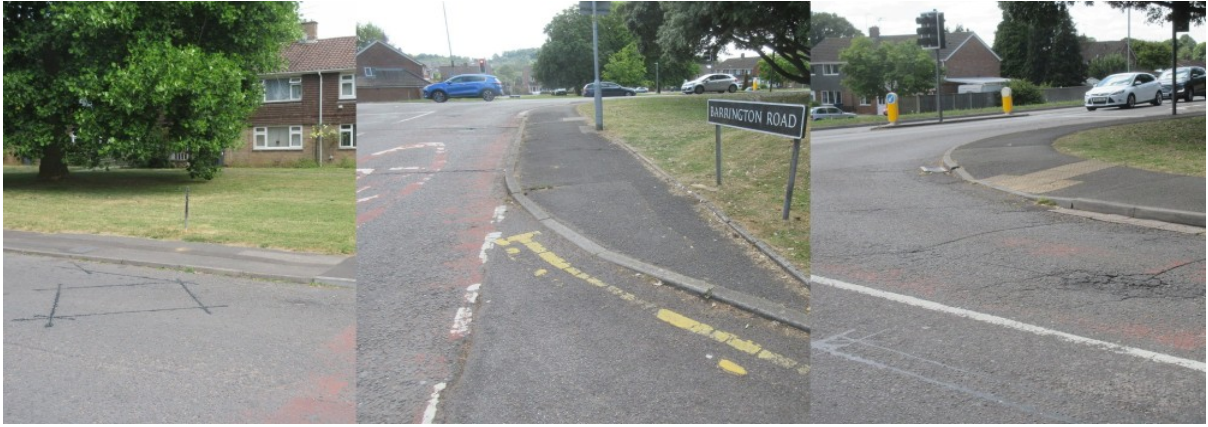
36-

Barrington Road road-sign completely missing, apart from one post. Drop-kerb to access London Road pavement is very poor. Drop kerb from London Road crossing the entrance of Barrington Road is also very poor for wheelchair users.

Location	Road Name	Issue(s)	Responsibility	Potential Action Required
36	<a href="#">Barrington Road (Junction with Seth Ward Drive)</a>	Missing street nameplate (Barrington Road)	Highways Maintenance	Street nameplate replaced in 2020. No further action required.
		Poor dropped kerb at entrance to crematorium	Highways Maintenance	Dropped kerbs don't have to be flush with the road surface and would typically have up to a 6mm upstand but can have up to a 25mm upstand before becoming a significant trip hazard. Existing dropped kerb is within these tolerances. No further action required.
		Poor dropped kerb across London Road	Highways Maintenance	Existing dropped kerb is generally okay. However, the carriageway surface in front of the dropped kerb on the crematorium side of the road could be improved to improve use of the crossing point for wheelchair/mobility scooter users.
37	<a href="#">Seth Ward Drive</a>	Poor maintenance of briar roses	Salisbury City Council	Salisbury City Council to advise on potential remedial actions at this location.
