**Summary Review of Issues Raised in Bishopdown Estate Report**

# Bishopdown Residents Association

## Survey of Bishopdown Estate – 2019

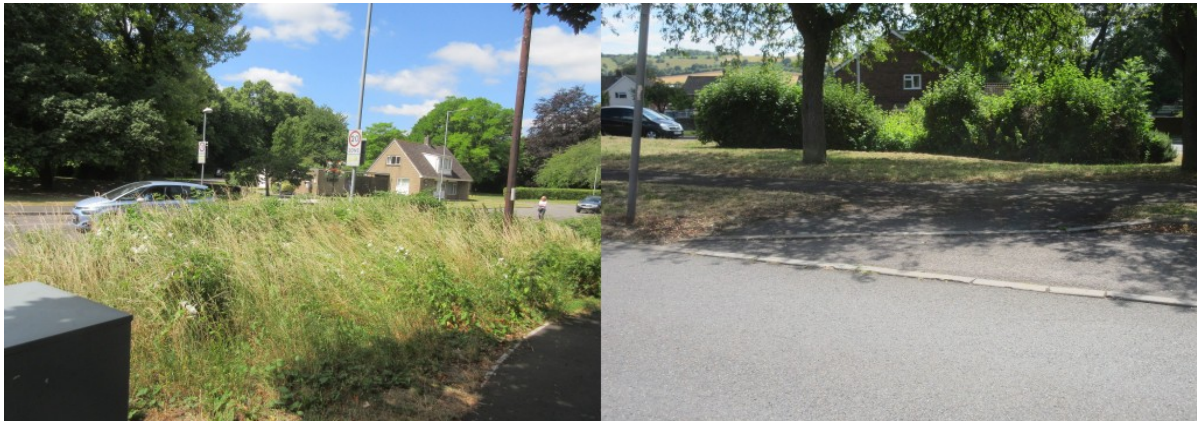
37-

Junction of Seth Ward Drive and Barrington Road – the semi-circle of briar-roses has been poorly maintained in recent years to the detriment of its performance. Layby and entrance from Seth Ward Drive to Bishopdown-Laverstock Cycleway, this has been poorly done using two successive drop-kerbs, neither of which is flush to the road surface. This should be improved.

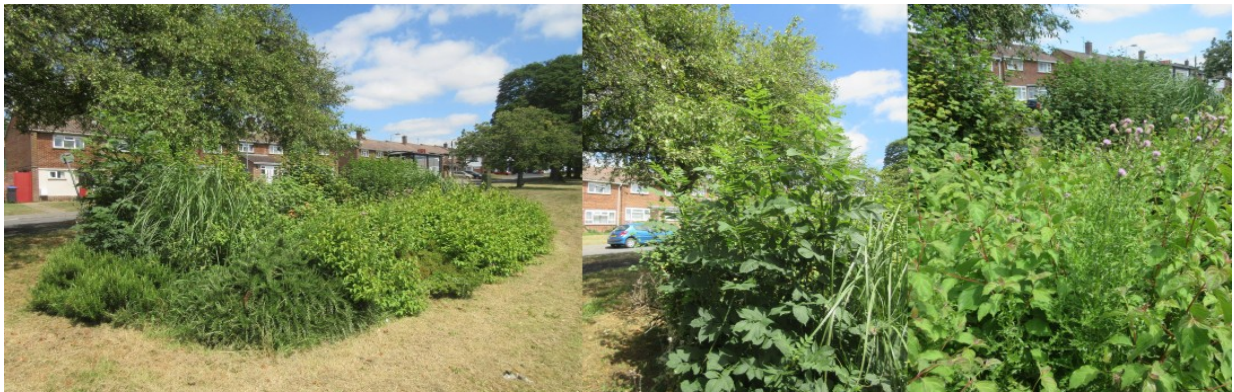
38-

Bus Stop bottom of Seth Ward Drive – this shrubbery has not been maintained, and has been infiltrated by tree-saplings, blackthorn, thistles etc. Can someone who understands gardening – ie: NOT idverde who are completely incompetent – please maintain this shrubbery properly.

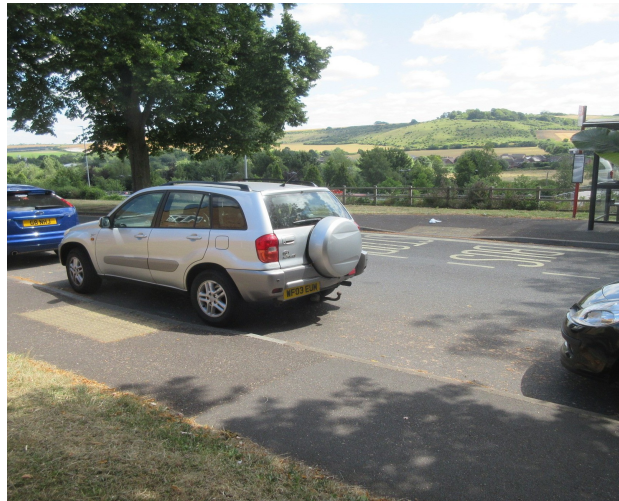
Lower bus-stop in Seth Ward Drive, again the drop-kerb crossing point impeded by parked vehicle...

The same also applies to the crossing point at the bus stop near the entrance of Blyth Way.

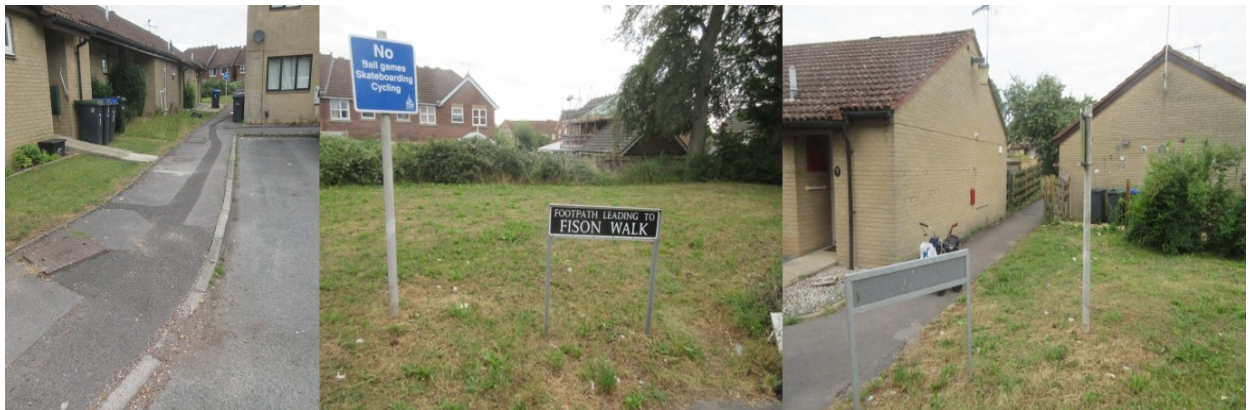
42

Footway in Hallum Close leading to Fison Walk. Many of the residents of Fison Walk are elderly and less-abled, several appear to use wheelchairs. This drop-kerb and footway are alike in poor condition, and are representative of general conditions.

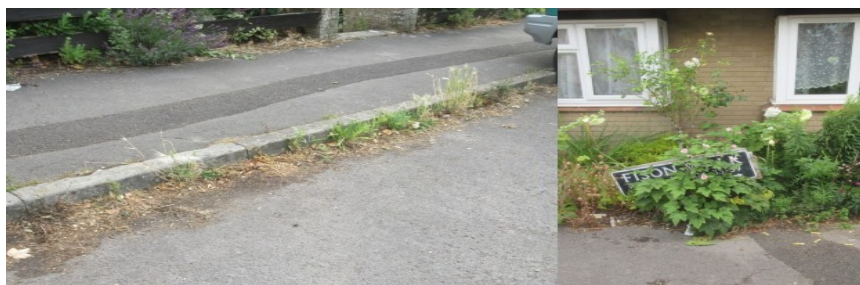
43- General state of kerbs and gutters – debris and weeds.

Sign for lower part of Fison Walk needs reinstating.

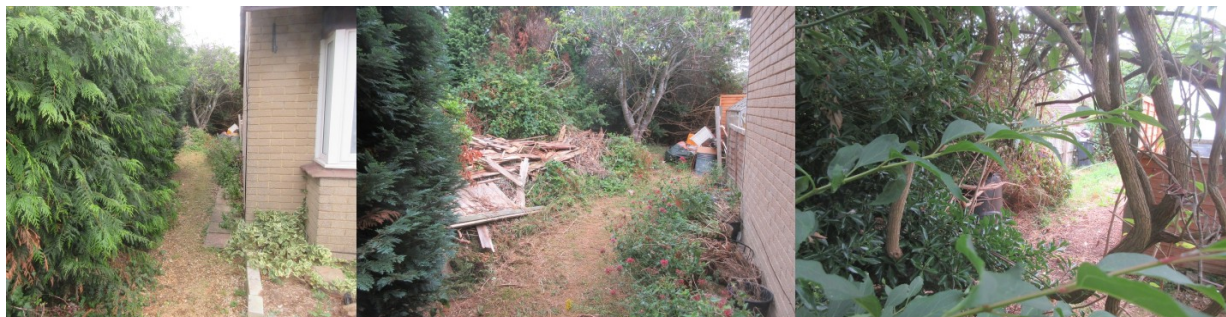
44

Between Nos. 29 & 31 Fison Walk an access path was left when built to allow residents to get to and from rear gardens. This has now become overgrown with trees and shrubs and a haven for litter and overflow of people's gardens. The elderly residents are unable to bring bins out from the rear – this has apparently been seen by Mostyn Coombes in June 27<sup>th</sup> 2019. What is being done?

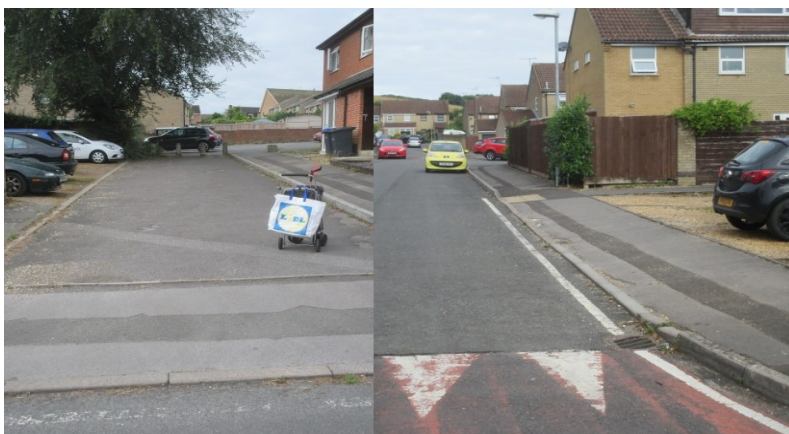
46-

A main route from Bingham Road (and the rest of the Estate) to Jewell Close, and thereby on to Bishopdown Farm Estate, this garage space and parking place is used by many walkers, cyclists and the less able. The drop-kerbs and bollards are a problem to this, and should be improved.

Drop-kerb from Jewell Close into footpath through to Bishopdown Farm estate. The kerbs here are typical of the area generally.

<b>Location</b>	<b>Road Name</b>	<b>Issue(s)</b>	<b>Responsibility</b>	<b>Comments / Potential Action Required</b>
46	<a href="#">Jewell Close</a>	Poorly installed dropped kerbs on pedestrian route from Bingham Road to Bishopdown Farm	Highways Maintenance Housing Department	Existing dropped kerbs are generally okay and within acceptable tolerances. The only exception being the dropped kerb that provides the access to the off-street parking area in front of Nos. 37-41 Jewell Close where the kerb upstand is on the threshold for intervention. However, this dropped kerb is not essential to the pedestrian route and shouldn't be considered a priority for replacing/improving. No further action required.
47	<a href="#">Fison Walk</a>	Improved street nameplates required	Traffic Engineering CATG	Provided replacement and additional street nameplates. Proposals to provide improved street nameplates in Fison Walk have been designed and costed
