## **Salisbury Night Audit Report**

### **Introduction and background**

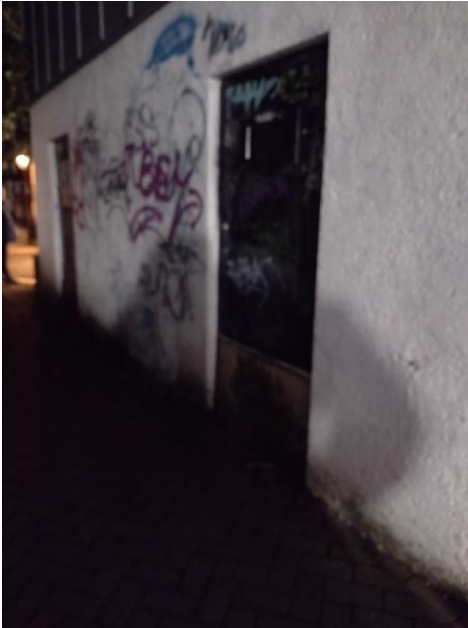
We found graffiti on the wall of **Culver Street car park** and reported it on MyWilts. We felt that the lighting was good in Culver Street car park and we know it has good CCTV coverage. Nonetheless several members of the audit party noted that they did not feel safe parking in this car park, some saying that applied even during daylight hours. We discussed various ideas for making this a more appealing car park to use. The following suggestions were made:

- Making the top floor a parking resource for local residents so that people are coming and going on a regular basis. This might improve the atmosphere and the presence of pedestrians might make the car park less intimidating to women on their own.
- Putting a security guard on duty in the car park 24/7 (costs involved) to discourage gangs of youths from using the car park as a meeting place and to help stop graffiti.
- Making an area of the car park 'for sole women drivers only' overseen by a 24/7 warden (costs involved) which would be a proactive way of encouraging women to use the car park. This type of scheme or variations of it have been in use in Germany since the 1990s and are also being used in Austria, Switzerland and China.

We recommend that a review of Culver Street car park is undertaken with a view to improving the perception of safety it gives to members of the public, particularly after dark. A number of suggestions are made on page 4 of this report.

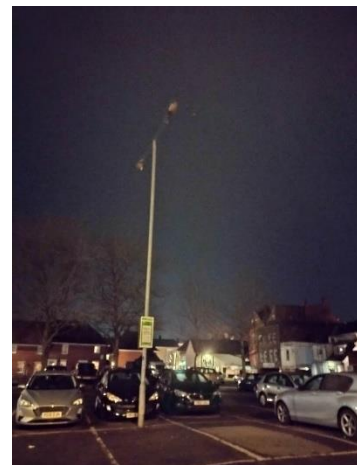
We found that the main light in **Brown Street car park** is not working (right) and has been out for

some time. This has been reported to Facilities Management of Wiltshire Council and is included in the list in appendix 2.

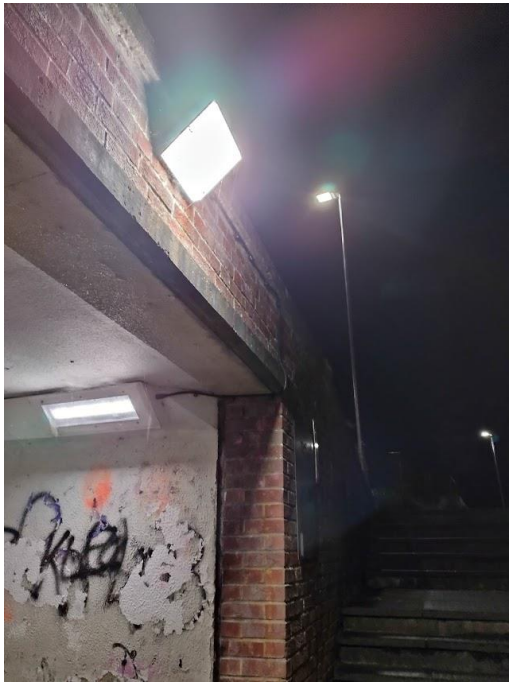
We found several of the tunnels had very good lights over the exits (left). These were excellent and the placement of several more of these would improve the visibility for people exiting the tunnels after dark.

We recommend that mirrors and/or additional lights are placed at the ends of tunnels and underpasses to make exiting these spaces less intimidating after dark.

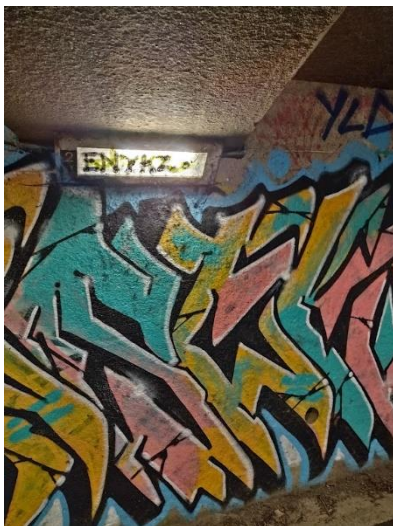
### **New Bridge Road underpass tunnel**

The graffiti on the lights (left) means that although the lights are working, they are obscured which makes the tunnel dark. We have reported this on MyWilts (see appendix 2)
