Bishopdown Residents Association

Survey of Bishopdown Estate – 2019

Bishopdown Estate walkabouts

Walk 01- Bishopdown Road- from hill-top to lower end of estate.

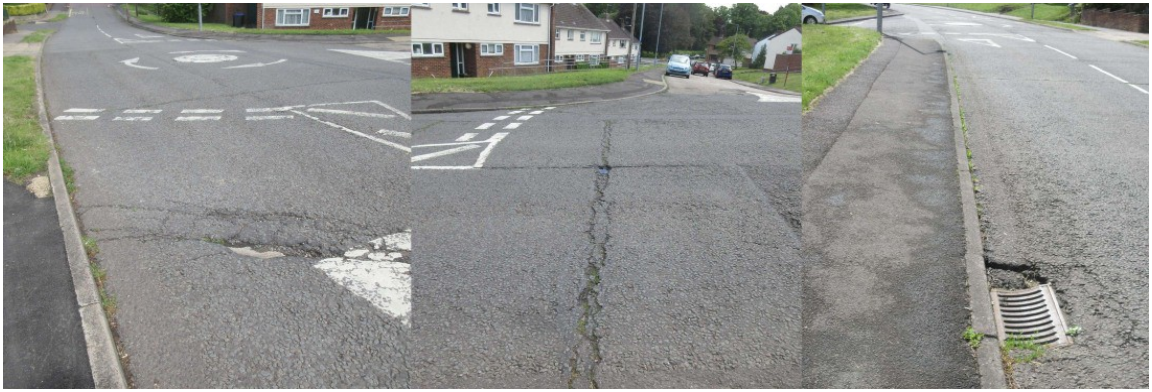
7

Broken road surfaces above, and below, the roundabout junction of Bishopdown Road and Denison Rise. Below the junction, this drain has sunken hazardously.

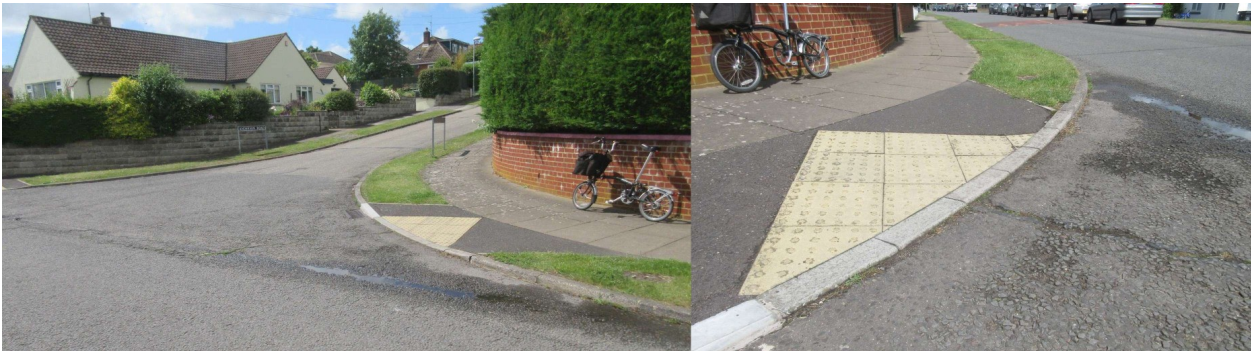
9

Footway crossing entrance from Bishopdown Road from Anderson Road. The road surface is poor, and the drop kerb is not flush with the road surface.

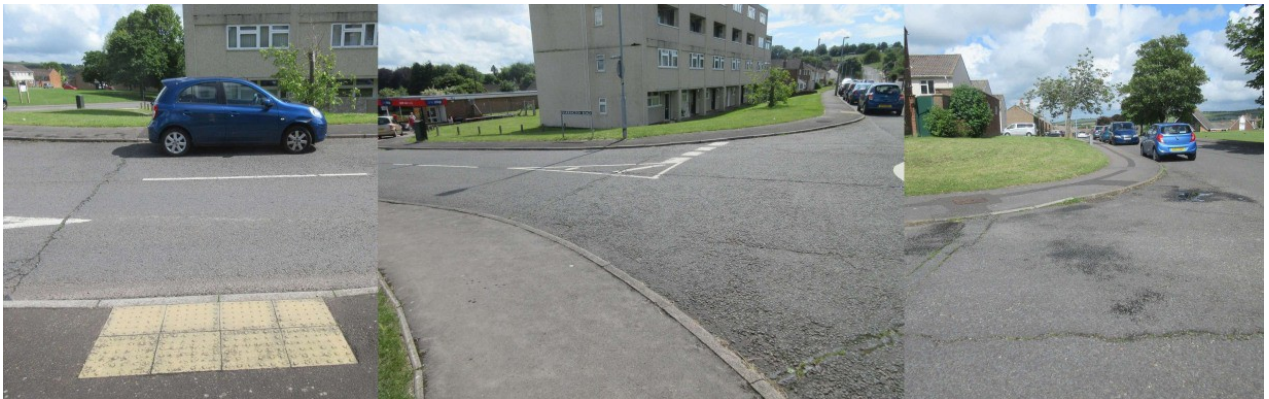
12

Drop-kerb crossing point of Bishopdown Road by Bishop's Court flats – a car is impeding the crossing point, therefore thought should be given to marking this as a proper crossing point. Similarly, at the junction of Barrington Road with Bishopdown Road there is no crossing point at all for wheelchair and other less able users. Thirdly, the entrance of Gilbert Way has no drop kerb crossing point at all.

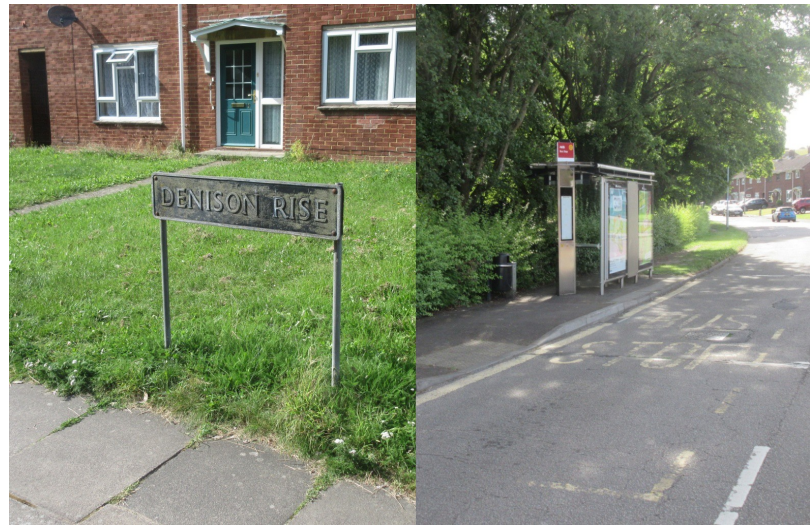
16a- Bus Stop in Denison Rise by entry to Burgess Green. This bus stop, placed on a narrow green verge, has its back to the road, and is often daubed with graffiti. The enclosed nature of it, often with overhanging greenery, makes it a potentially threatening environment.

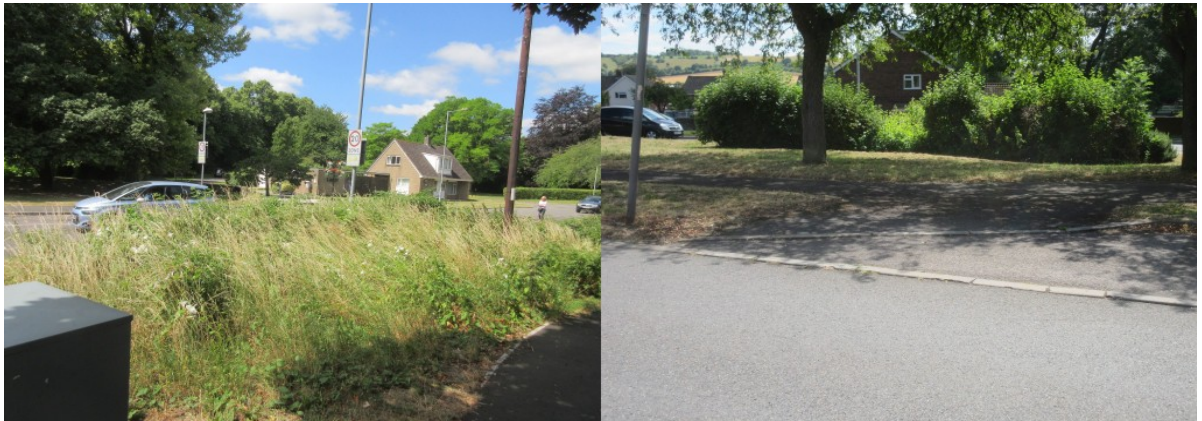
37-

Junction of Seth Ward Drive and Barrington Road – the semi-circle of briar-roses has been poorly maintained in recent years to the detriment of its performance. Layby and entrance from Seth Ward Drive to Bishopdown-Laverstock Cycleway, this has been poorly done using two successive drop-kerbs, neither of which is flush to the road surface. This should be improved.
