Special Inspection Report

Project: Bank Street Melksham,

Prepared by: J Haines Date: 12th May 2004

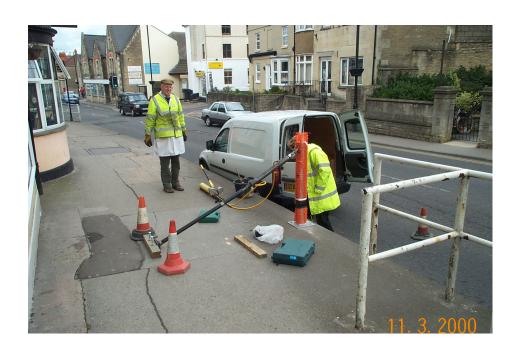
A temporary steel post was fixed to one of the better of the existing slabs using similar fixings to those proposed for the final fixing. On testing the post a crack opened up across the footway slab at approximately 80% of the required loading, and not allowing for any factors of safety. This test confirmed that even the best of the existing footway slabs are unsuitable for mounting the barrier.

The existing slabs are not sufficiently robust to provide the required mounting strength for a public barrier designed to class3 loading. It is also not believed that a suitable alternative method of mounting could be carried out for the immediately available budget.

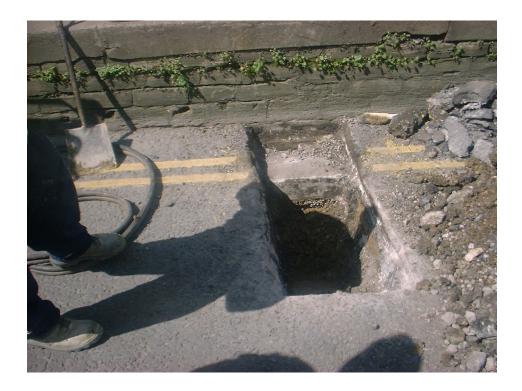
Two holes were excavated, one opposite the Flower shop and the second adjacent to the small flight of steps near the Home Appliance showroom.

The first hole was dug to a depth of 700mm and extended 1000mm out from the wall. The high voltage electricity service was located 750mm out from the wall at a depth of 600mm. No other services were found. There was also a precast concrete kerb laid flat adjacent to the wall and approximately 100mm deep. The purpose and extent of this kerb is not known. The second hole was dug to a similar dimension however no services or buried kerbs were found at this location.

From the trial holes taken it is believed that a wall could be built in front of the existing wall without diverting any utility apparatus. The wall would not have do be designed as a retaining wall as the existing wall is adequate, the new wall will however have to resist the forces imposed by the railings. A brief outline design suggests that the new construction would need to be

founded 700mm below the existing road level in order to achieve sufficient active pressure on the front face to resist overturning, with reinforced concrete used in order to keep the construction slender and thus minimise any restriction to the carriageway.
