Report Ref: M2551-v2

REQUIREMENTS FOR SOUND INSULATION

**CLUB KARMA,
17 STATION HILL, CHIPPENHAM SN15 1EQ**

10 November 2012

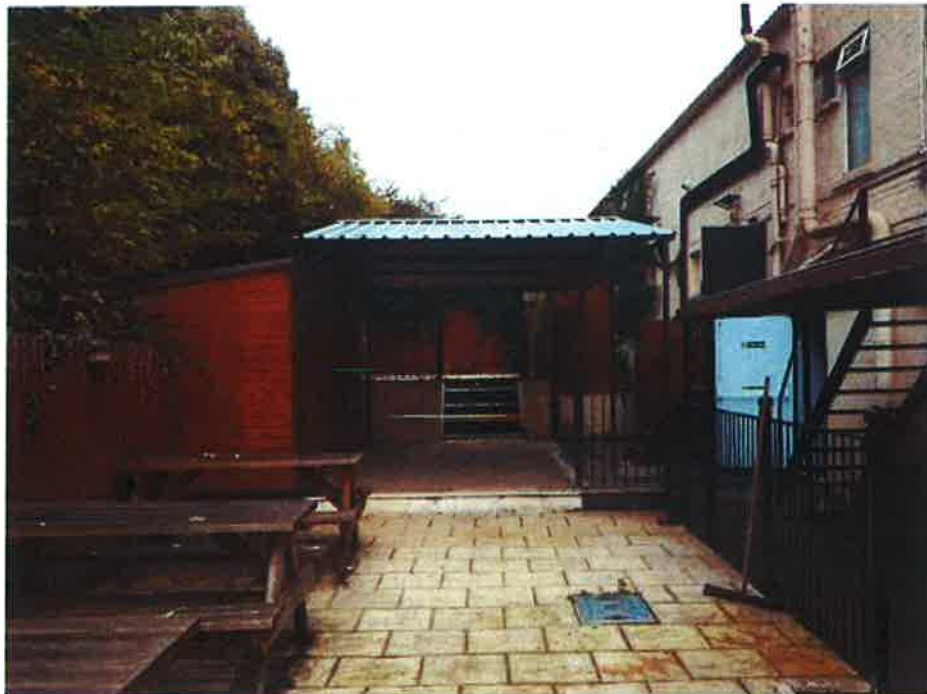
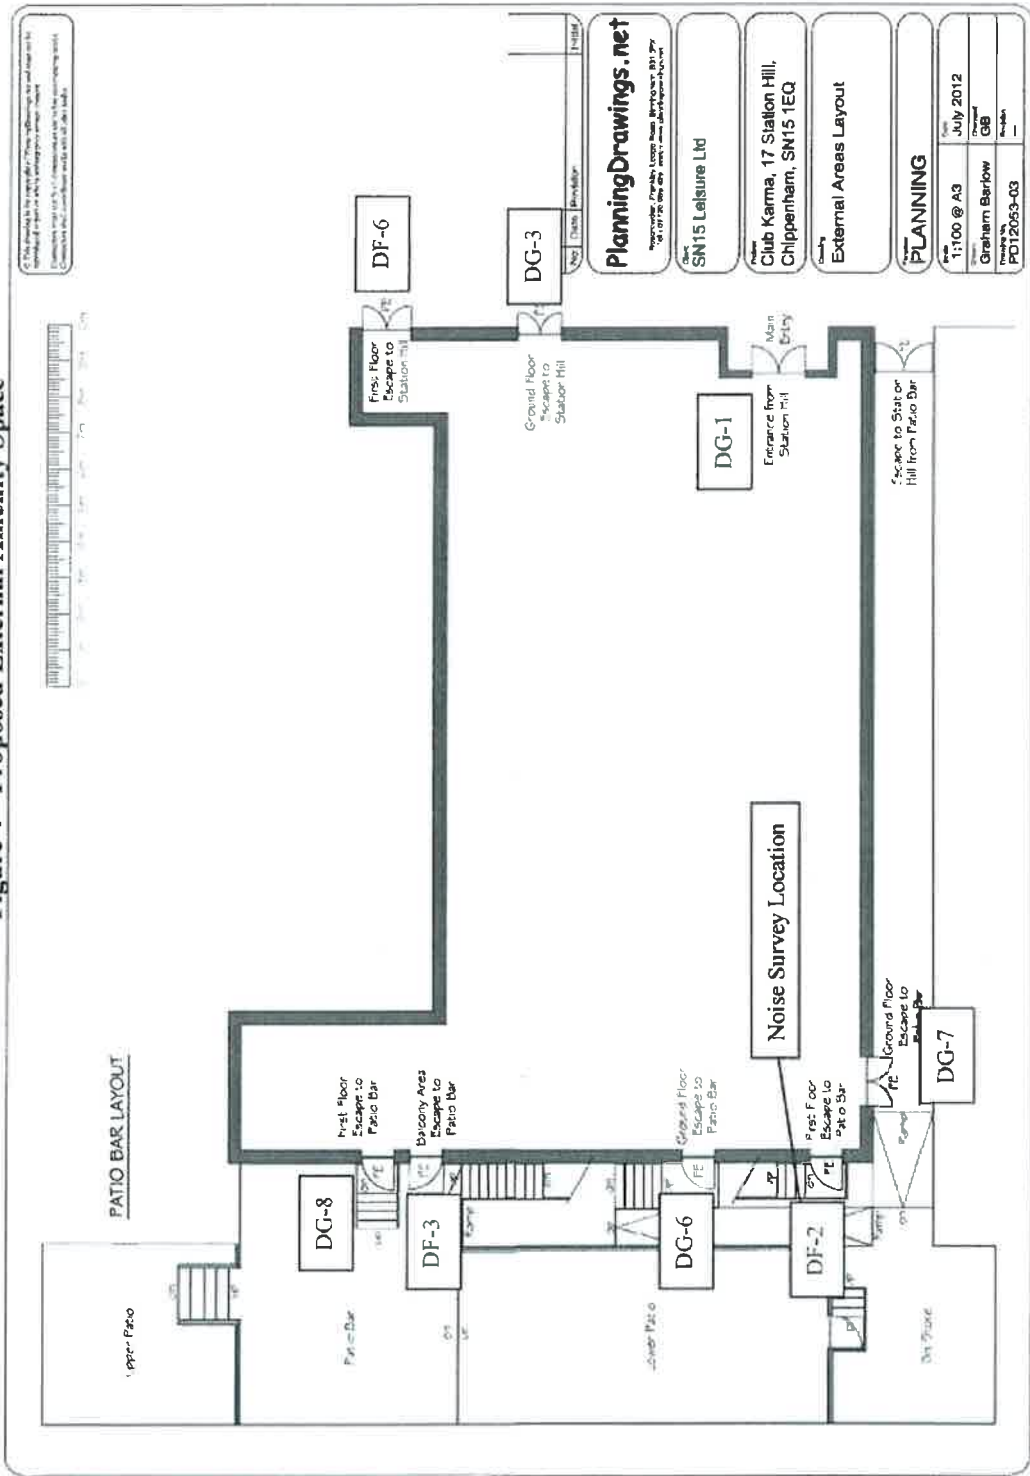
Figure 4 - Proposed External Amenity Space

The seating area would be set on the Lower Patio, as shown in Figure 4 and indicated in the near field of the photograph below:

The southerly part of this patio (nearest the camera) does have a line of sight to the rear elevation of the neighbouring block of flats and, given the height of that building relative to the patio, it is concluded that site screening by means of fencing is not a totally effective acoustic solution.

If it is proposed that the floor of the area will be covered with a soft matting, the fence to the perimeter will be increased by 1m, and that large umbrellas will be used over each table. To a greater or lesser extent, each will provide a finite reduction in the noise transmitted between the seated area and the neighbouring windows.

Avoiding significant disturbance to the occupants of those flats, it would be suggested that the external seating area should be usable up to 23.00 each evening. The precise limits for use, however, will be largely governed by the management of the space, and the reaction to any adverse comment from local residents. It is therefore recommended that the operators adopt the following management plan:

- (i) Post signs in the external area to highlight the proximity of residential neighbours
- (ii) Initially, allow access to the seating area up to 23.00 each evening and thereafter reduce access back to the covered area shown in the photograph above. This location will benefit the residents by the increased distance and the screening from the noise-sensitive buildings. If managed as a smoking area, rather than an area to congregate and converse at length, noise levels should be significantly lower therein, perhaps 60 - 65 dB(A). Residual levels at the residential windows would be between 25 and 30 dB(A), which would be deemed acceptable.

- (iii) Within the management plan, allow for a regular inspection of the external areas by staff. They should be instructed to act upon any rowdy or noisy behaviour

- (iv) If, after a few weeks of use, the external area in this fashion does not generate any contact from the neighbours, consider extending the usable hours of the seating area, by no more than 1 hr at a time, and then gauge community reaction. If complaints are received, however, a restriction on the use may be required

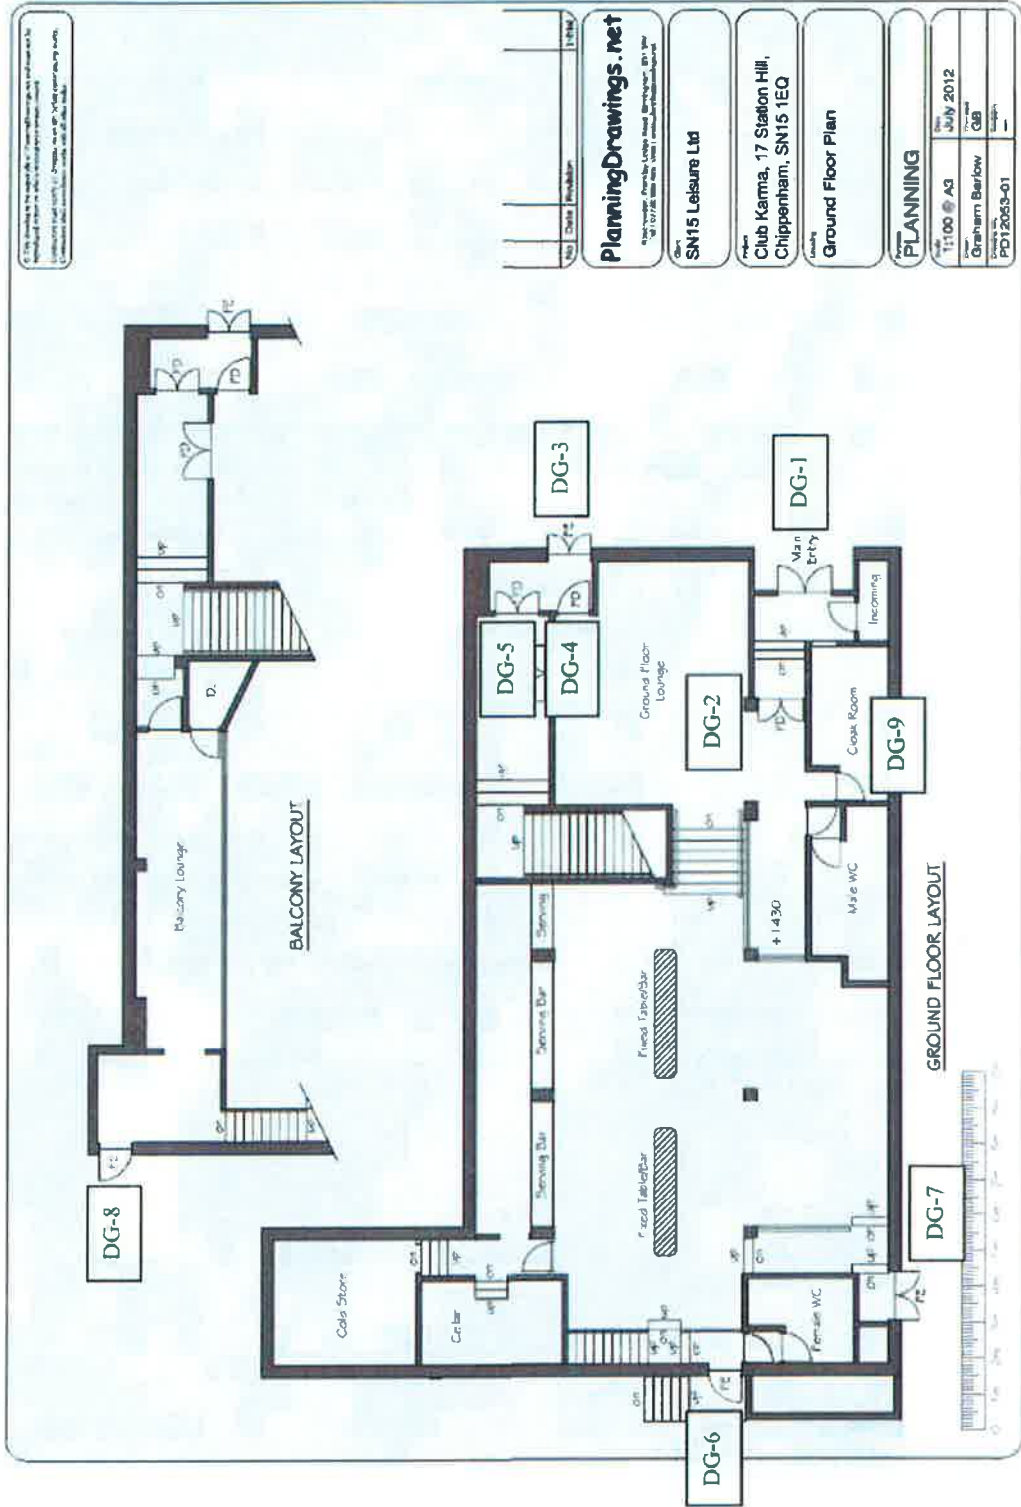
Figure 2 - Proposed Ground Lounge Bar

The majority of work on the ground floor relates to the control of noise emanating from external doors. The specific recommendations are provided below (door codes are clarified in Figure 2):

Door	Recommendations
DG-1	Existing door to be refurbished to achieve a sound reduction of 35 dB Rw, as per the notes below
DG-2	Doors to be reinstated. 50mm solid core timber leaves, with rebated meeting style and self-closing mechanism, in a rebated frame. Acoustic seals to the head and jambs
DG-3	Existing door to be refurbished to achieve a sound reduction of 35 dB Rw, as per the notes below
DG-4	Existing door to be refurbished to achieve a sound reduction of 35 dB Rw, as per the notes below
DG-5	Existing door to be refurbished to achieve a sound reduction of 35 dB Rw, as per the notes below
DG-6	Existing door to be refurbished to achieve a sound reduction of 35 dB Rw, as per the notes below
DG-7	Replace existing door with a proprietary steel door set rated at 45 dB Rw. This would then require internal noise levels to be limited to 65 dB(A), which is very quiet for the intended use. The alternative is to modify the area inside the external door to create a lobby. The new internal door of the lobby, and DG7, must then achieve a sound reduction index of 35 dB Rw, as per the notes below

DG-8	Existing door to be refurbished to achieve a sound reduction of 35 dB Rw, as per the notes below
DG-9	Internal door to the Cloak Room must be kept closed, and would benefit from a set of standard acoustic seals to the head and jambs.

35 dB Rw Doorset - 50mm thick solid timber leaf, well fitting into a rebated frame. Acoustic seals to the head, jambs and (where appropriate) meeting styles. Automatic dropping seal at the base or (preferred) drag seal and raised steel threshold plate. See Appendix 1 for details.

Lobby Construction - Either in 100mm aggregate block, or 70mm fully insulated stud with 2 x 15mm Wallboard to either side. Ceilings (if appropriate) built as 22mm t&g chipboard over fully insulated joists with 2 x 15mm Wallboard to the underside.

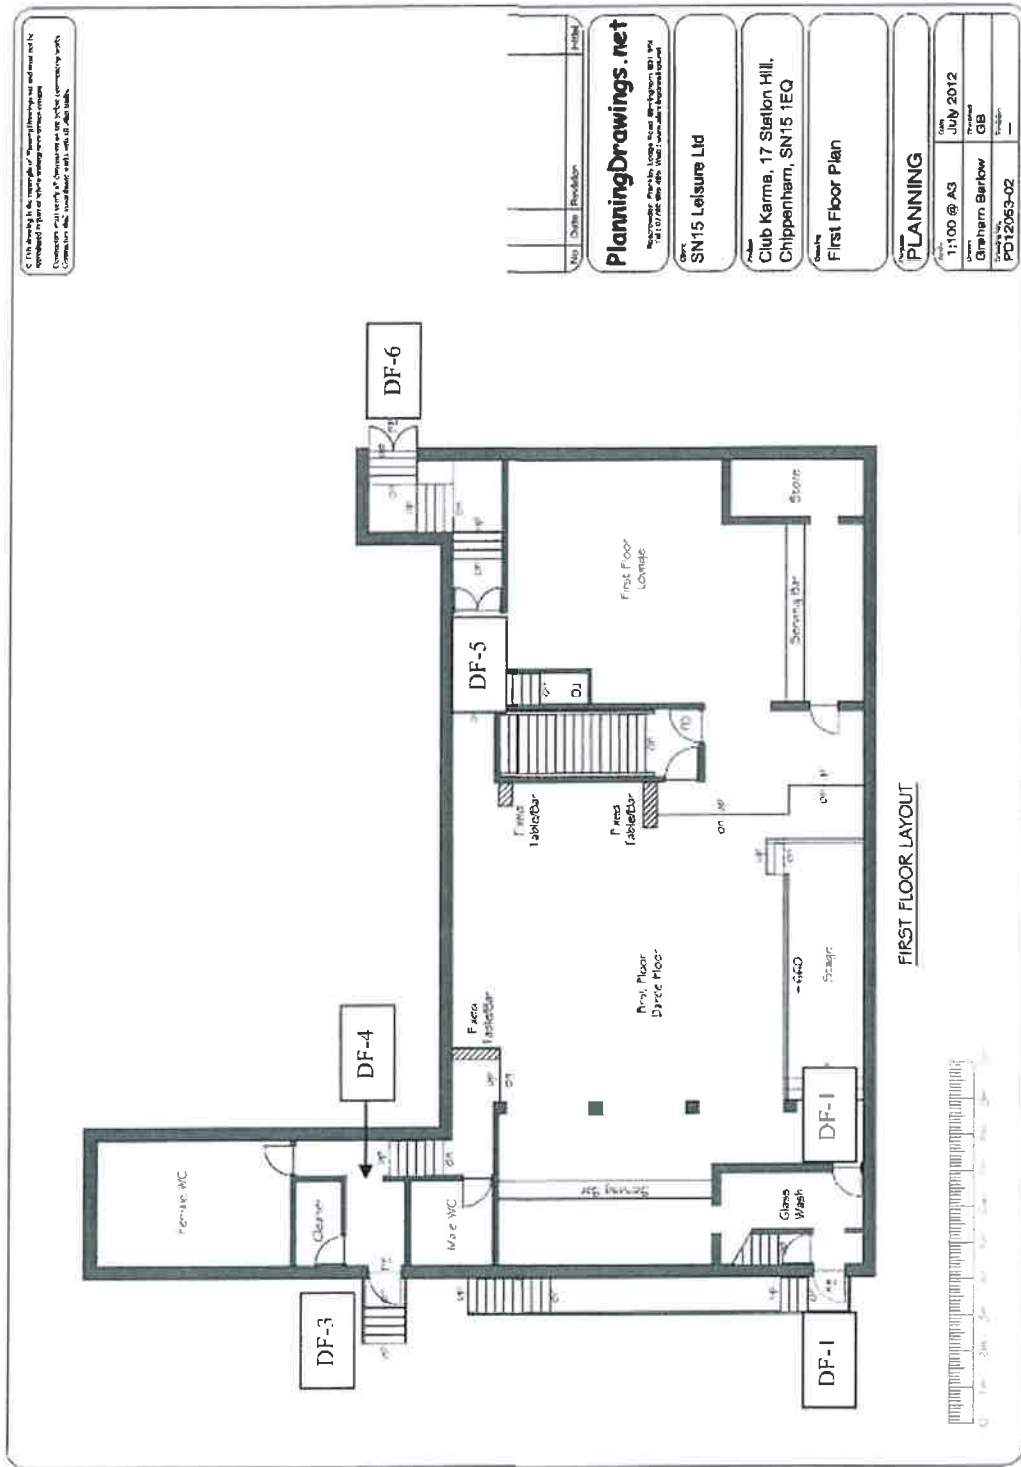
Figure 3 - Proposed First Floor Dance Area

With reference to the door codes in Figure 3, the following works are necessary:

It is noted that there is a potential weakness in the sound insulation strategy, with a noise path from the dance floor across the bar servery (which will be open), directly to external door DF-2 and then to outside. This is likely to warrant the requirement for an additional 35 dB Rw doorset set between the Bar and the Glass Wash area, or between the Glass Wash area and DF-2.

Door	Recommendations
DF-1	Existing door to be refurbished to achieve a sound reduction of 35 dB Rw, as per the notes in 5.1. Self closing mechanism also required
DF-2	Existing door to be refurbished to achieve a sound reduction of 35 dB Rw, as per the notes in 5.1.
DF-3	Existing door to be refurbished to achieve a sound reduction of 35 dB Rw, as per the notes in 5.1
DF-4	New internal door be installed into the structural opening here. Door construction to achieve 35 dB Rw.
DF-5	Existing door to be refurbished to achieve a sound reduction of 35 dB Rw, as per the notes in 5.1. This will involve the adjustment of the existing leaves to provide a rebated meeting style
DF-6	Existing door to be refurbished to achieve a sound reduction of 35 dB Rw, as per the notes in 5.1. Door to be kept closed which Club is active.

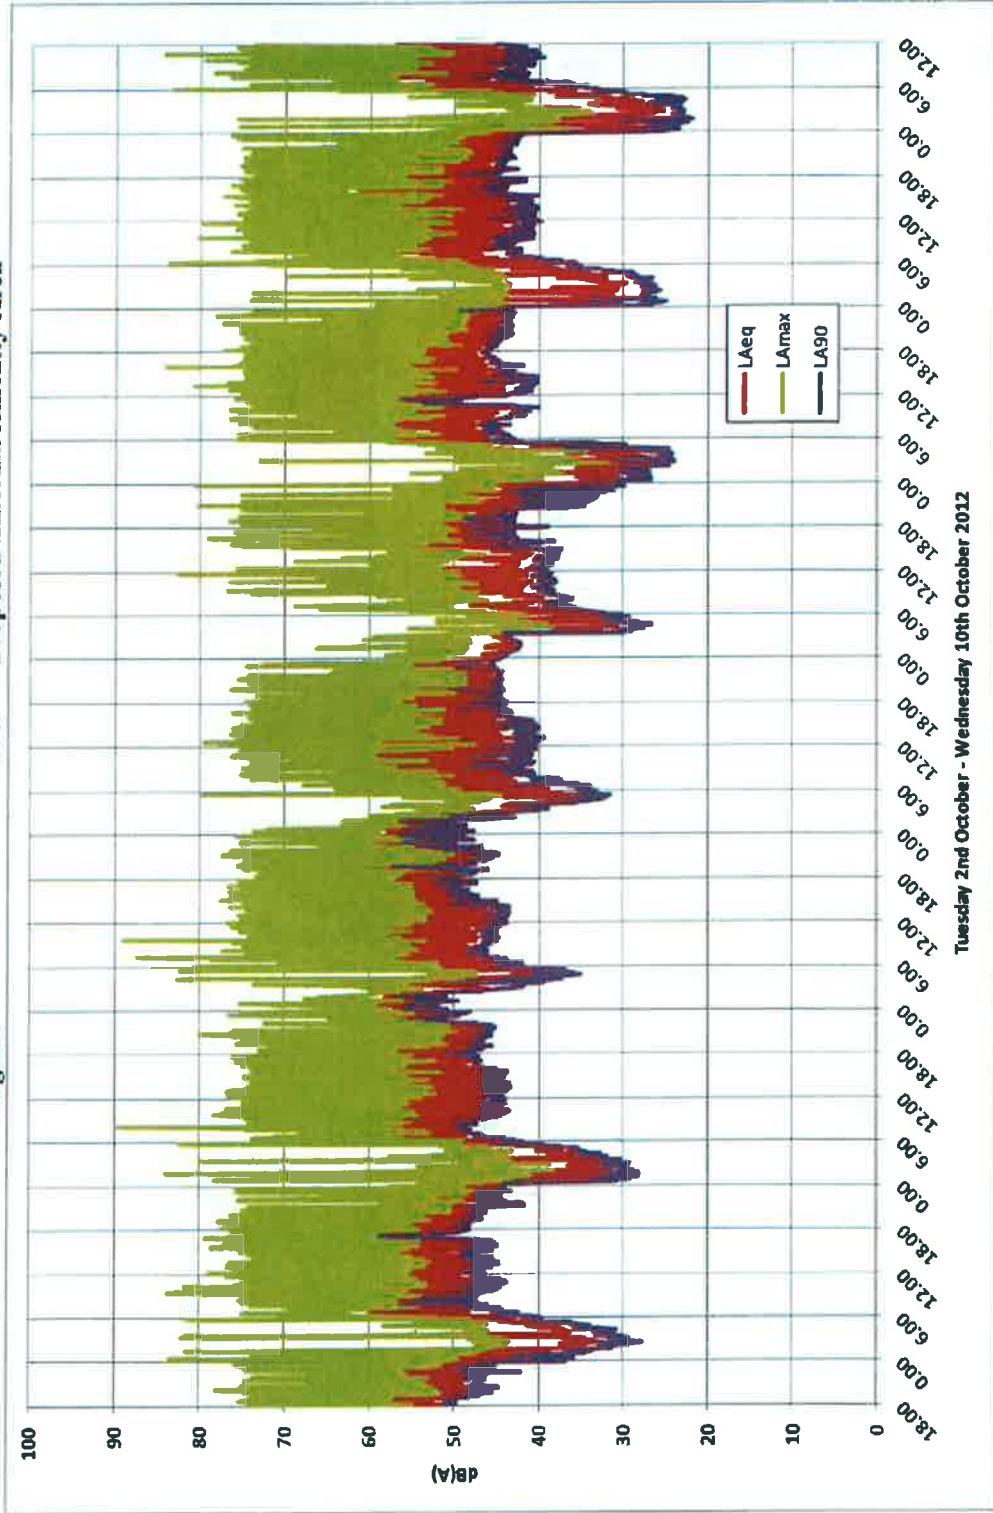
Figure 5 - Measured Noise Levels in Proposed External Amenity Area

Figure 5 indicates the variation of the three parameters during the survey period. It can be seen that in the period up to 2.00 am each morning, the background noise parameter, L_{90} , can fall to a level of about 25 dB(A). The equivalent ambient noise levels fall to a minimum of 30 dB(A) L_{Aeq} .
