B3105 Woolley Green – Site Assessment

> > Document Reference – WC-WG-SA-R001-REV A 24th April 2107

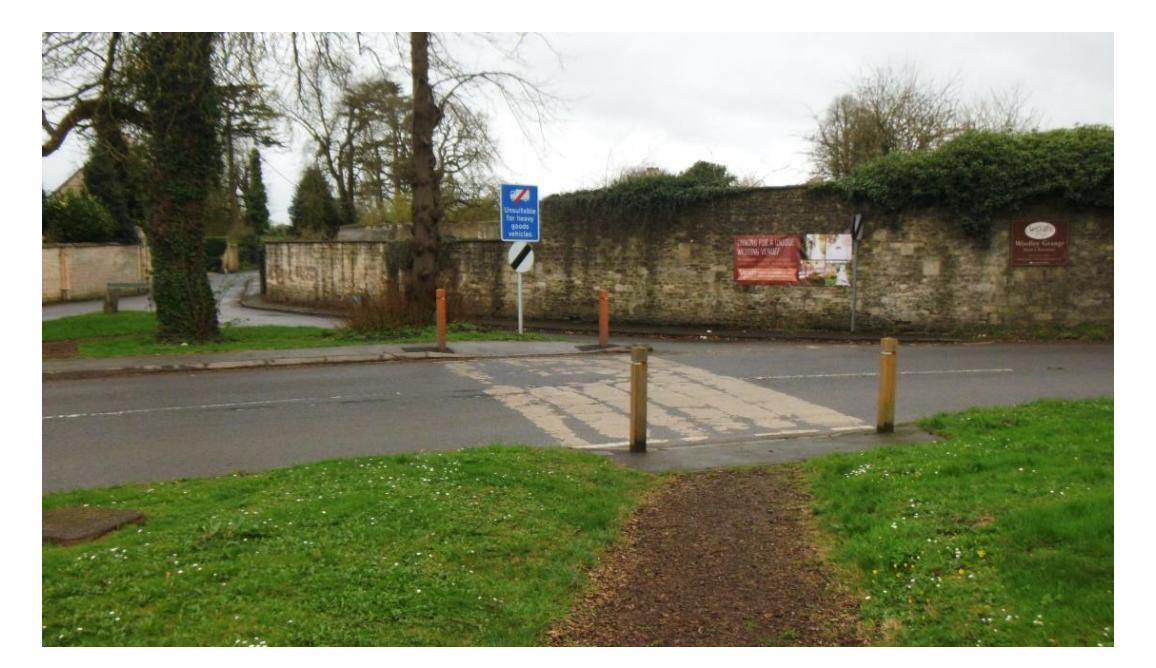
Photograph 1 - Looking south across B3015 towards Woolley Street

16. As is typical in rural environments, provision for pedestrians is generally sporadic in nature and in the case of the Woolley Green area is largely confined to Woolley Street by means of a formal footway on the western side. To assist pedestrian movement across the B3105, an uncontrolled crossing point has been provided from the triangular splitter island to an unbound surface footpath link on the north side. The crossing point is further highlighted with wooden bollards and buff coloured high friction surfacing, although as photograph 1. demonstrates, its current condition is poor and would benefit from maintenance improvements.

- 31. Refurbish the existing road markings and consider the use of additional 'SLOW's on the approach to the double bend
- 32. Refurbish the coloured surfacing at the existing uncontrolled crossing point.

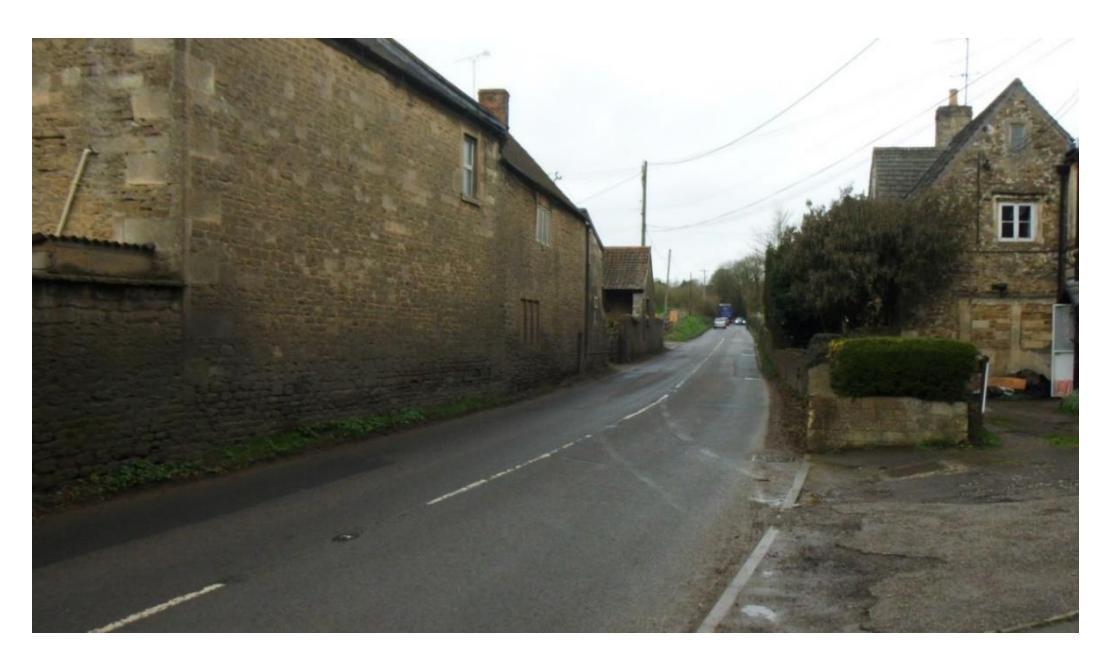
Photograph 2 – B3105 looking northwards towards Bradford Leigh Crossroads

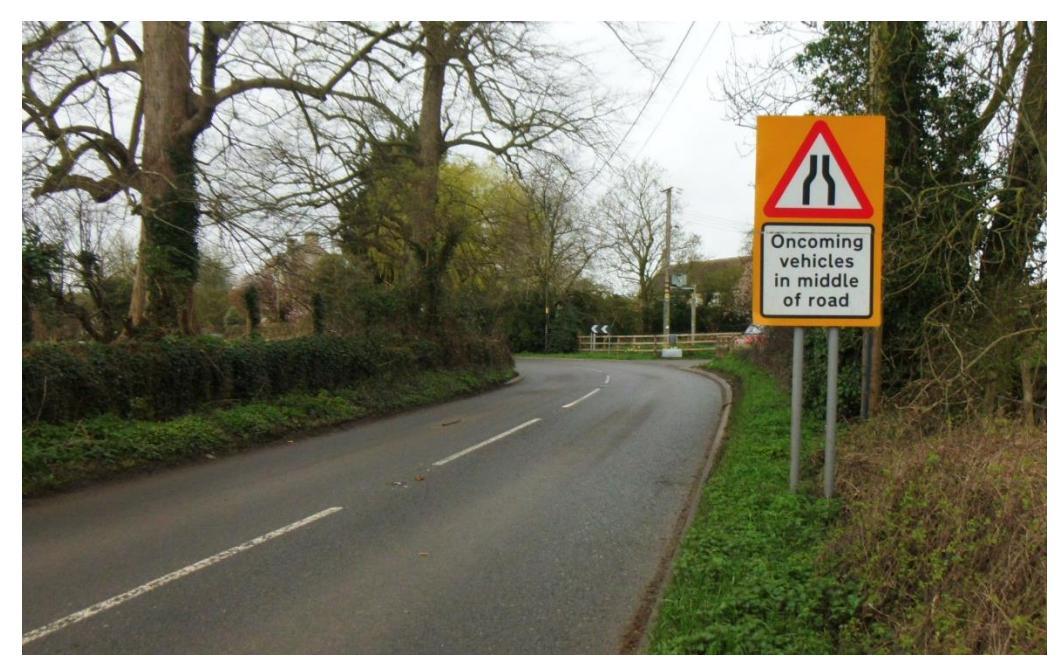
12. The main B3015 approaches to the hamlet are adjoined by either significant hedgerows or buildings which abut the highway. The carriageway width is reasonably consistent at circa 6.0m to 6.5m in width, however the presence of the building and hedgerows do contribute to a feeling of constraint and enclosure (See photograph 2). In addition to the junction with Woolley Street, there is a private driveway leading to Woolley Barn Farm and a small number of residential properties with a further 6 private accesses to properties / fields. On both main road approaches, advance warning signs to Diagram 513 (double bend) are provided, whilst on the south eastern approach (offside) is an additional warning sign to Diagram 515 (road narrows on both sides). See photograph 3. Chevron signs to Diagram 515 are also located opposite both bends.

Photograph 3 - B3105 looking North West towards commencement of double bend

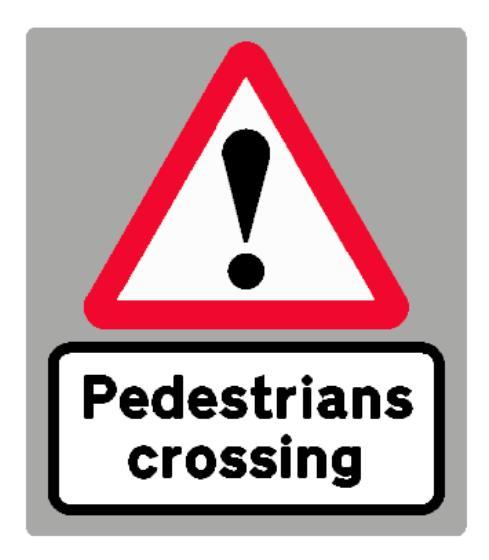
Figure 4. Example of advanced warning sign to Diagram 562

- 29. Consider the implementation of a 40mph limit on the B3105 through Woolley Green to link up with the current restriction to the north at Bradford Leigh.
- 30. Undertake a comprehensive sign review within the study area and install replacement / new signing where appropriate. The provision of advance signs to Diagram 562 to warn of the presence of pedestrians is of particular importance. Refer to Figure 4. For example of sign.
