Meeting: Eastern Area Planning Committee

Date: Thursday 15 July 2021

7 **Planning Applications** *(Pages 3 - 34)*

Eastern Area Planning Committee

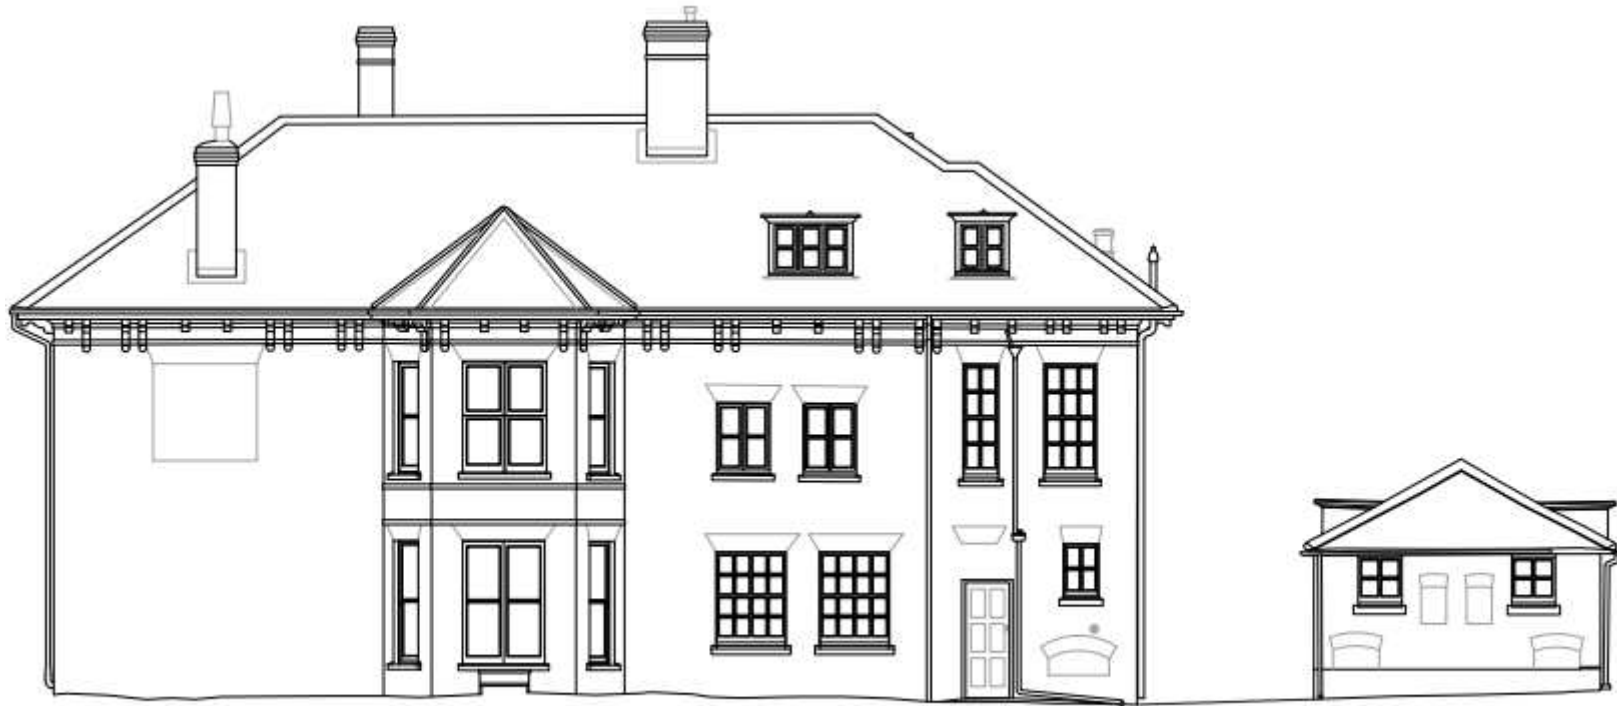
Existing North Elevation

REAR ELEVATION (NORTH)

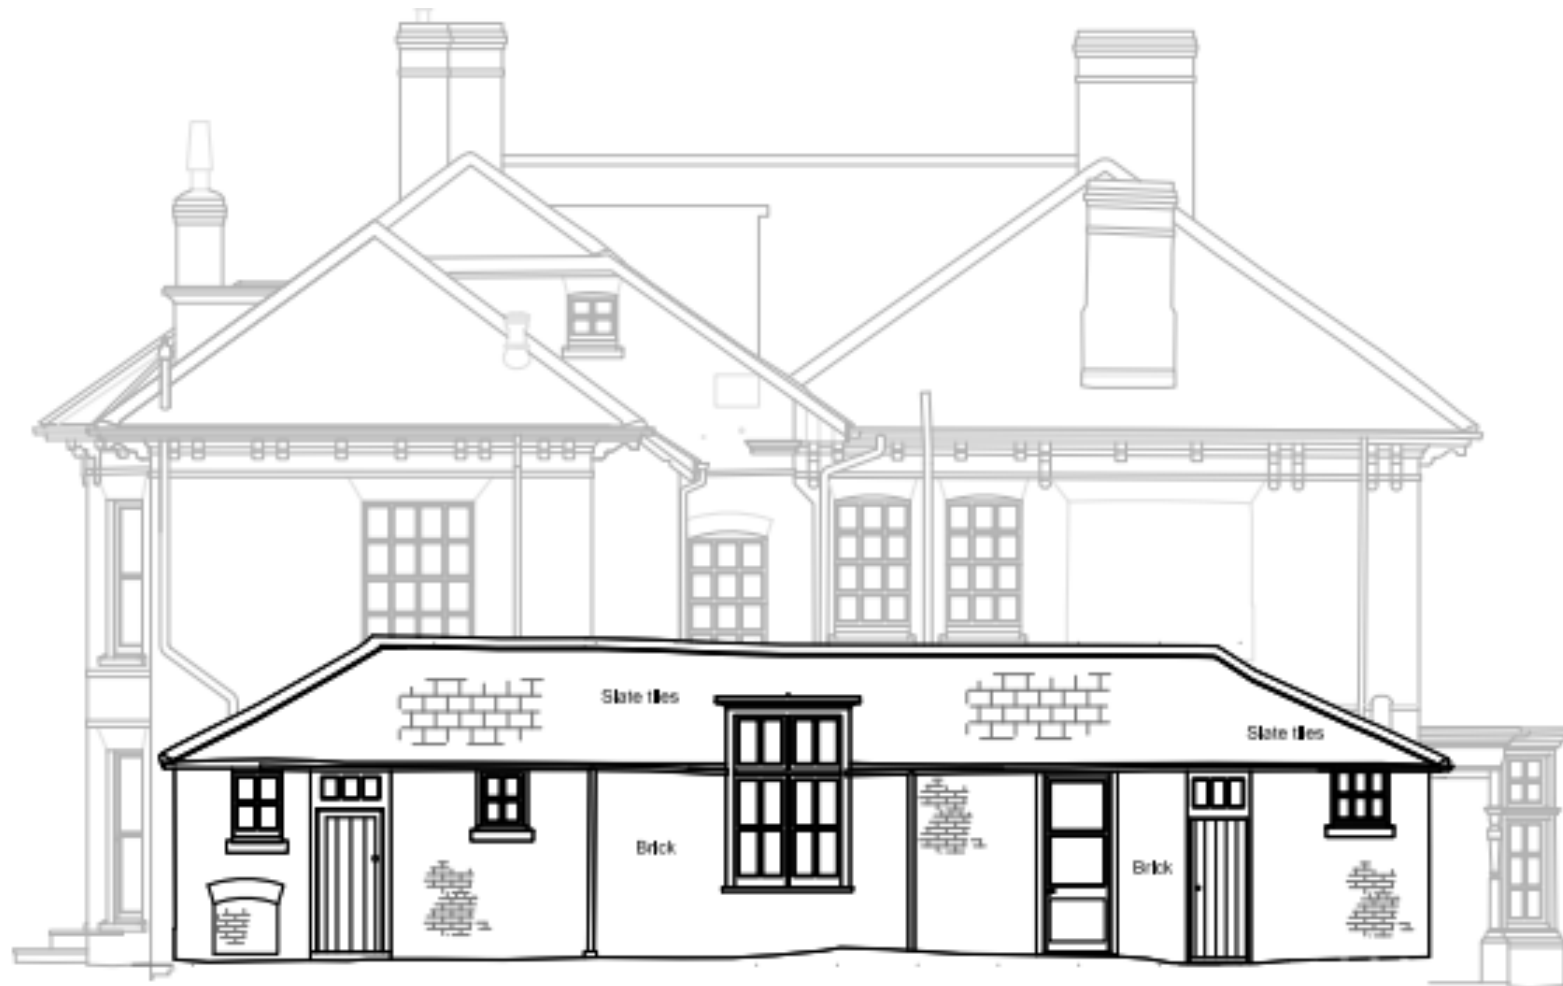
OUTER SIDE ELEVATION (WEST)

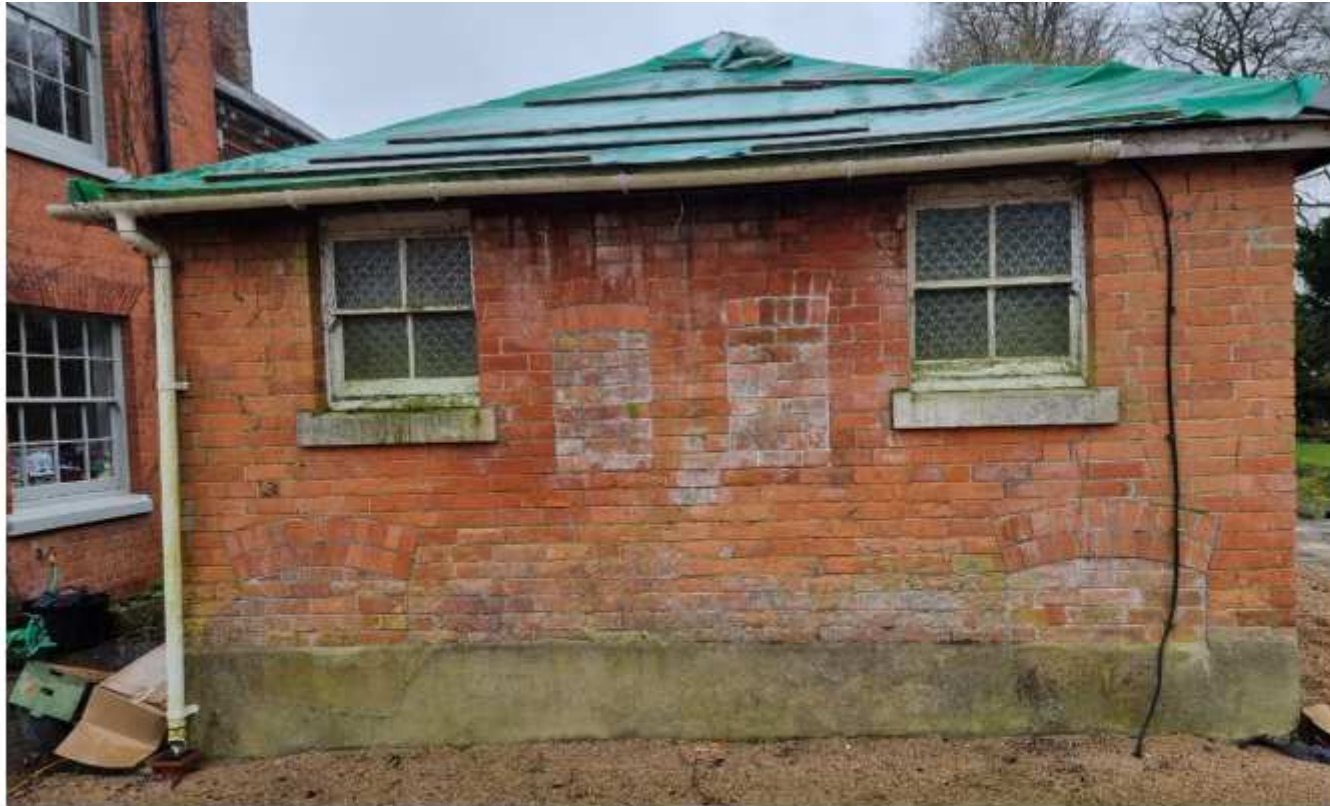
North elevation

- Poor brickwork condition
- Modern cementitious render
- Partial failure of roof

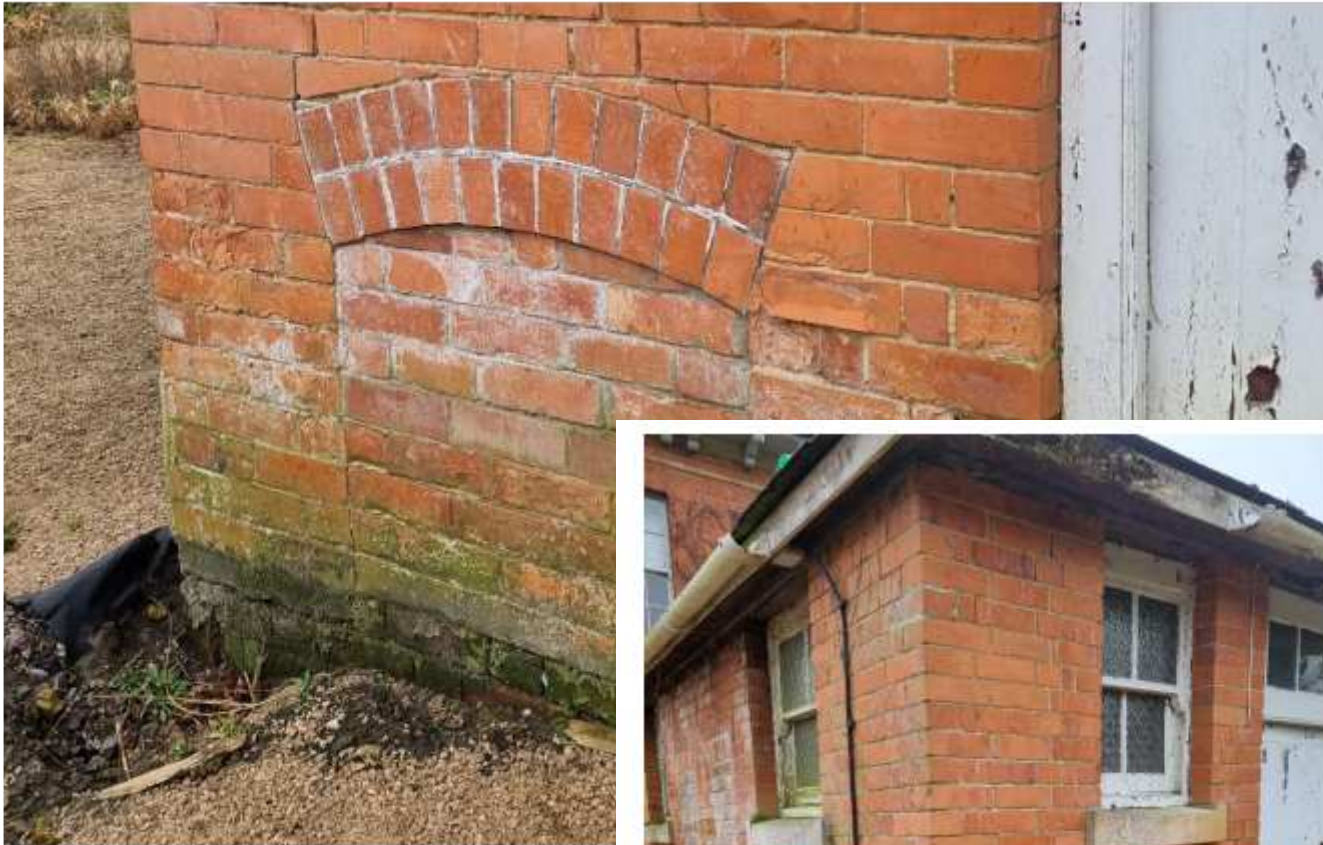
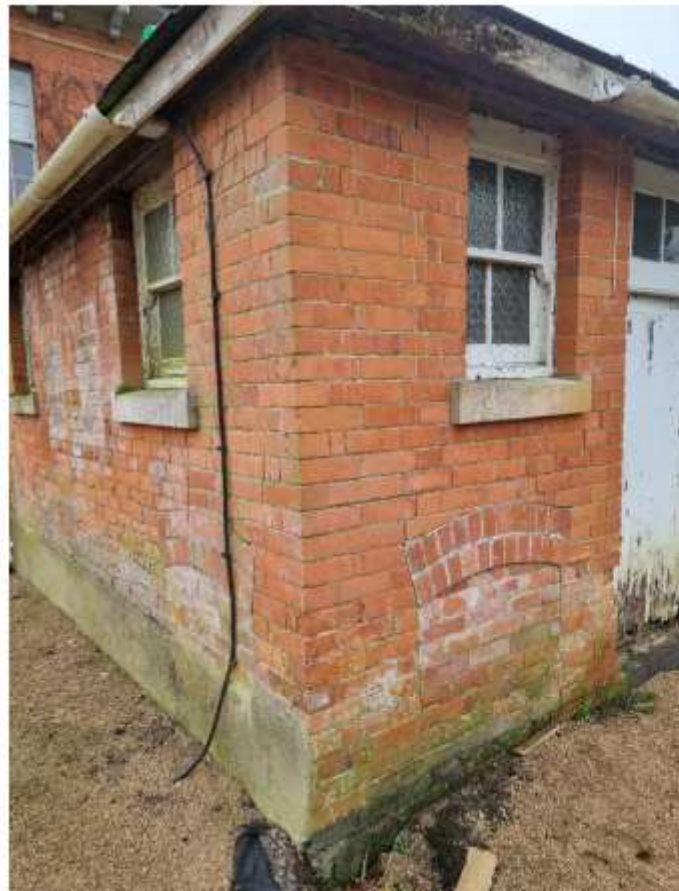
North-West corner

- Very damp brickwork below floor level
- Missing mortar joints (typical)
- Poor brickwork condition generally at low level (typical)
- Shallow 'foundations'

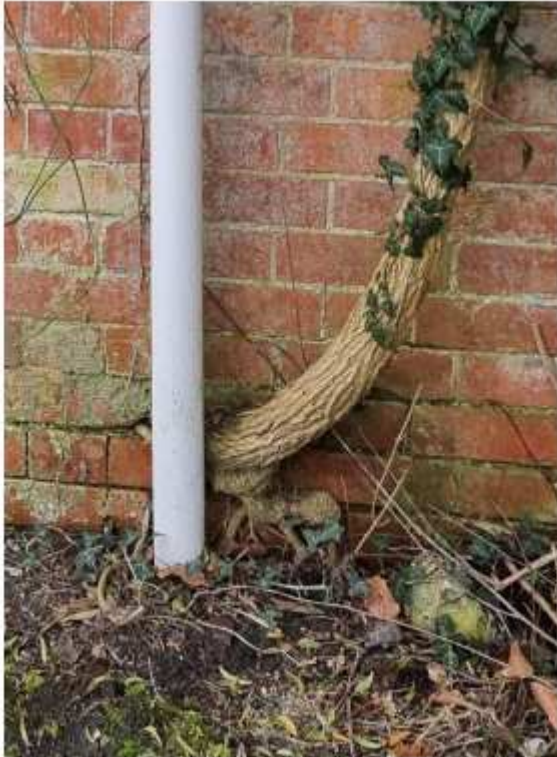
West elevation

- Very damp & damaged brickwork below floor level
- Missing mortar joints (typical)
- Poor brickwork condition generally at low level (typical)
- Deflected ridge line
- Vine growth in masonry

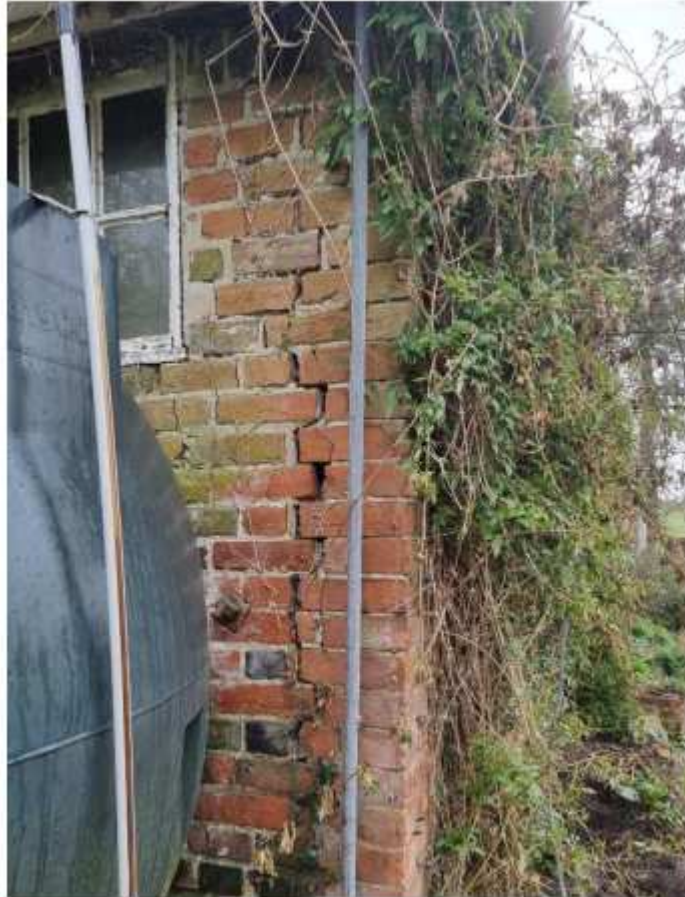
South-West corner

- Eroded/missing mortar joints behind tank
- Cementitious pointing 'repairs'
- Vertical crack between South and West elevations
