**A4 Curzon Street, Calne
Pedestrian Crossing Assessment**

Project Title: A4 Curzon Street, Calne

Report Title: Pedestrian crossing assessment

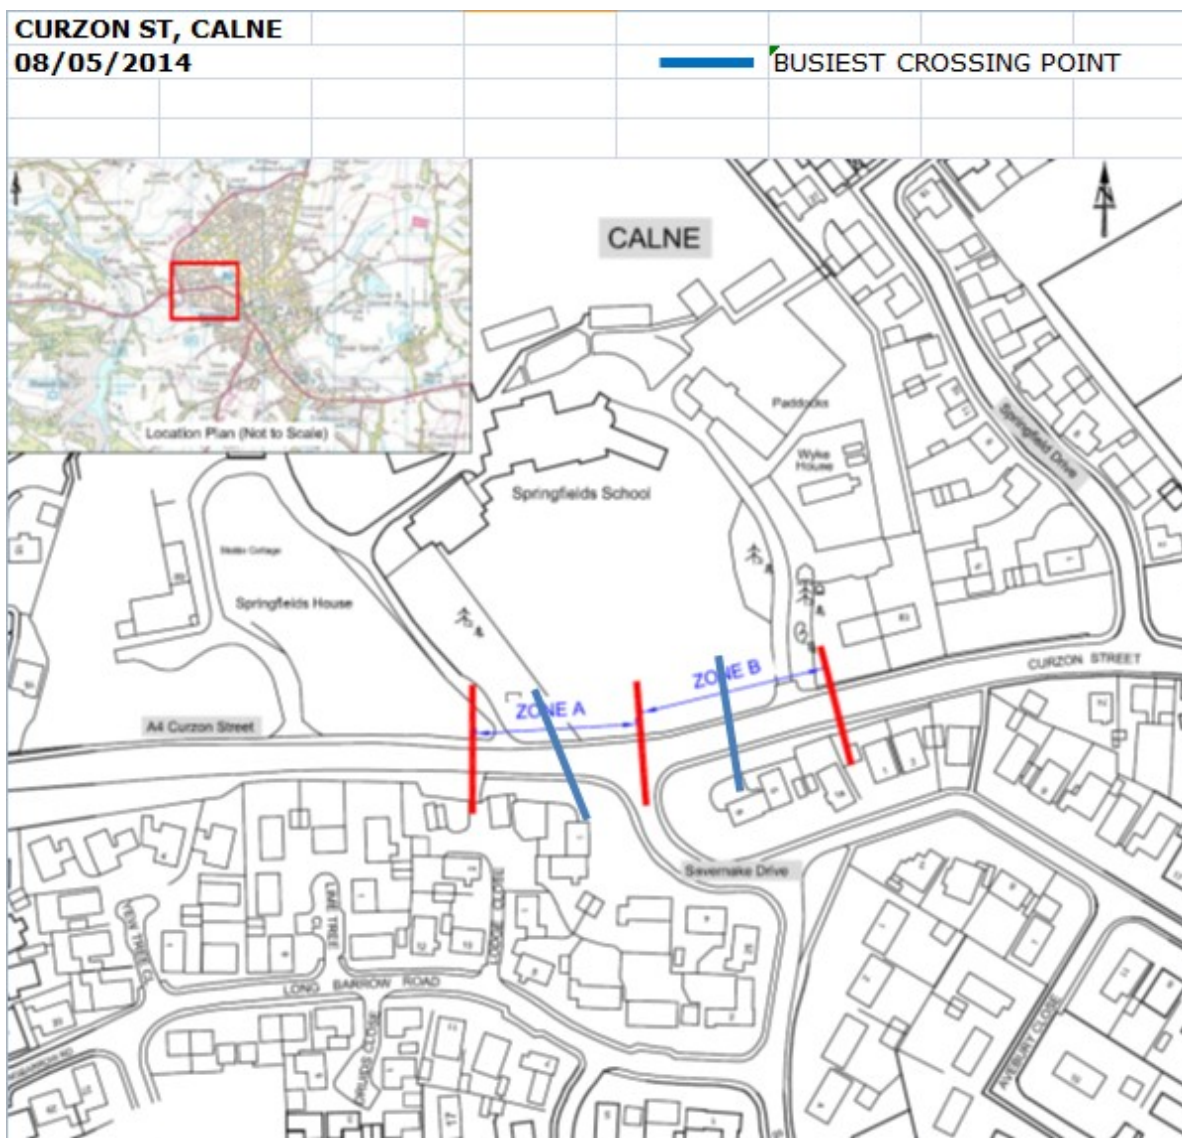
7.0 Appendix C – Pedestrian movement record

The busiest crossing locations in the two zones are shown on the plan at **Appendix C**.

A pedestrian count survey took place in May 2014 to establish the numbers and locations of pedestrians currently crossing the road. The survey was undertaken between 0700 - 1900. The survey recorded pedestrians crossing Curzon Street over two zones located either side of the Savernake Drive junction.
