# Maud Heath's Causeway, East Tytherton Feasibility Study

HIGHWAYS, TRAFFIC & NETWORK MANAGEMENT

**Report Title: Maud Heath's Causeway, East Tytherton Feasibility Study**

**Date: 19/08/2014**

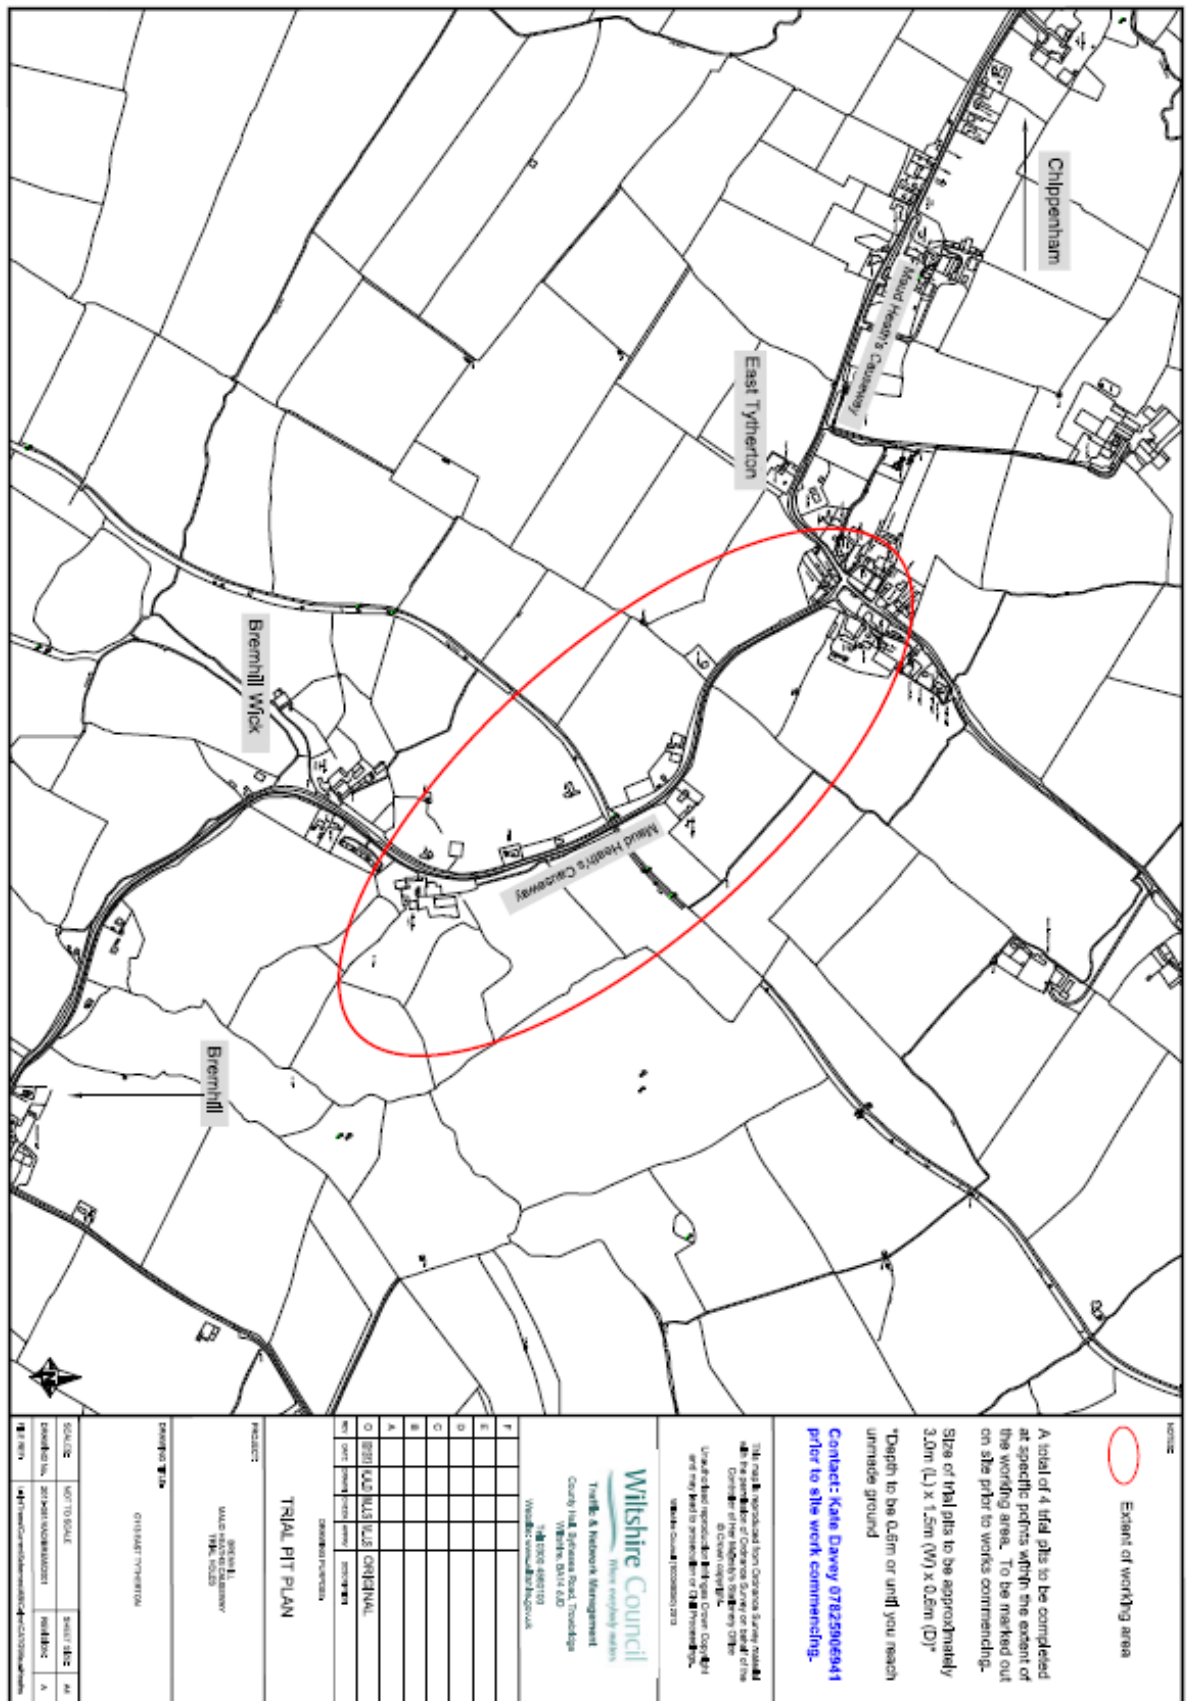
**TRIAL PIT PLAN**  
 PROJECT: BREMILL  
 MAUD HEATH'S CAUSEWAY  
 15/01/2020

Extent of working area

A total of 4 trial pits to be completed at specific points within the extent of the working area. To be marked out on site prior to works commencing.

Size of trial pits to be approximately 3.0m (L) x 1.5m (W) x 0.6m (D)\*

\*Depth to be 0.6m or until you reach unmade ground

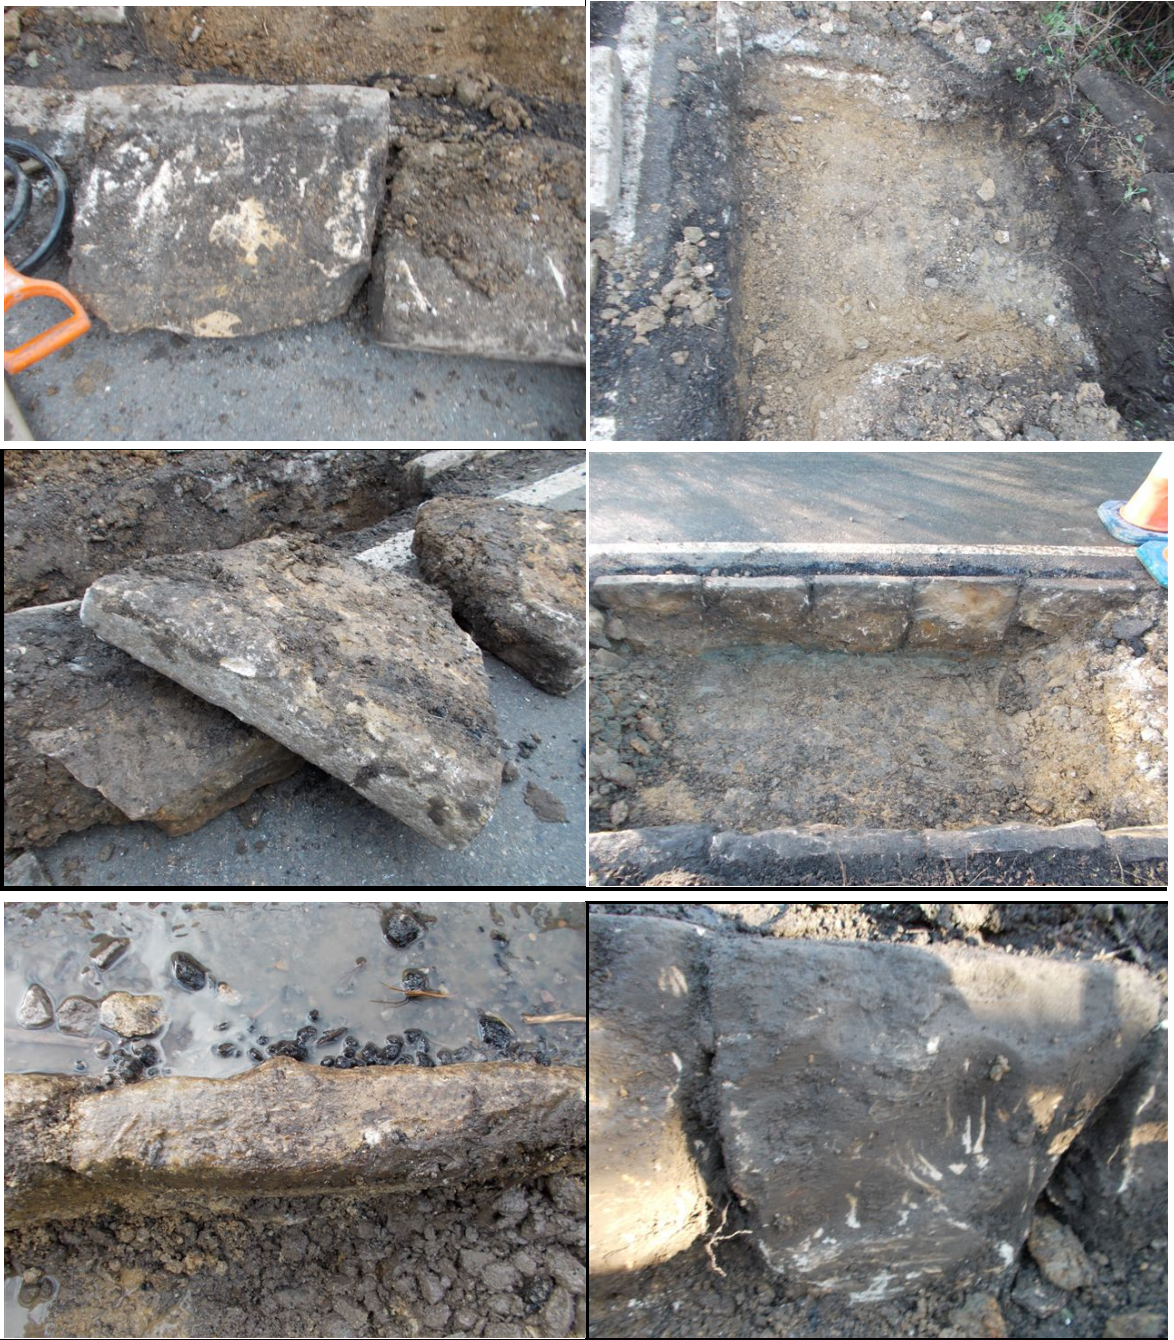
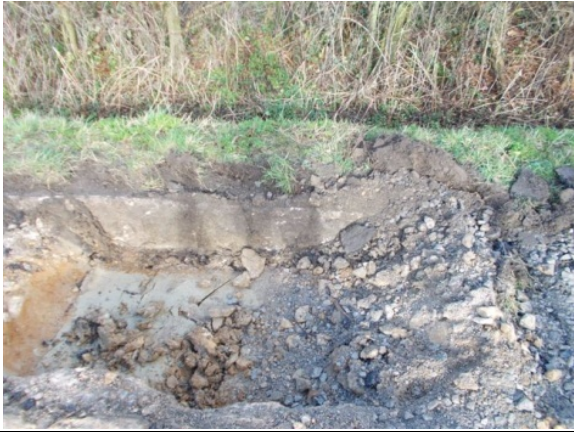
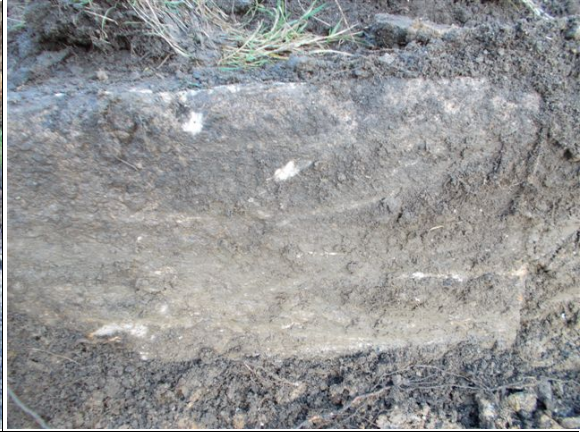
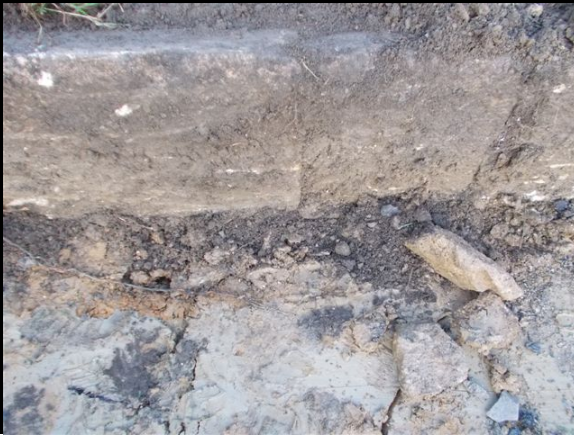
**Appendix D – Trial Hole Photographs**

<u>Trial Hole</u>	<u>Kerb measurement</u>	<u>Kerb condition</u>
1 – near monument	450mm deep	Good condition to re-use especially kerbs at back of footway
2 – opposite Elm Cottage	450mm deep	12 kerbs taken out 11 of which in good condition to re-use
3 – near Wickbridge Stables	Between 400 – 500mm deep	13 kerbs taken out all of which in good condition to re-use
4 – near Homefields	180 – 220mm deep	Good condition to re-use especially kerbs at the back of the footway

The results of the trial holes indicate that the majority of the original kerbs which are situated at the back of the footway are in good condition and can be removed and used at the front of the footway. This will allow the correct upstand to be used in order to decrease the likelihood of overrunning the footway. With the original kerbs being used at the front of the footway we can source conservation edgings to be installed at the back of the footway giving it the stability and appearance it requires.

Our recommendation is to reconstruct the existing footway along the entire length of 700m, using the original kerbs from the back of the footway and installing them at the front with new conservation edgings installed at the back of the footway. We will use our standard footway construction for the new surface but leave the few short sections where the original stone can be seen for the full width of the footway.
