**A4 Curzon Street, Calne
Pedestrian Crossing Assessment**

Project Title: A4 Curzon Street, Calne

Report Title: Pedestrian crossing assessment

Date: October 2014

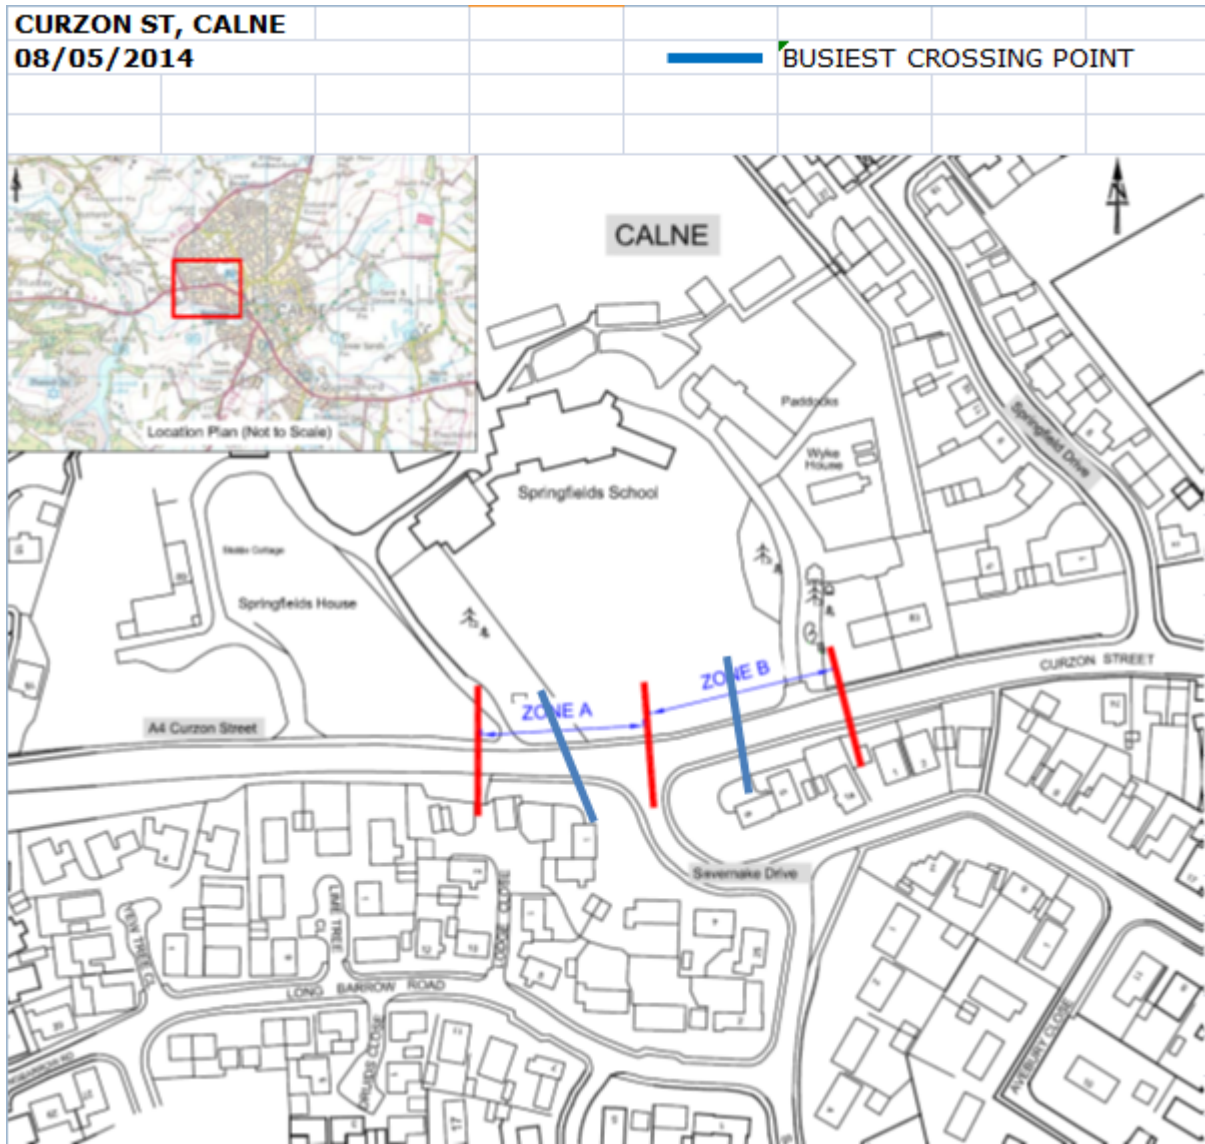
7.0 Appendix C – Pedestrian movement record

A pedestrian count survey took place in May 2014 to establish the numbers and locations of pedestrians currently crossing the road. The survey was undertaken between 0700 - 1900. The survey recorded pedestrians crossing Curzon Street over two zones located either side of the Savernake Drive junction.

The busiest crossing locations in the two zones are shown on the plan at **Appendix C**.

Taking into consideration the data collected, the site assessment, the crossing options available and the adopted Wiltshire Council practise for pedestrian crossings it is recommended that an enhanced uncontrolled crossing be provided within Zone A as close as is practical to the busiest crossing location recorded during the pedestrian surveys. It is however noted that this will have to take account of the existing bus stop and shelter provision that exists in this area.
