# Wiltshire Wildlife Trust

*Advisory report February 2019*

## Nadder - Tisbury

28 February 2018

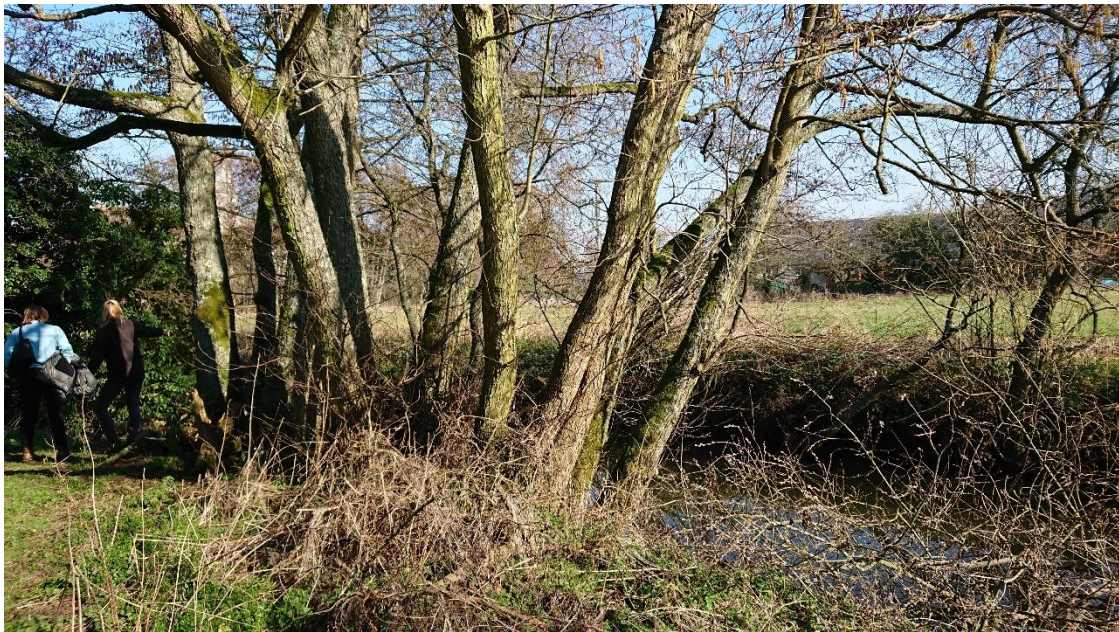
At the beginning of the reach there are many trees, the majority on the left-hand bank, which are over-shading the channel (Figure 2). There is also dog access to the river from the left-hand bank which has caused erosion. Further down the reach the left-hand bank is a solid concrete revetment (Figure 3) for approximately 80m, the right-hand bank is willows that have been managed and re-grown, forming a dense wall that is shading the channel heavily (Figure 4). Some of these willows are growing into the channel which is creating nice natural woody debris, assisting the natural processes of the river.

*Figure 2: Area of Alder trees shading the channel at the start of the reach visited.*

Overall, the river would benefit from some tree clearance to allow more light into the channel. This would also be beneficial for the creation of the sensory garden as the proposed site is currently heavily shaded. In this area there is a small section of erosion where it appears dogs are entering the water, this would benefit from dog exclusion to allow riparian vegetation to re-grow.

The river is in relatively good condition but would benefit from the removal of some trees along the reach visited. These are marked up on figure 5, please note this is just advisory and further tree surveys, including bat surveys, would be required before any action is taken. The trees recommended for removal are alder trees (*Alnus glutinosa*), currently they are shading both the channel and site for the sensory garden. The removal of some limbs on the right-hand bank that are leaning over and shading the river, including the line of willows, is also recommended.

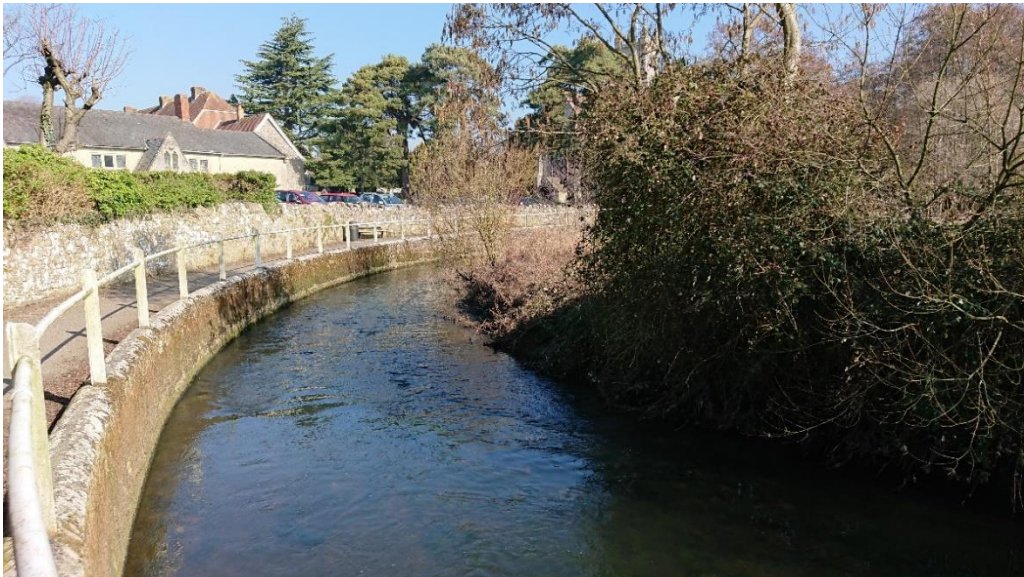
Water levels were relatively high at the time of the visit and the water was coloured meaning the bed was not visible. This is not unexpected at this point on the Nadder as it rises in limestone and greensand, slowing primarily through agricultural land before reaching Tisbury. The flow appeared relatively sluggish at the beginning of the reach visited, indicating a deeper channel however it sped up towards the end, with natural riffles revealing gravels on the river bed (Figure 3).

*Figure 3: Natural riffles towards the end of the reach visited. This figure also shows the concrete revetment.*

In general it would be advisable to install small woody structures alongside the hard revetment, to trap sediment, softening the bank and providing marginal habitat for wildlife and plants. However, in this location these would not be recommended as they would be exposed to flows on the outside of the bend and have the potential to fail over time. The majority of sediment will be deposited on the inside of the bend and this is where marginal vegetation should be encouraged to grow.

Consequently it is recommended that the right-hand bank is closely monitored and this is not allowed to become too over shaded.

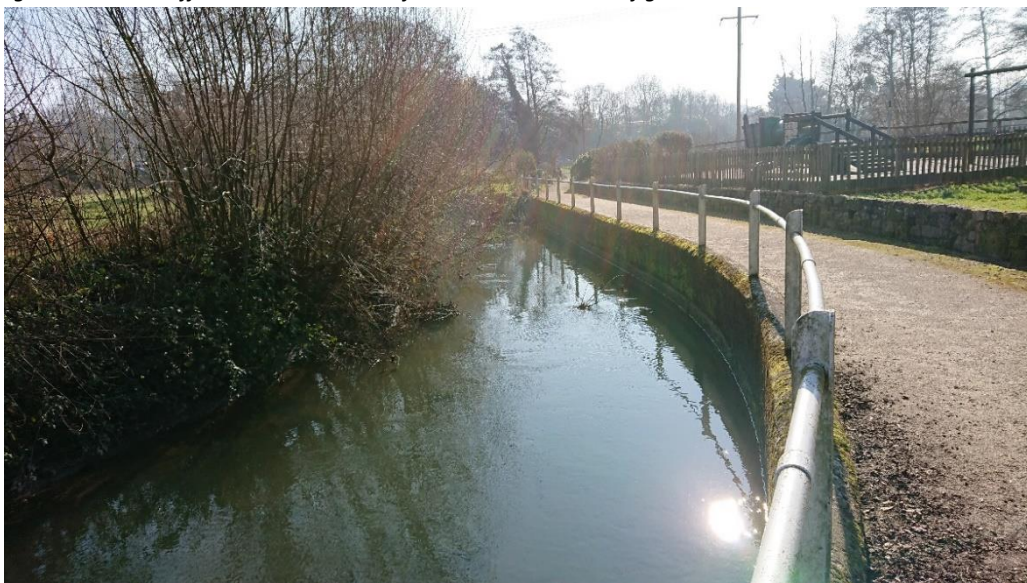
*Figure 4: Willow over shading the channel in summer but also providing wood debris into the channel.*

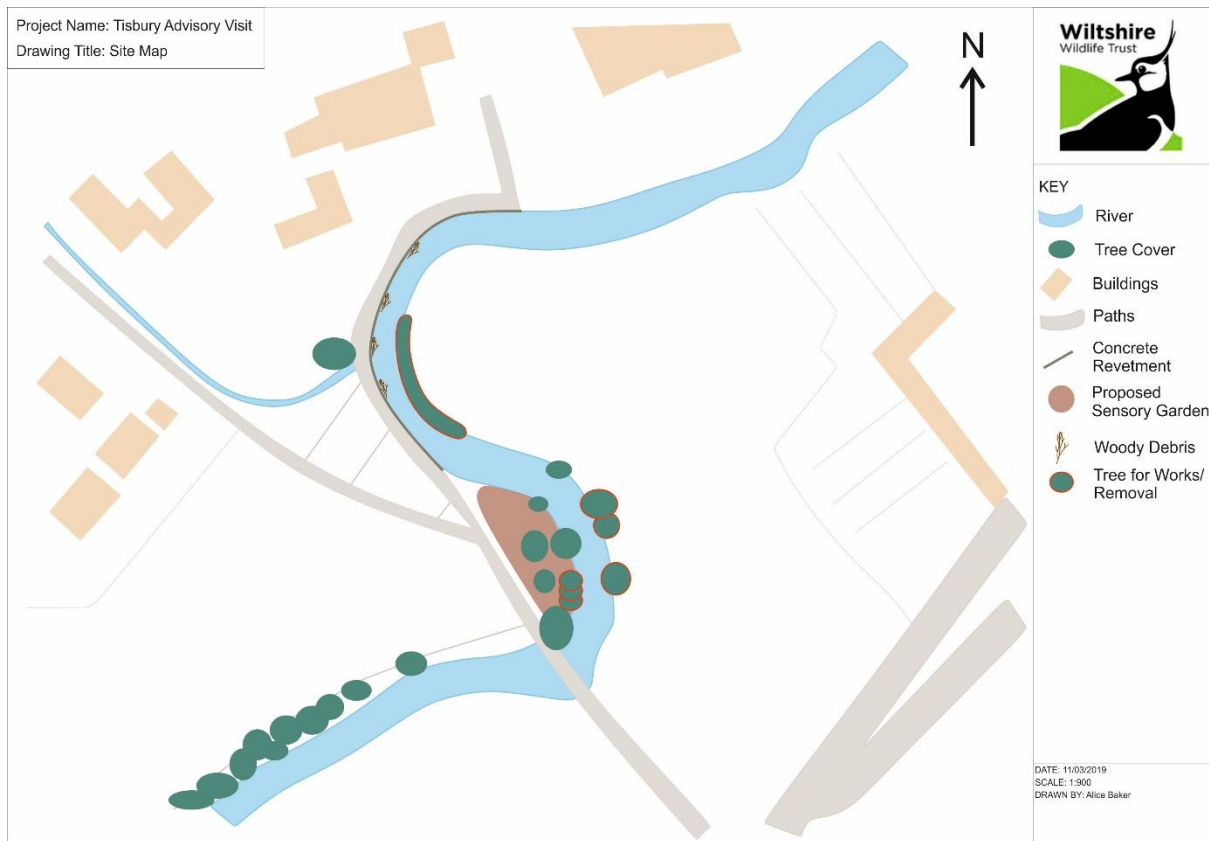
Figure 5: Map of locations proposed works

There is a small area of erosion on the left-bank in the area marked for the sensory garden. This appears to be caused by dogs entering the channel. This would benefit from fencing or reinforcement to allow marginal vegetation to stabilise the bank and prevent further erosion and sediment deposition into the channel. It is recommended that the vegetation up to the bank top and 1m away is left unmanaged. The only exception to this would be the removal of the invasive non-native plant Himalayan balsam which is known to be present in this area.
