**A4 Curzon Street, Calne  
Pedestrian Crossing Assessment**

**Project Title:** A4 Curzon Street Calne

**Report Title:** Pedestrian Crossing Assessment

**Date:** August 2019

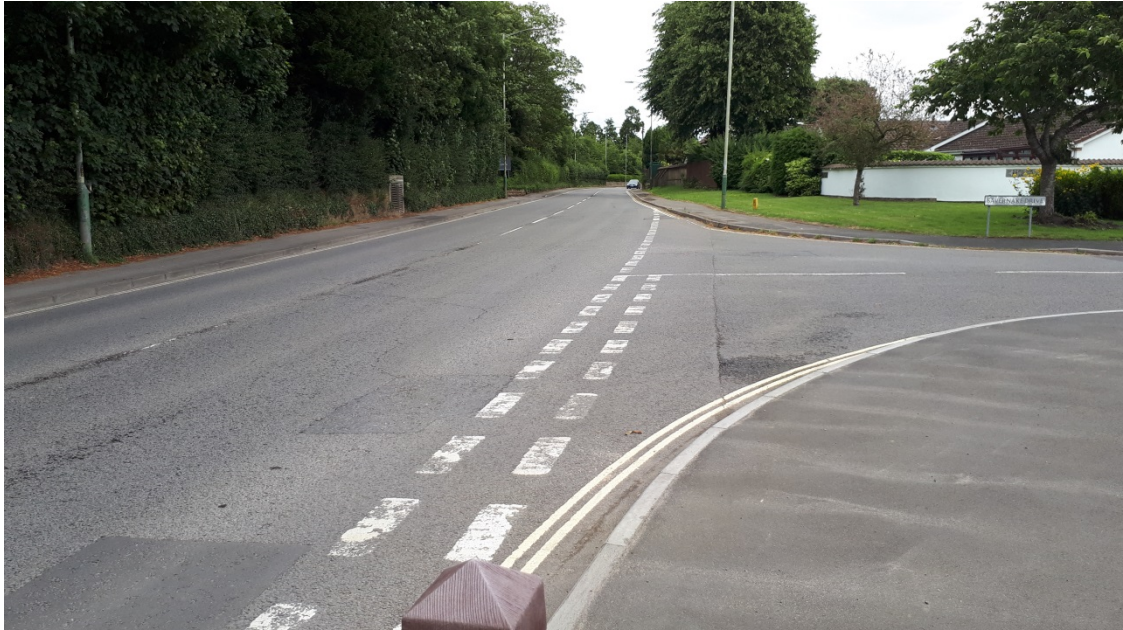
**Photo 1 – Visibility from South side of crossing in an Easterly direction.**

DMRB *Volume 6 - Section 1, Table 2* outlines the requirement for SSD for each respective design speed. In the case of Curzon Street the recorded 85<sup>th</sup> percentile speed is 34 mph. The closest design speed available in Table 2 is 60kph or 37.3mph, whereby the 'desirable minimum' SSD is 90m. In this instance the SSD from either side of the advisory crossing point was measured in excess of 90 metres.

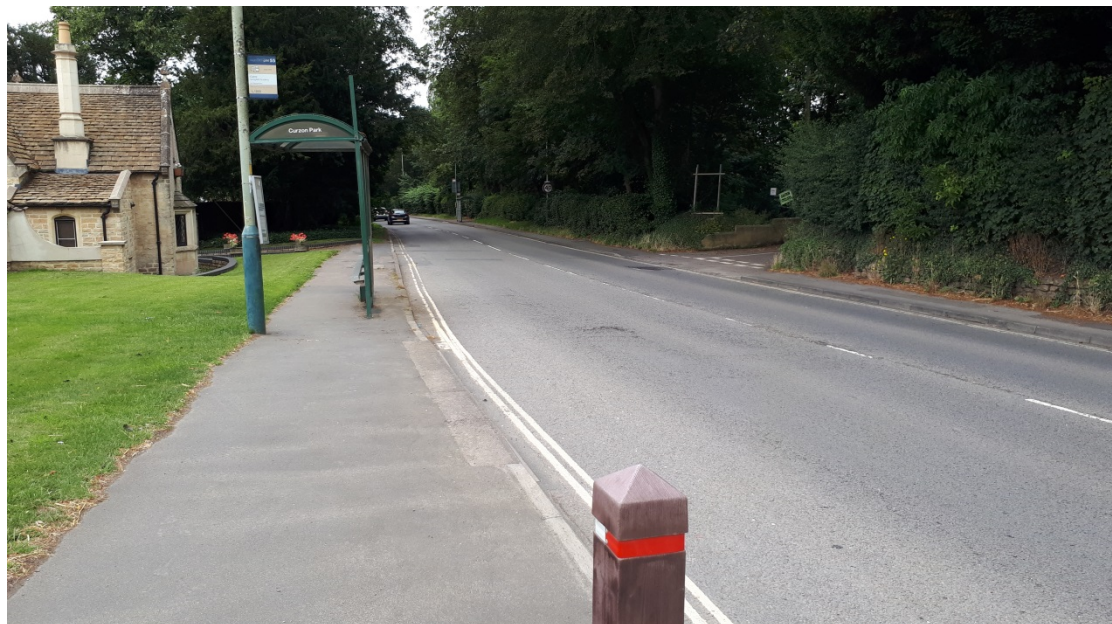
**Photo 2 - Visibility from South side of crossing in a Westerly direction**

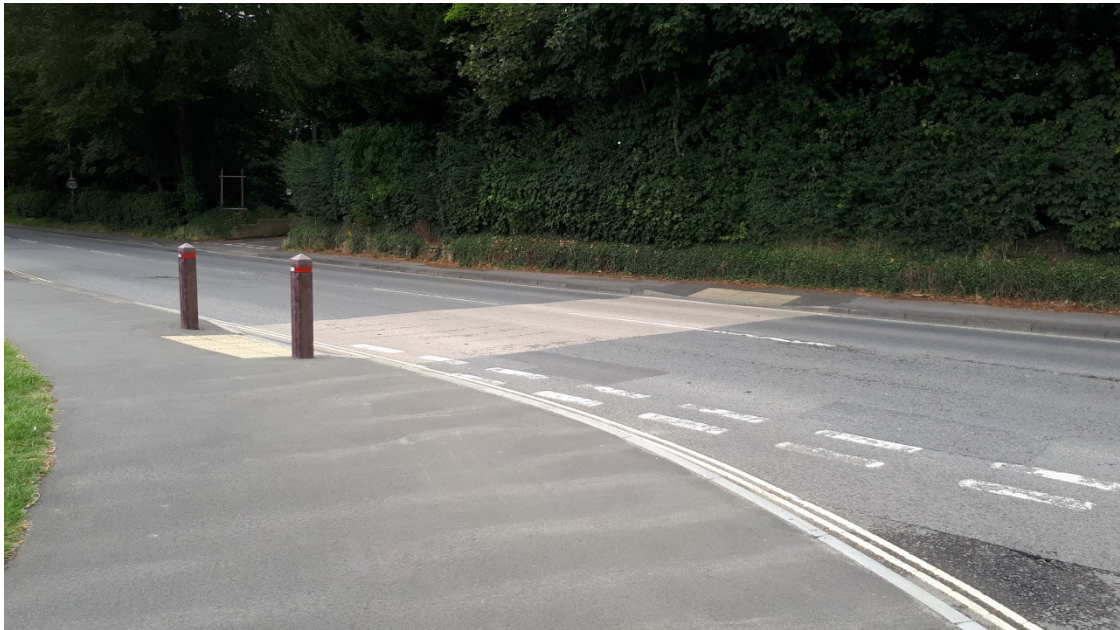
There is currently an enhanced uncontrolled crossing point located at Zone A. This consists of dropped kerbs, high friction coloured strip, bollards (on the South side) and tactile paving.

Looking at the numbers of pedestrians crossing, the gap availability in the traffic, the time taken to cross the road and the available visibility it is considered that the existing enhanced crossing point facility is appropriate for this location.
