# Lyneham Banks Repairs

22/6/2023

Royal Wootton Bassett & Cricklade  
Area Board Meeting

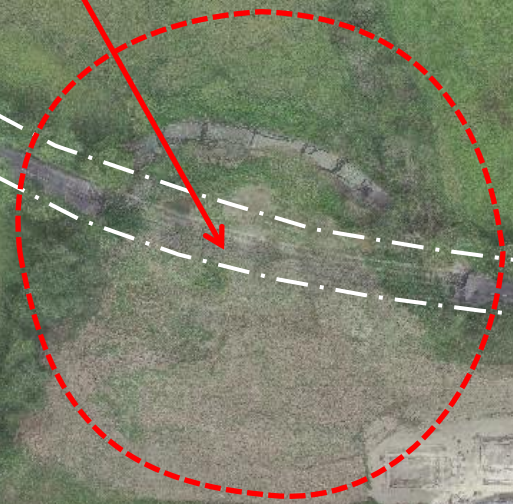
**Current situation**

Main landslip area

B4069

Motorholics

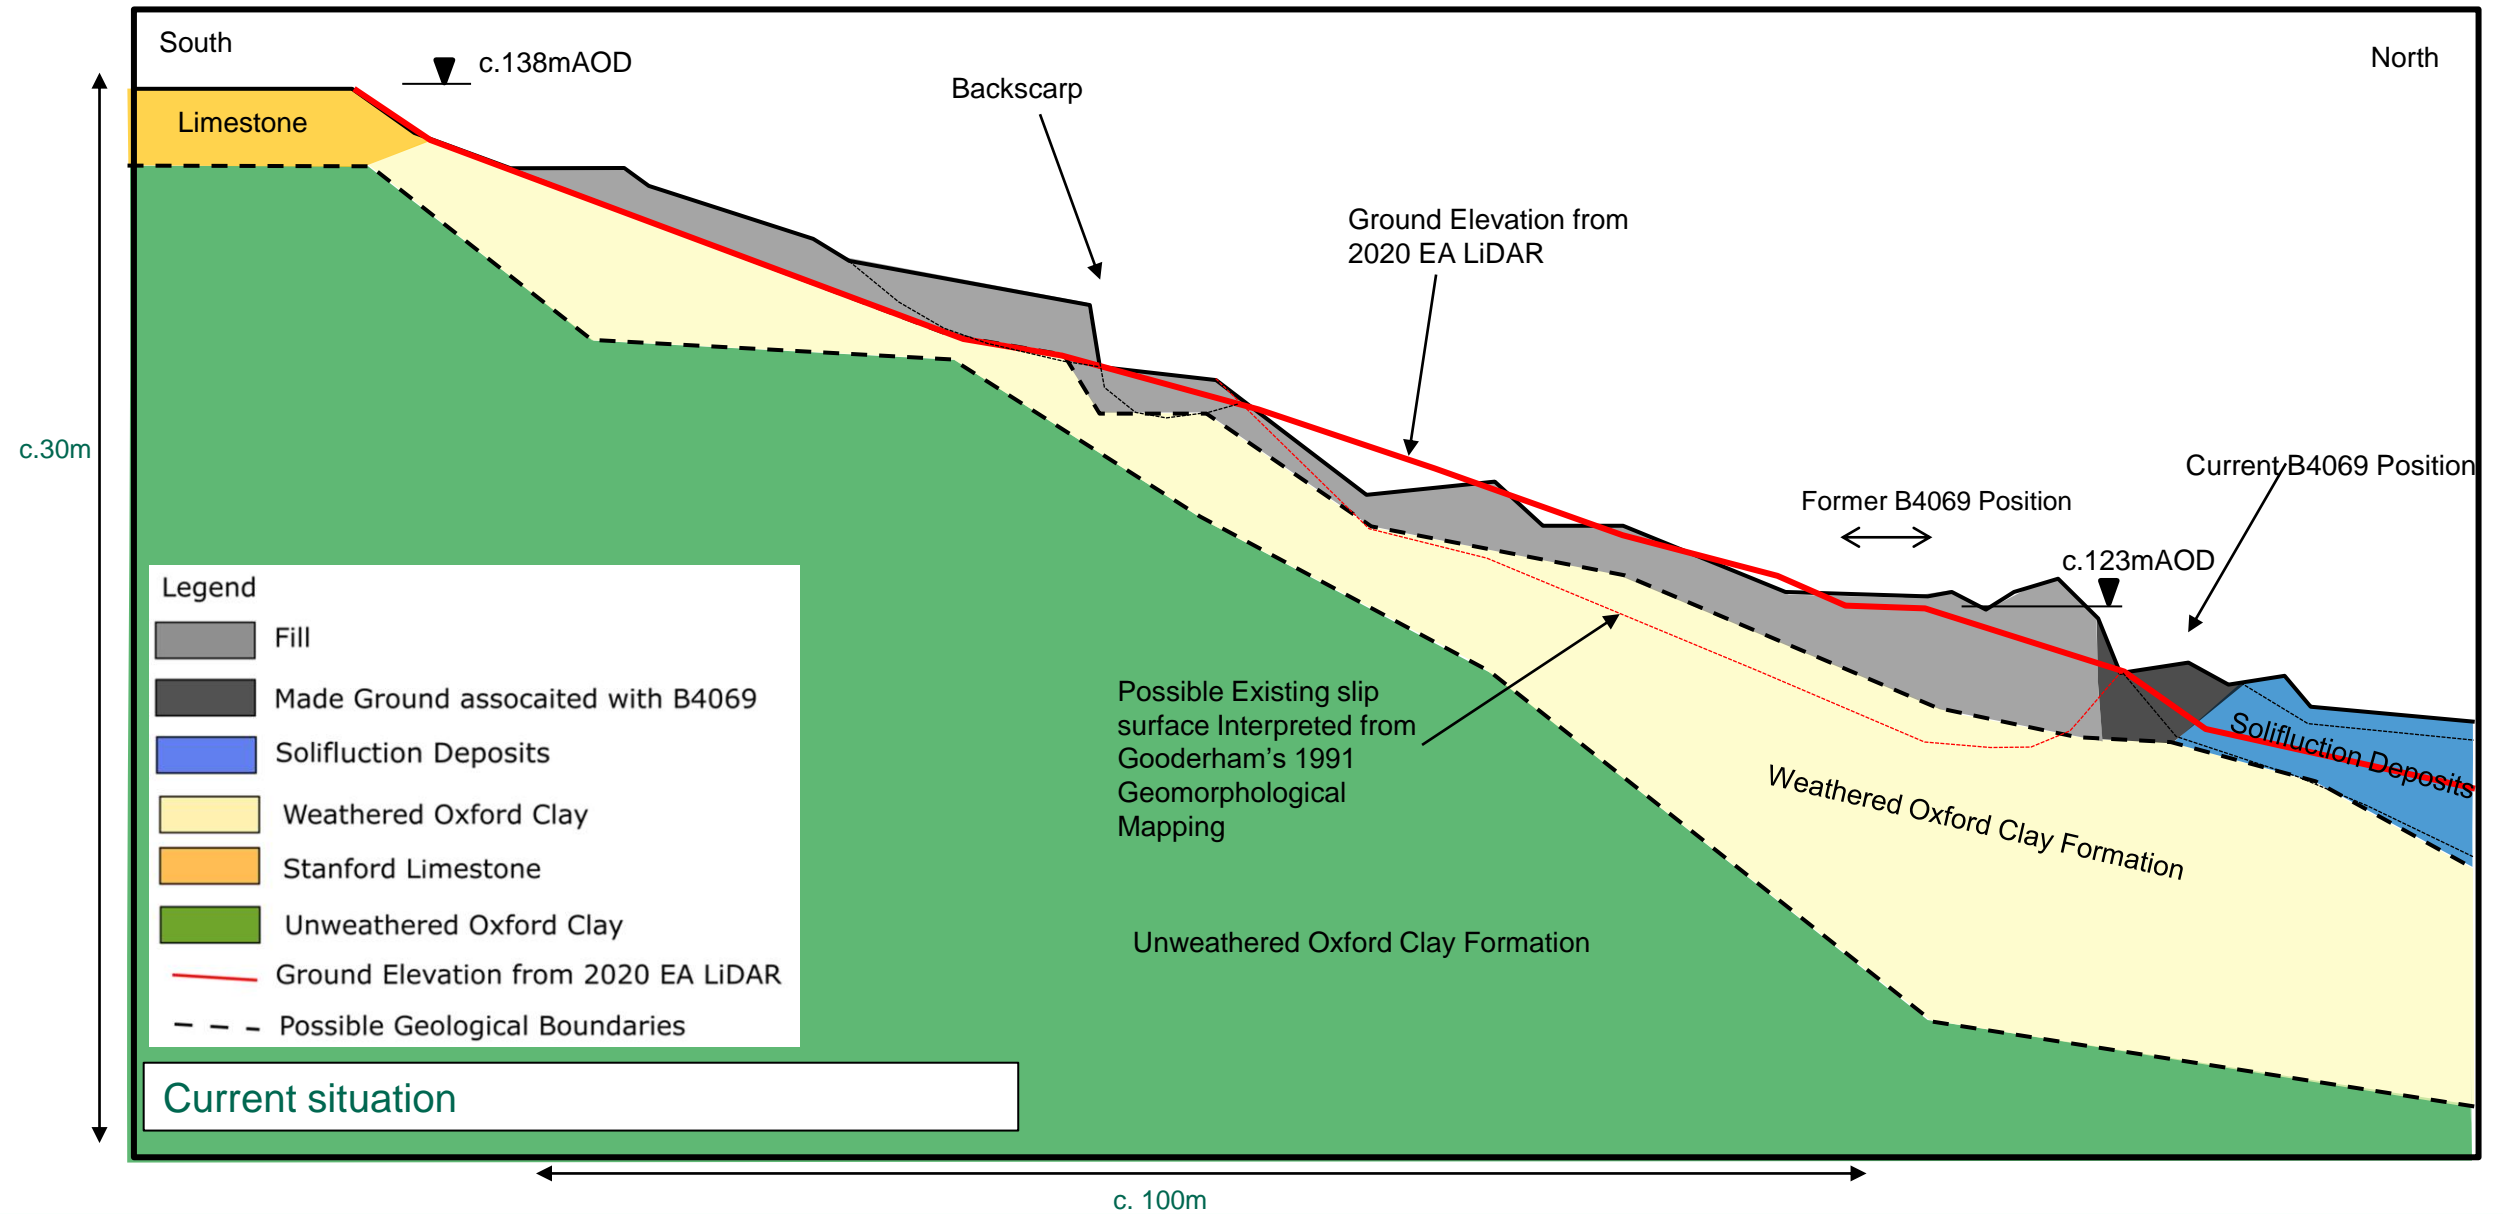
Main areas of required remediation:

- A) Upper slope (main body of landslide)
- B) Road corridor (B4069)
- C) Lower slope

Area west of main landslide

*Road is still intact but area of previous road cracking*

Area east of main landslide

*Road is still intact but built on relict slip (pre-1991 mapping) and land has been raised by developer*

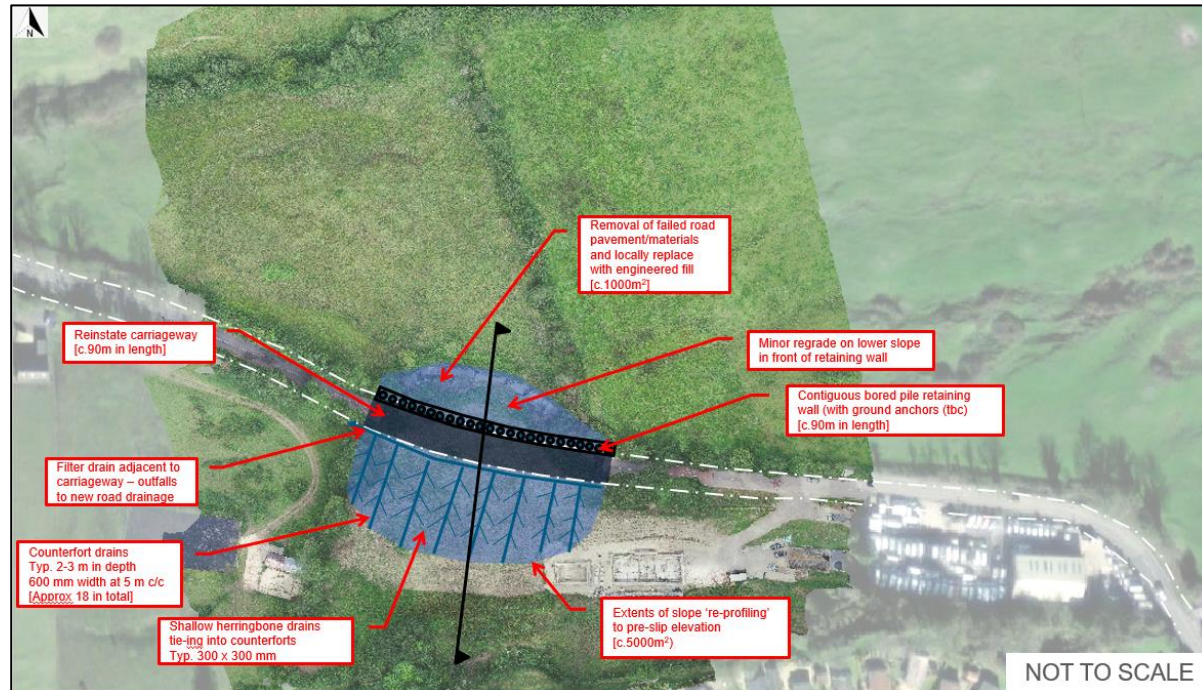
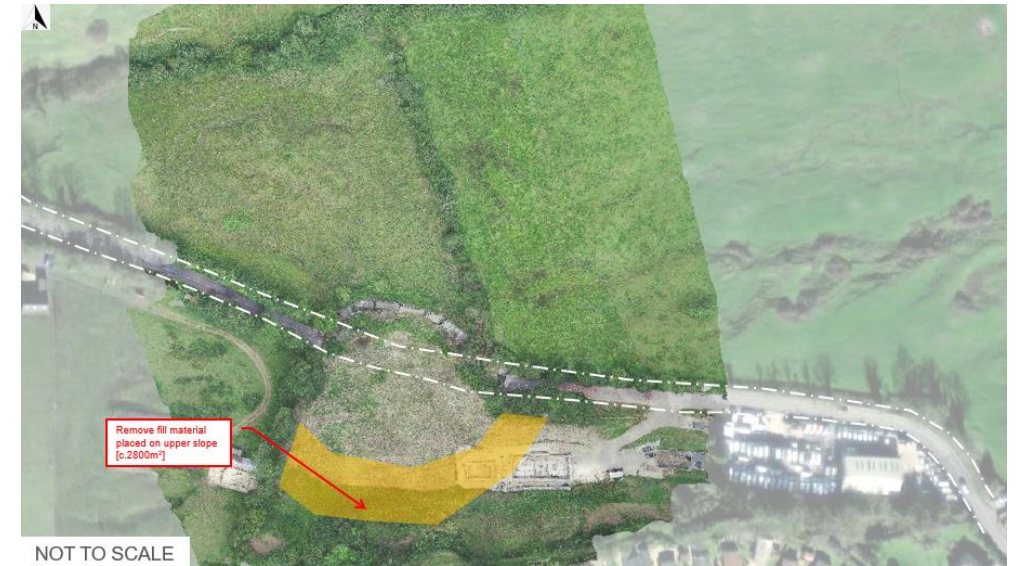
- Core works – earthworks and drainage
- Option 3 – piled retaining wall with counterfort drainage

Final proposals will be subject to detailed design
