**DEPARTMENT OF NEIGHBOURHOOD & PLANNING
TRAFFIC & NETWORK MANAGEMENT**

B3109 Bradford Road, Corsham

**Pedestrian Crossing Assessment
Report**

Project Title: B3109 Bradford Road, Corsham - Pedestrian Crossing

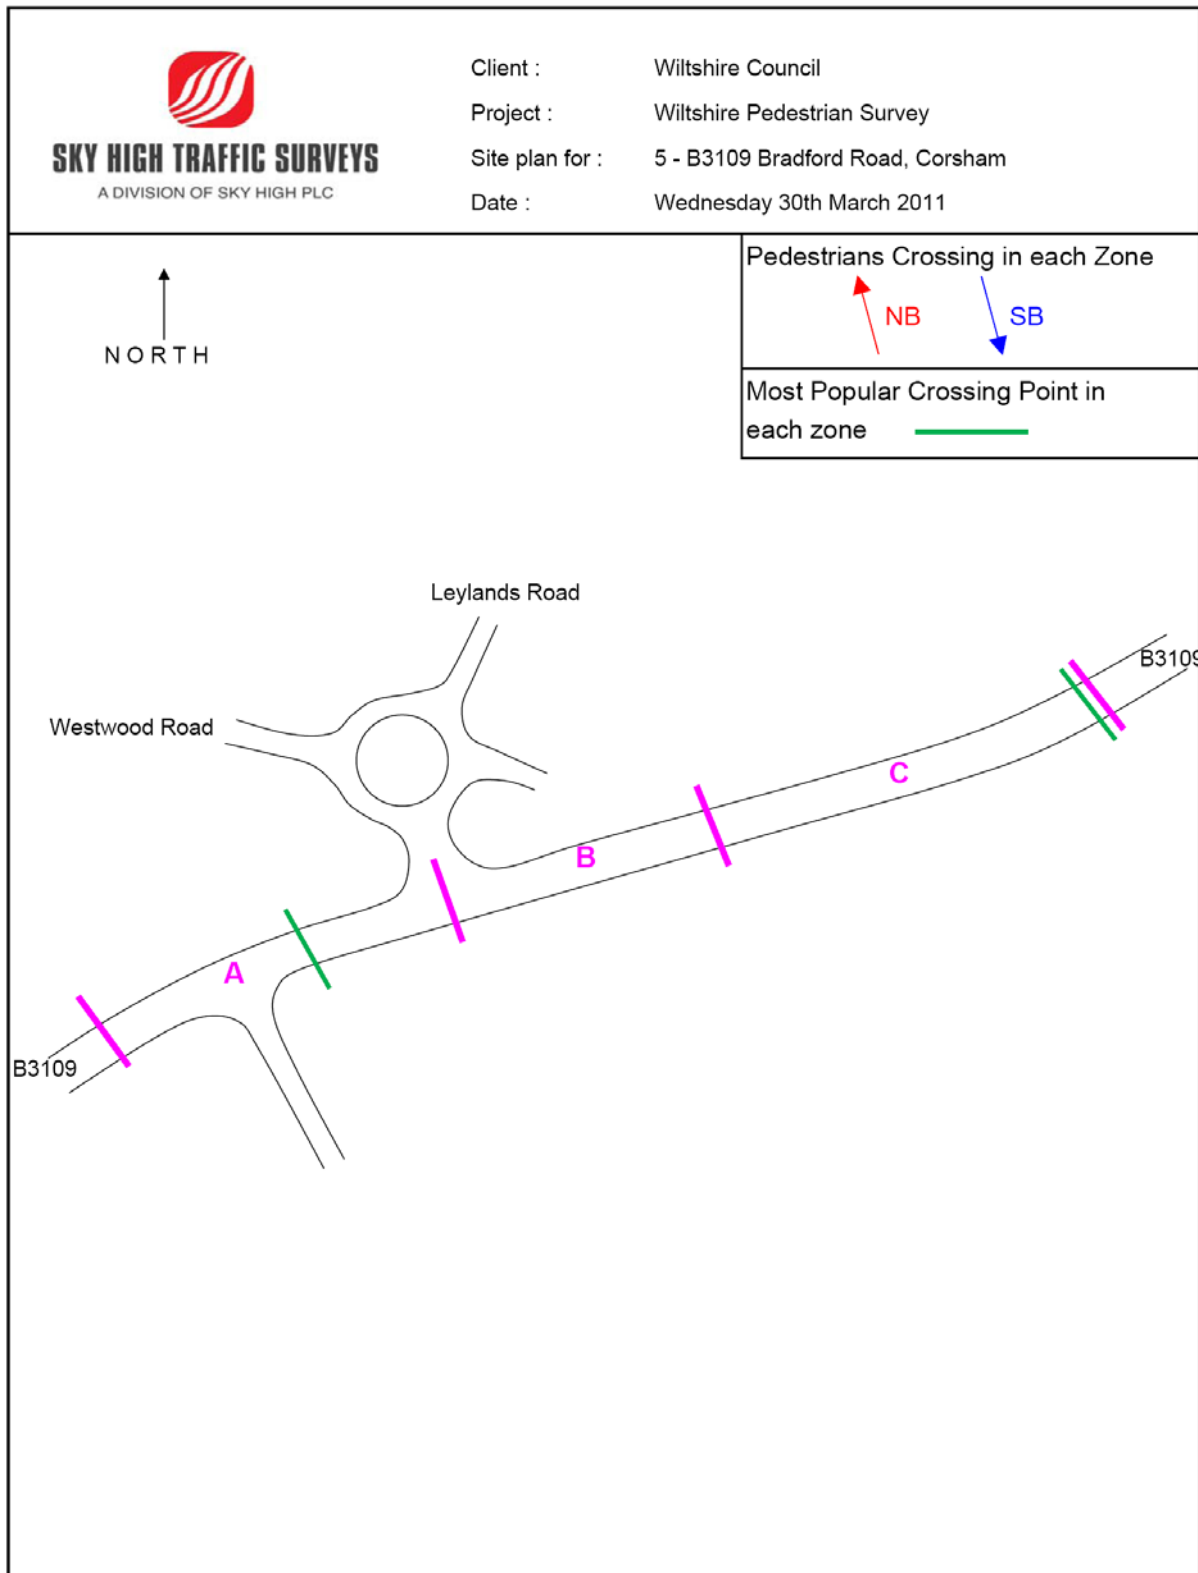
Appendix C – Pedestrian Survey Locations

A pedestrian count survey took place on Wednesday 30th March 2011 to establish the numbers and locations of pedestrians currently crossing the road. The survey was carried out from 7.00 am to 7.00 pm. The length of carriageway from the western side of the junction with Skynet Drive to a point 160m east of the junction with Rudloe. This was subsequently divided into 3 zones and Pedestrian numbers were recorded within each zone with the busiest crossing point also being identified. A plan showing the extents of the zones and the busiest crossing points can be found at Appendix C.

The pedestrian movements which are recorded have been identified as happening between the junctions of Skynet Drive and Bradford Road.
