Consultation responses from T Farthing

# Scour Inspection Report

## Black Bridge (BA37)

PREPARED FOR: Environment Agency  
COPY TO: Leigh-Ann Jones  
PREPARED BY: Simeon Davies  
DATE: 31<sup>st</sup> March 2017  
PROJECT NUMBER: 487026

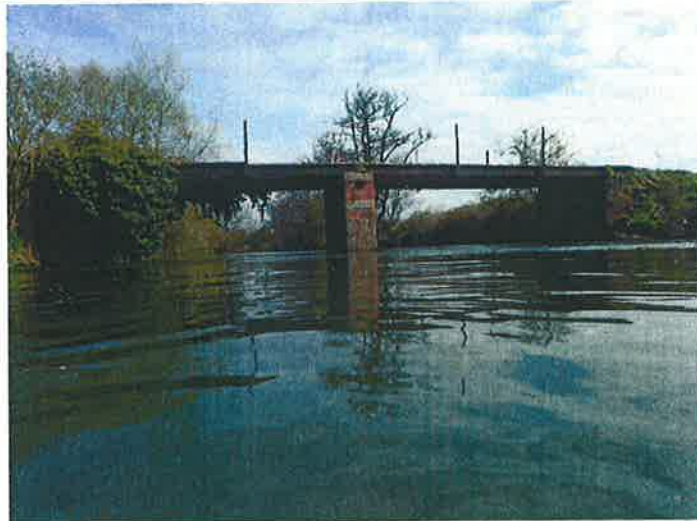
Black Bridge (BA37)  
Grid Ref: ST 90684 65027  
South Elevation (Downstream)

Black Bridge (BA37) carries a field accommodation bridge from east to west over the River Avon.

The structure is a two-span reinforced concrete deck cast on to six steel I beams with permanent concrete formwork panels, supported on a central engineering brick and stone pier and engineering brick and stone abutments.

The bridge measures 4.87m wide with equal 8.1m clear spans. Access to the watercourse was gained via the south west embankment; access to the abutments and central pier by the inspection technician was gained via water entry using surface supplied diving equipment.

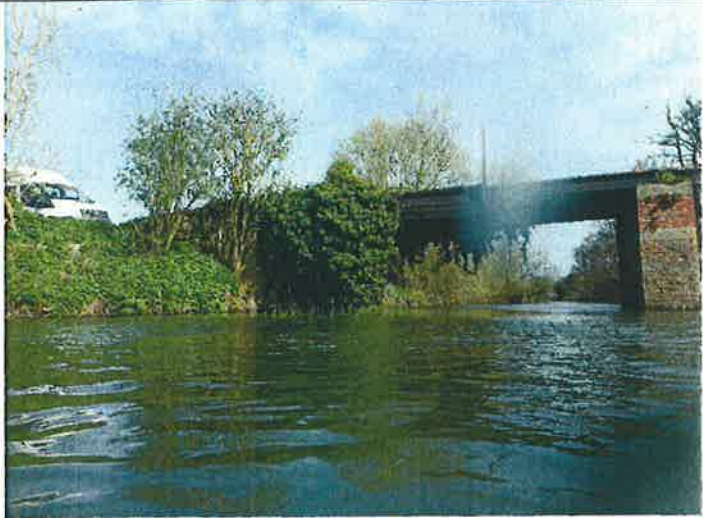
Access requirements	Waders	Drysuit	Diving	Platform/boat
Location	West abutment			
Photograph

Construction details	The abutment is constructed predominantly in engineering brick with intermediate stone courses and is founded on stacked stone masonry blocks. It measures 3.16m high, 4.63m wide and 0.92m thick.			
Foundation details	The foundations appear to be stone masonry blocks bearing directly on to the natural riverbed, measuring up to 630mm high from the silt/stone riverbed.			
Water depth at abutment	0.7m at the abutment face, max depth within the channel was 2.0m.			
Direction of flow in relation to abutment	Parallel to abutments.			
Invert / bed material	Loose bed material, consisting mainly of silt and sporadic large stones.			
Existing scour protection	The engineering brick is founded on stacked stone masonry blocks, which protrude 700mm out from the face of the abutment; measuring 630mm high from bed level over the length of the abutment. There is a stone masonry revetment to the south west embankment, extending downstream, partially obscured by the adjacent earth embankment.

Scour	There is no scour to the abutment or the stone masonry foundations. There is minor open jointing to the abutment face due to vegetation growth.

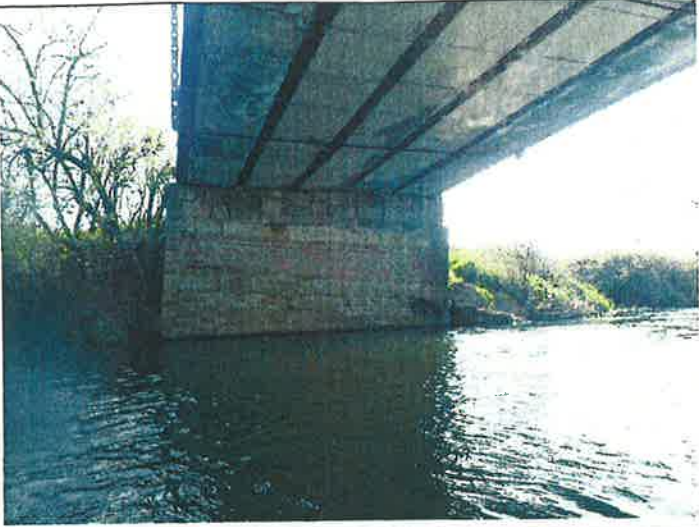
Access requirements	Waders	Drysuit	Diving	Platform/boat
Location	East abutment			
Photograph

Construction details	The abutment is constructed predominantly in engineering brick with intermediate stone courses and is founded on stacked stone masonry blocks. Upper courses of concrete block have been added. It measures 3.75m high, 4.63m wide and 0.92m thick.			
Foundation details	The foundations appear to be stone masonry blocks bearing directly on to the natural riverbed, measuring up to 630mm high from the silt/stone riverbed.			
Water depth at abutment	1.45m at the downstream elevation, 1.3m at the upstream elevation; max depth within the channel was 2.0m.			
Direction of flow in relation to abutment	Parallel to abutments.			
Invert / bed material	Loose bed material, consisting mainly of silt and large stone.			
Existing scour protection	The engineering brick is founded on stacked stone masonry blocks, which protrude 700mm out from the face of the abutment; measuring 630mm high over the length of the abutment. There is rock armour to the south east embankment, extending downstream. A concrete revetment extends upstream of the structure, predominantly obscured by the adjacent earth embankment.

Scour	<p>There is settlement to the entire abutment. There is a concrete block repair/reconstruction to the top of the abutment measuring 720mm high on the downstream elevation reducing to 485mm high on the upstream due to the angle of the abutment. The south side of the abutment is 265mm lower than the north side (clearly visible in the photograph).</p> <p>There is scour to the south side of the abutment, measuring 1.7m long, 0.8m high and 1m deep. The stone masonry block foundations are missing over this length, with erosion to the riverbed and beneath the abutment.</p>

There is scour to the base of the concrete revetment to the north east of the abutment, measuring 0.5m high, 0.5m wide and 0.7m deep.
--	---

- 1) There is settlement and scour to the east abutment, which has caused rotation of the structure. The downstream 1.7m is completely unsupported due to the scour to the stone masonry foundations. In the short term, the abutment requires stabilizing by underpinning to prevent further deterioration of the structure. A long-term solution would also be required.
- 2) A weight limit should be attached to the structure following the load assessment calculations from the investigation works.
- 3) The voids to the cutwater should be filled, to prevent further deterioration of the pier, which could destabilise the bridge.

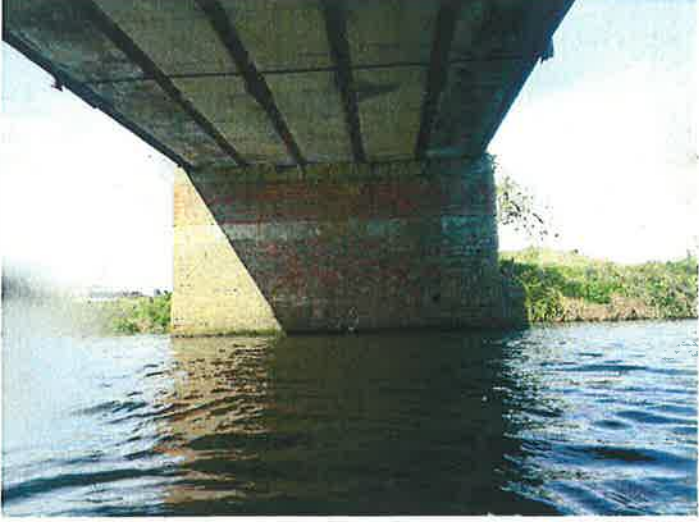
Access requirements	Waders	Drysuit	Diving	Platform/boat
Location	Central Pier			
Photograph

Construction details	The pier is constructed in engineering brick with a stone masonry intermediate course and cut water. The pier measures 5.15m wide, 920mm thick and 3.1m high.			
Foundation details	The foundations appear to be stone masonry blocks bearing directly on to the natural riverbed, measuring up to 700mm high from the silt/stone riverbed.			
Water depth at pier	0.7m at the cutwater, max depth within the channel was 2.0m.			
Direction of flow in relation to pier	Parallel to pier.			
Invert / bed material	Loose bed material, consisting mainly of silt and large stones.			
Existing scour protection	The engineering brick is founded on stacked stone masonry blocks, which protrudes 800mm out from the face of the abutment; measuring 700mm high around the perimeter of the pier.			
Scour	<p>There is scour to the base of the cutwater, measuring 1.1m high, 0.92m wide and 1.2m deep.</p> <p>There is scour to the east side of the pier, measuring 1m long, 0.2m high and 0.5m deep.</p> <p>There is an area of missing brickwork to the north end of the west face of the pier, measuring 330mm long, 280mm high and 220mm deep.</p> <p>Around the pier, there is open jointing to the stone masonry foundations, measuring up to 200mm deep.</p> <p>There is scour to the downstream face of the pier, measuring 920mm wide, 500mm high and 300mm deep.</p>

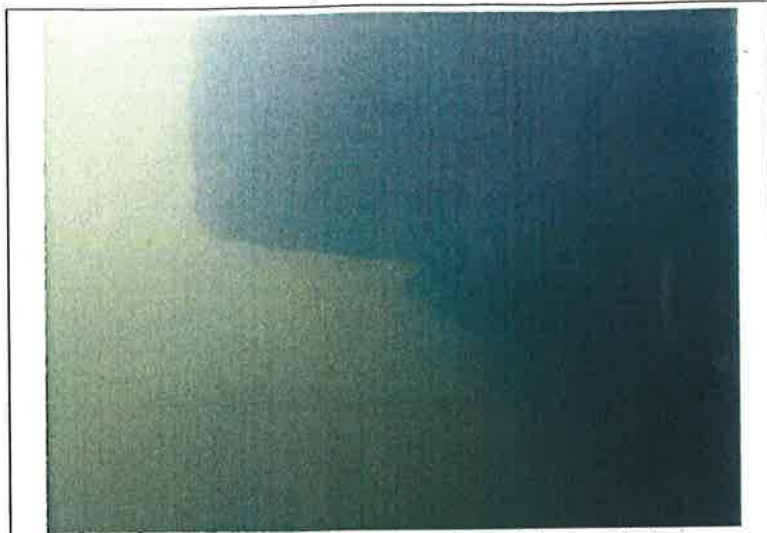
Photograph No. 1: Scour to the cutwater of the central pier

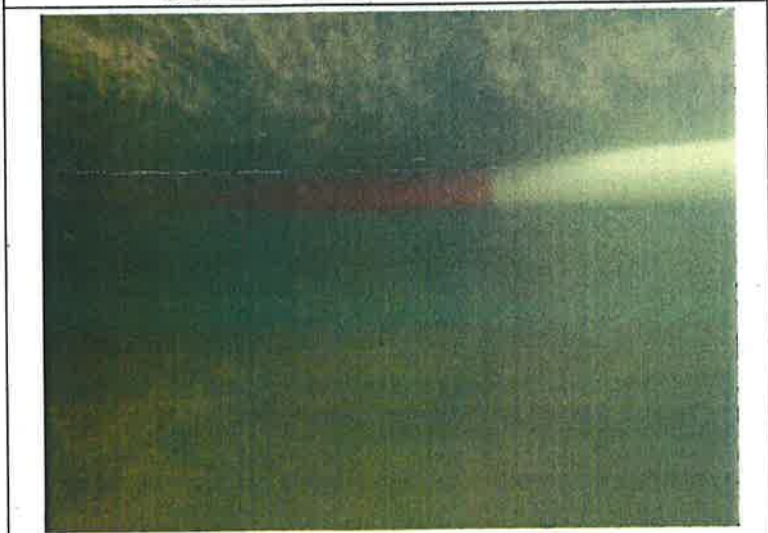
Photograph No. 2: Scour to the east abutment

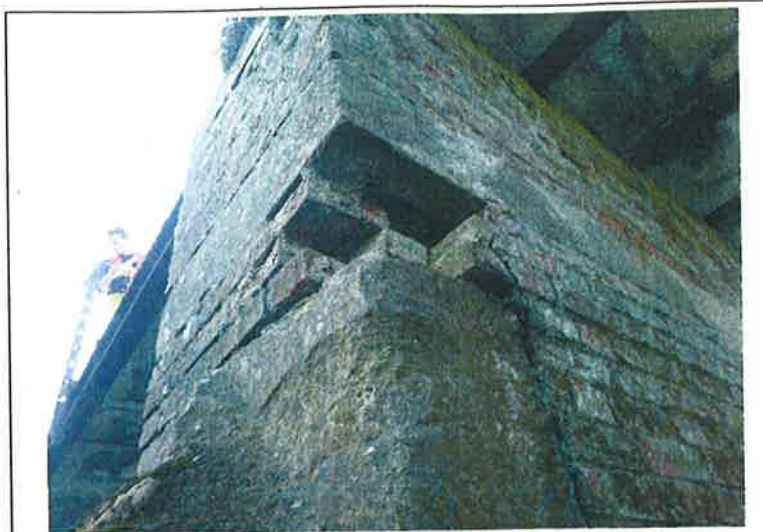
**Photograph No. 3: Missing brickwork to the central pier**

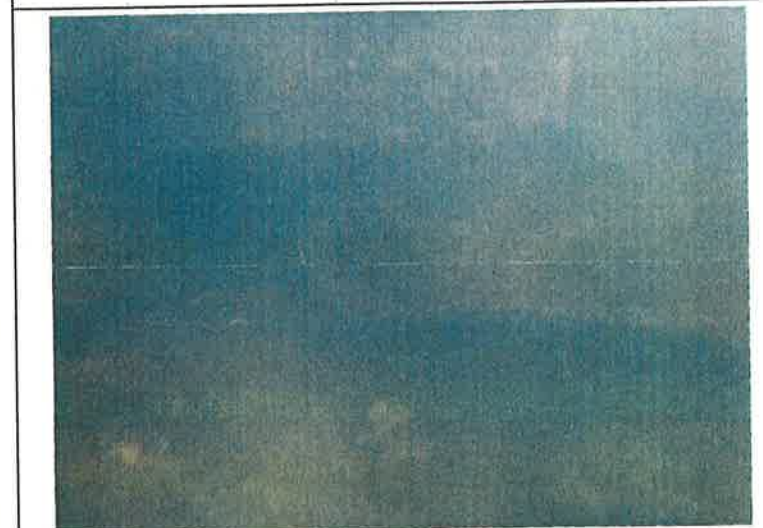
**Photograph No. 4: Typical open jointing to the stone masonry block foundations**
