A3102 Hilmarton

Pedestrian Crossing Assessment

Project Title: A3102 Hilmarton Pedestrian Crossing

Report Title: A3102 Hilmarton Pedestrian crossing assessment

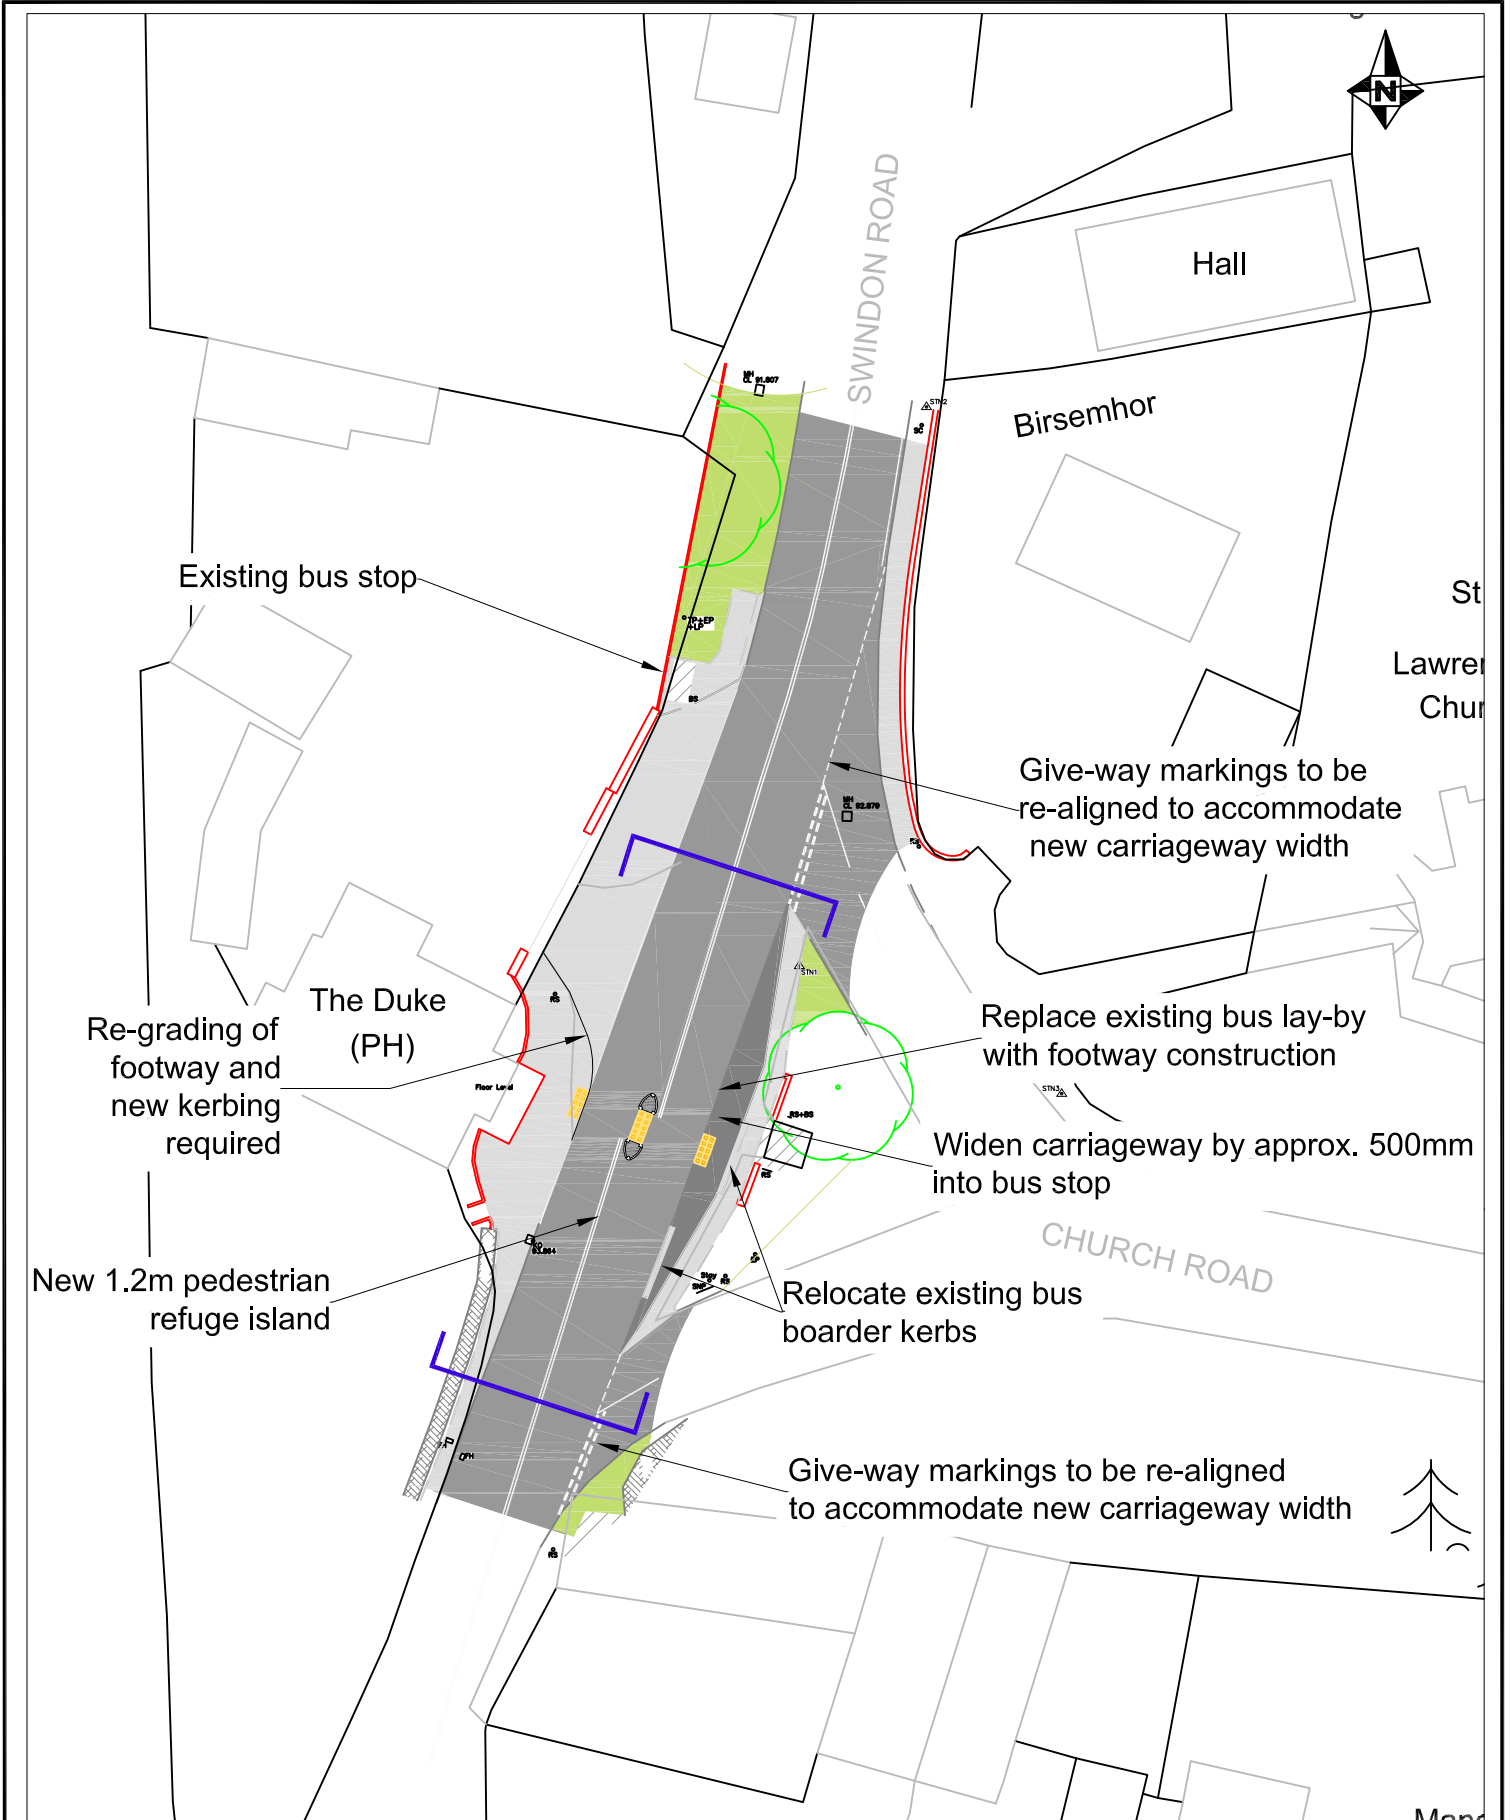
DRAWING TITLE: Pedestrian Refuge Island

NOTES:
 Location and dimensions of pedestrian refuge island are subject to change dependant upon further design investigations

Extents of carriageway resurfacing

Taking into consideration the data collected, the site assessment, the crossing options available and the adopted Wiltshire Council practise for pedestrian crossings it is recommended that a pedestrian refuge sited outside of The Duke public house would provide the most appropriate measure to assist pedestrian movement.

It must be noted that there are additional physical constraints associated with the construction of a pedestrian refuge at this location. The carriageway is 7.7m wide at this point, which does not allow sufficient space for a standard 1.8m wide pedestrian refuge and the required 3.5m wide vehicle running lanes. However, it is possible to utilise the existing bus lay-by to provide additional carriageway space thus allowing the construction of a 1.2m wide pedestrian refuge. This is the minimum width allowable for such a facility.

There is currently a level difference between the bus lay-by and the adjacent carriageway running lane; therefore it will be necessary to undertake carriageway resurfacing within the area shown on the plan in Appendix D.

A plan outlining the recommendation and extent of the additional waiting restrictions is included in Appendix D.
