**WILDLIFE AND COUNTRYSIDE ACT 1981 – SECTION 53 PROPOSAL TO
ADD A BYWAY OPEN TO ALL TRAFFIC AT THE OLD FORD CROSSING
ADJACENT TO PINKNEY BRIDGE, PINKNEY, SHERSTON**

ECOLOGICAL APPRAISAL

**Jenny Ford
Countryside Officer (Ecology)**

August 2004

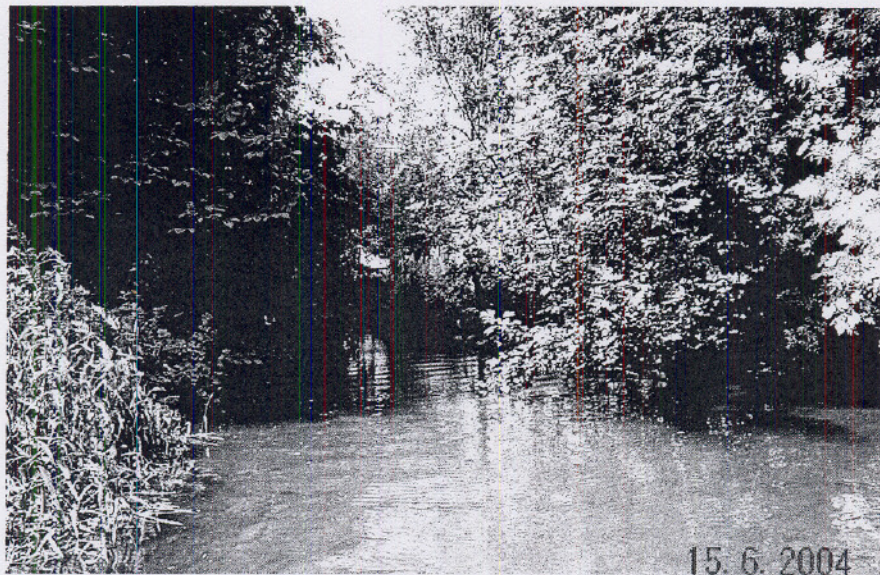
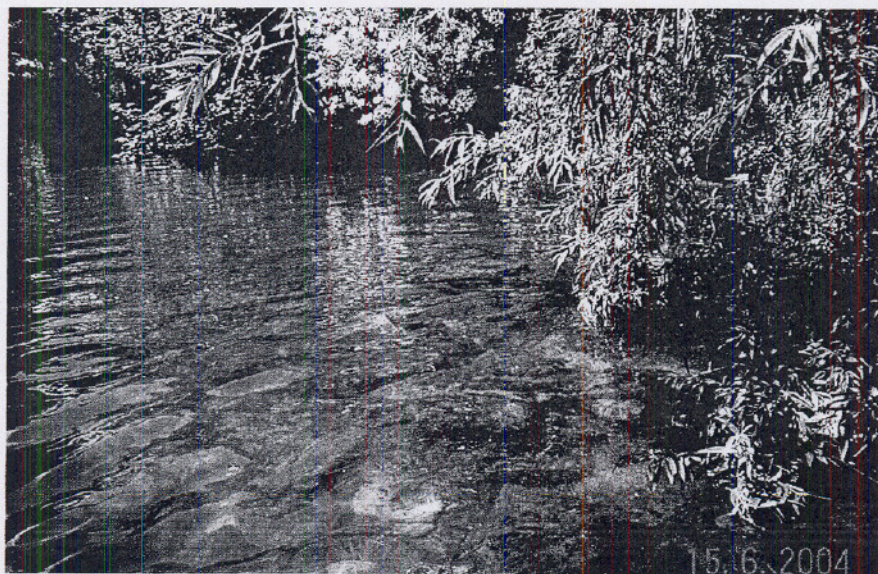
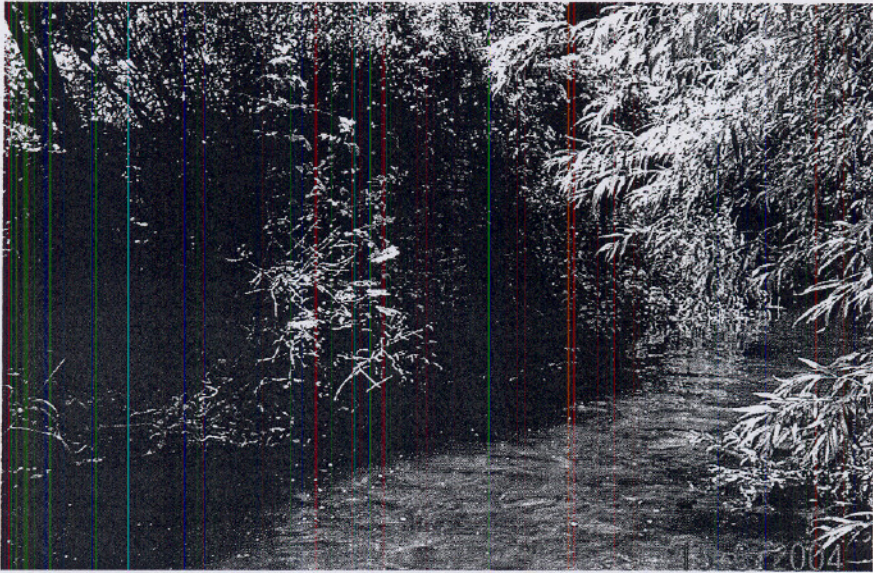
The detailed survey forms are attached as Appendix 1. Photographs of the site are provided in Plates 1 to 3. The river formed a glide at this location and the channel was approximately 10 to 12m wide. Overhanging trees provided 60 to 90% shading of the channel. Both sides of the channel were lined with retaining walls. In the east of the site, the retaining walls were replaced by a bank with a slight overhang on the northern side and dense stands of riparian vegetation on the southern side. Riparian vegetation within the east of the site comprised predominantly reed canary-grass (*Phalaris arundinacea*), great willowherb (*Epilobium hirsutum*) and bur-reed (*Sparganium erectum*). In addition, small amounts of filamentous algae were present in the channel. Adjacent land uses comprised a garden and mature woodland on the southern bank and a garden and horse paddock on the northern bank.

There were a large number of refuges present in the channel in the form of boulders and cobbles. The substrate beneath the refuges comprised bedrock, cobbles and gravels. The water depth was approximately 50 cm when surveyed in June and the water was clear with good visibility to the bed; however, when the site was visited in May, the water depth was 70 cm to 1 metre and clarity of the water was poor with a high degree of suspended solids.

The habitat appeared to be of excellent quality for crayfish: there were numerous refuges available for crayfish in the form of boulders on the river bed and crevices in the retaining walls. Two quadrats were searched for crayfish within Site 1 (one from the centre of the channel and one from the margin) and the results are presented in Table 2 below.

The results above indicate the presence of a healthy white-clawed crayfish population at Site 1. The abundance of crayfish per quadrat was greater than 5: using the suggested grading for qualitative assessment of relative abundance from Peay (2003), the abundance of crayfish at Site 1 is assessed as "very high". 80% of the females were carrying young and therefore the population is breeding. The successful breeding status of the population is also confirmed by the range of carapace sizes recorded, including three juveniles with a carapace length of less than 25 mm.

Plate 1: Site 1.

Plate 2. Site 1

Plate 3. Site 1

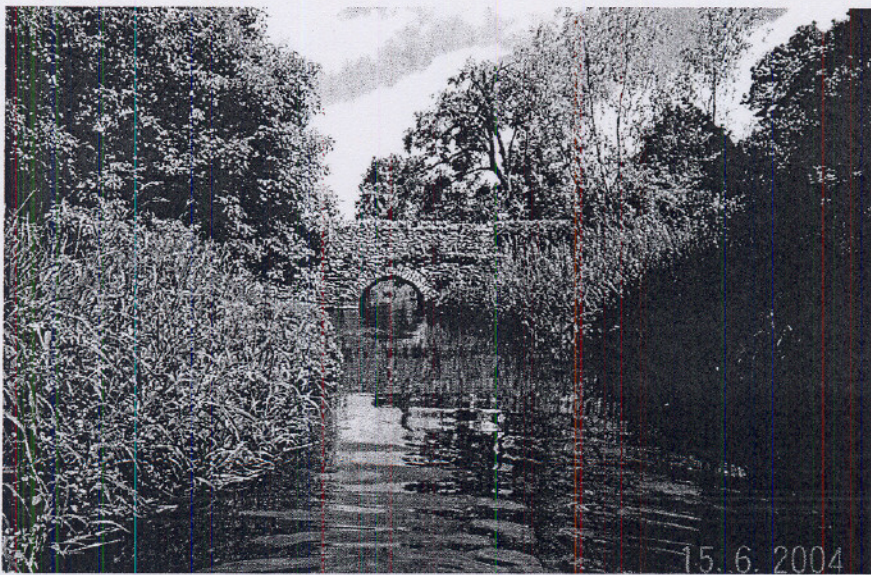
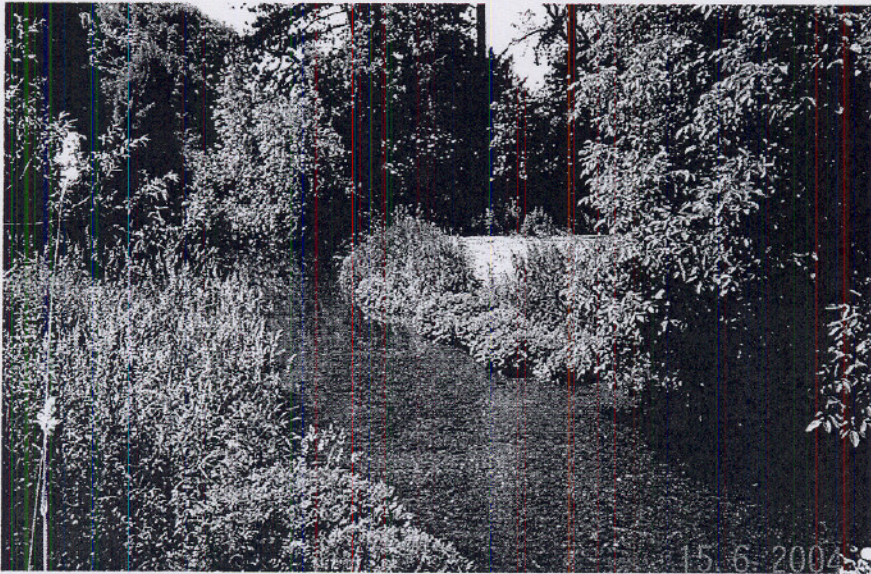
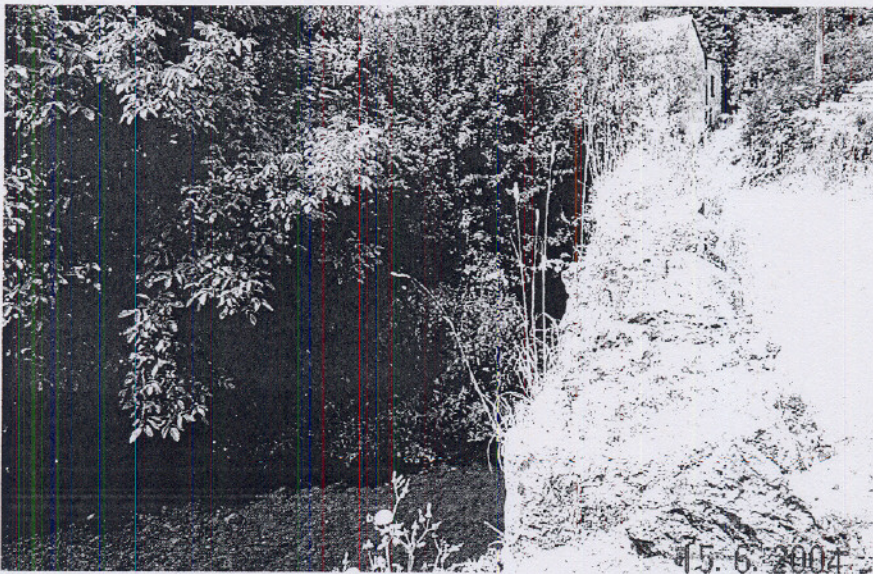
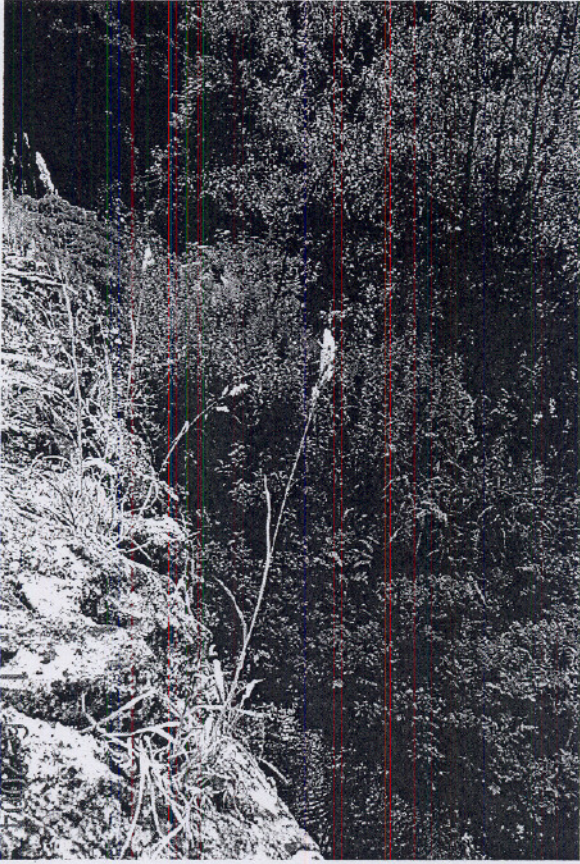
The detailed survey forms are attached as Appendix 1. Photographs of the site are provided in Plates 4 to 7. The river formed a run just upstream of the bridge at this location and the channel was approximately 10m wide. On the route of the proposed BOAT, the banks shelved gently and dense stands of emergent vegetation were located on both banks (no emergent vegetation was located within the channel). Emergent and riparian vegetation comprised reed canary-grass, water-cress (*Rorippa nasturtium-aquaticum*), yellow flag (*Iris pseudacorus*), nettle (*Urtica dioica*), great willow-herb, water mint (*Mentha aquatica*) and comfrey (*Symphytum officinale*).

Within the western part of the site (west of the proposed BOAT), dense stands of riparian and emergent vegetation were present on the southern bank and the northern bank had a slight overhang with a narrow strip of riparian vegetation. A small area of trees and scrub was located on the north bank immediately to the west of the crossing and provided approximately 10% shading of the site. In addition, small amounts of filamentous algae and submerged reed canary-grass were present in the channel. Adjacent land uses comprised a garden to the north and a lawn to the south.

The substrate present in the channel predominantly comprised gravel, pebbles and small cobbles with a few large cobbles. However, the substrate was predominantly silt adjacent to the stands of emergent vegetation. The depth of the water was approximately 10 cm when surveyed in June and the water was clear with moderate visibility to the bed.

Two quadrats were surveyed within Site Two on 16/6/04 but no crayfish were recorded. Site Two was considered to provide poor habitat for crayfish due to the lack of available refuges within the channel. In addition, the bank provided poor habitat for crayfish on the route of the proposed BOAT as there were no banks suitable for burrowing or with overhangs and no suitable refuges provided by tree roots. Some potential crayfish habitat was provided on the crossing by the stands of marginal vegetation; however, no crayfish were found when sweeping the vegetation with a pond net.

To the west of the proposed crossing, the bank with a slight overhang provided some potential for crayfish; however, no crayfish were found when sweeping beneath the overhang with a pond net.

Plate 4. Site 2

Plate 5. Site 2

Plate 6. Site 2.

Plate 7. Site 2

1. Total ban of vehicular use of the crossing.
2. Ban of pedestrian and equestrian use of the crossing during the brown trout spawning season. Brown trout commence spawning in October and the eggs lie in the gravels until March/ April (depending on the weather) when the alevins emerge. Consequently, the ban for pedestrians and equestrians should cover the period October to April.

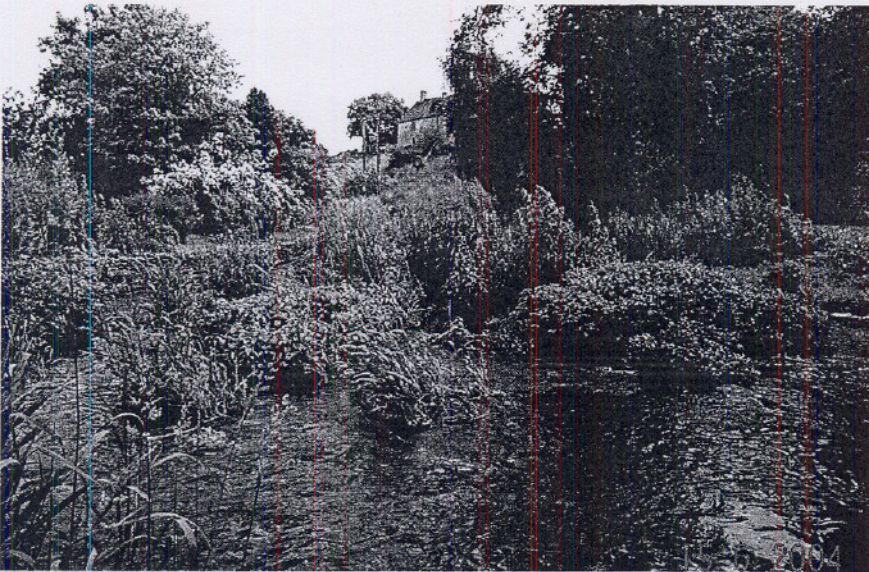
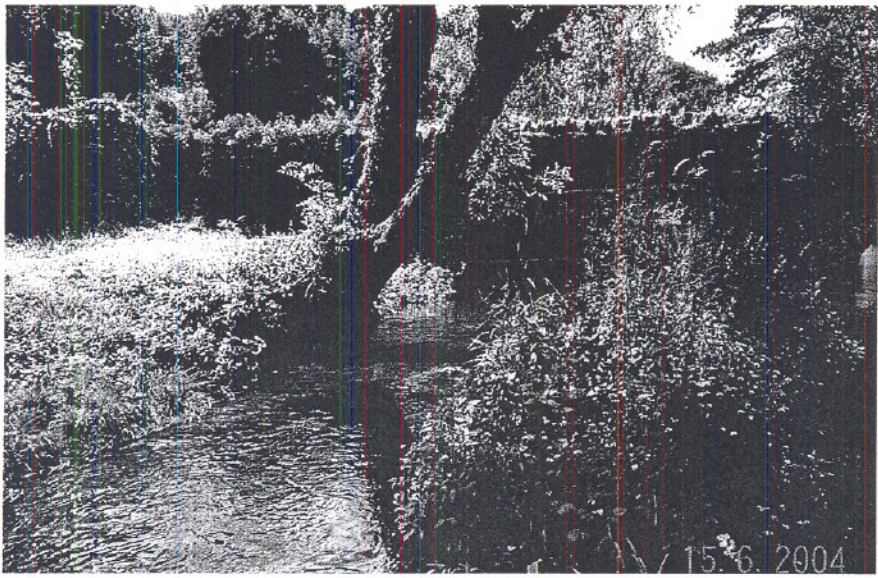
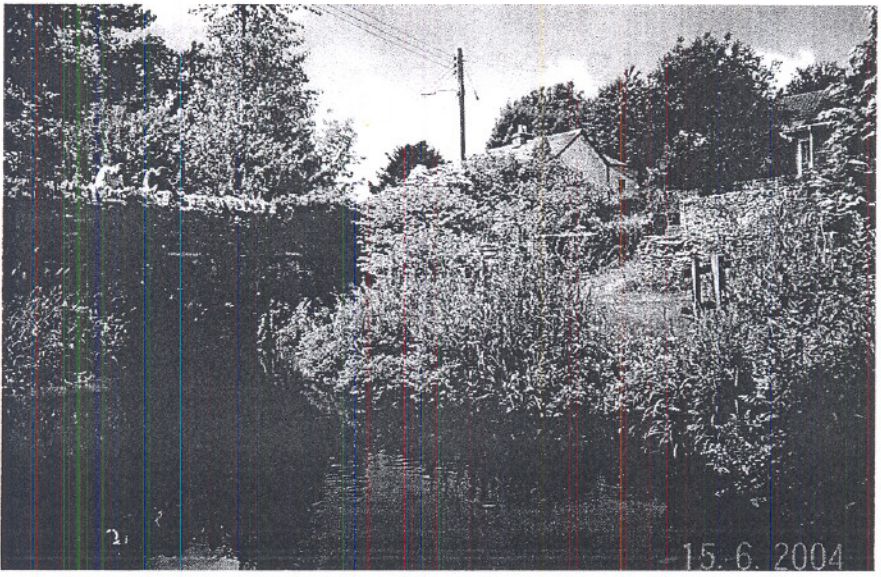
The detailed survey forms are attached as Appendix 1. Photographs of the site are provided in Plates 8 to 10. The river formed a glide, entering a short run and then an extensive riffle just downstream of the bridge at this location and the channel was approximately 15m wide. The banks were generally gently shelving although some sections of bank were undercut. Immediately downstream of the surveyed section, a limestone retaining wall formed the northern bank. A short stretch of retaining wall was also located on the northern bank immediately adjacent to the bridge.

Both banks supported narrow strips of emergent and riparian vegetation characterised by reed canary-grass, nettle, great willowherb and water-cress. A small stand of Japanese knotweed (*Fallopia japonica*) was located on the northern bank adjacent to the bridge. A semi-mature ash tree was located on the southern bank and resulted in 20% shading of the site. A small island was located in the centre of the site with dense water-cress and reed canary-grass. More extensive stands of emergent vegetation (water-cress and reed canary-grass) were located downstream in the riffle. Site Three also supported small amounts of filamentous algae.

The adjacent land use on both banks was gardens: the lawns extended to the narrow strip of riparian vegetation. The substrate comprised cobbles, pebbles, gravels and sand with some larger cobbles and boulders, particularly closer to the bridge. The water depth varied from 10 cm to 60cm on 5/5/04 and the water was clear with good visibility to the bed.

The habitat appeared to be of reasonable quality for crayfish: there were refuges available for crayfish in the form of a few boulders on the river bed, crevices in the retaining walls, roots of the ash tree and water-cress beds. The limiting factor for crayfish at this location could be the lack of many large boulders and the velocity of the water in the riffle: crayfish prefer slower-flowing habitats such as pools and glides where available (Peay, 2003). Five quadrats were searched for crayfish within Site 3 (one from marginal dead water adjacent to the northern bank, three from the centre of the channel and one from the margin adjacent to the ash tree on the southern bank) and the results are presented in Table 3 below.

The results above indicate the presence of a fairly healthy white-clawed crayfish population at Site 3. The average abundance of crayfish per quadrat was 2: using the suggested grading for qualitative assessment of relative abundance from Peay (2003), the abundance of crayfish at Site 3 is assessed as "high". Evidence of breeding was also recorded in the form of a berried female carrying eggs. However, an unusually high number of juveniles were recorded (approximately 70%) and there was a relatively low number of adults with a carapace length of 30mm+. This could mean that the habitat in Site 3 is in the process of being colonised by crayfish from further upstream. Alternatively, the habitat in Site 3 could be sub-optimal for adult crayfish (because of the low availability of refuges such as boulders) but provides good quality habitat for juvenile crayfish (because of the refuges provided by water-cress beds and filamentous algae). Further monitoring in subsequent years is required at this site related to the size distribution of the population before firm conclusions can be drawn.

Plate 8. Site 3

Plate 9. Site 3.

Plate 10, Site 3.
