The Wiltshire Council Parish of Holt (Holt Path No. 71) Rights of Way Modification Order 2013

Holt Manor, Wiltshire

Statement of Expert Witness Opinion from Aerial Photographs

Regarding the use of an alleged path, HOLT 71, between 1991 and 2011

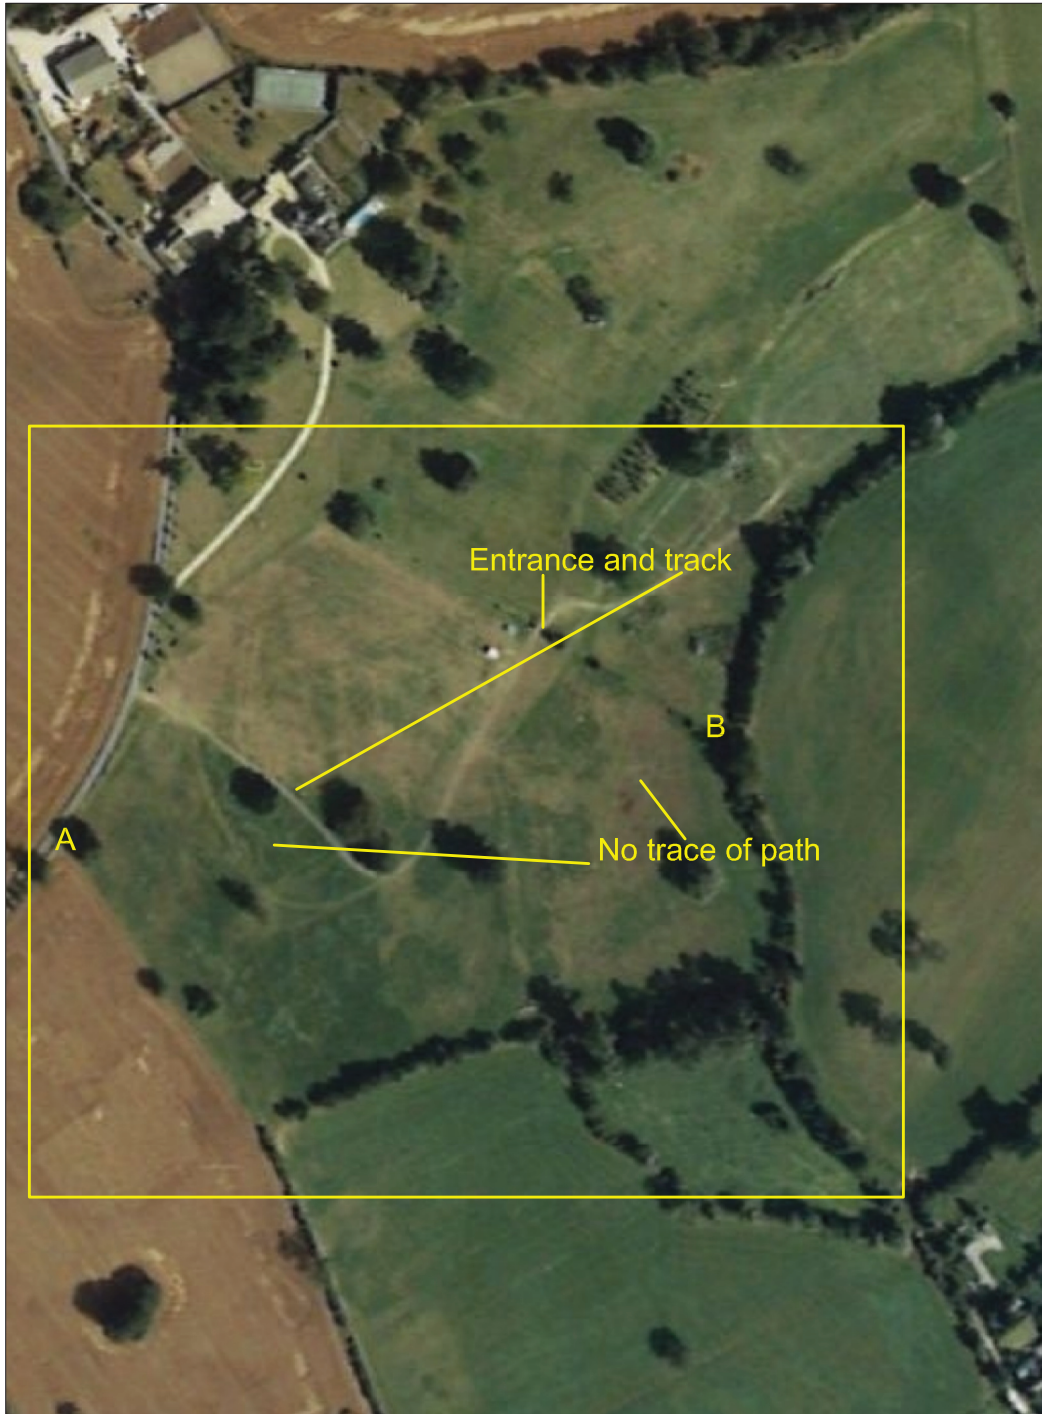
FIGURE 2 1991

- 5.1.1 In 1991 The Site is laid to cultivated grass.
- 5.1.2 There is a wide light toned access track into the site, which is highly visible, to the west of the alleged route of HOLT 71. This does not connect A and B and is marked on Figure 2.
- 5.1.3 The area between A and B shows very little sign of any regular or worn access track between the two points.
- 5.1.4 I conclude that a used path or track was not present in 1991 between A and B.

Drawing Title FIGURE 2
HOLT 71 on 19th August 1991

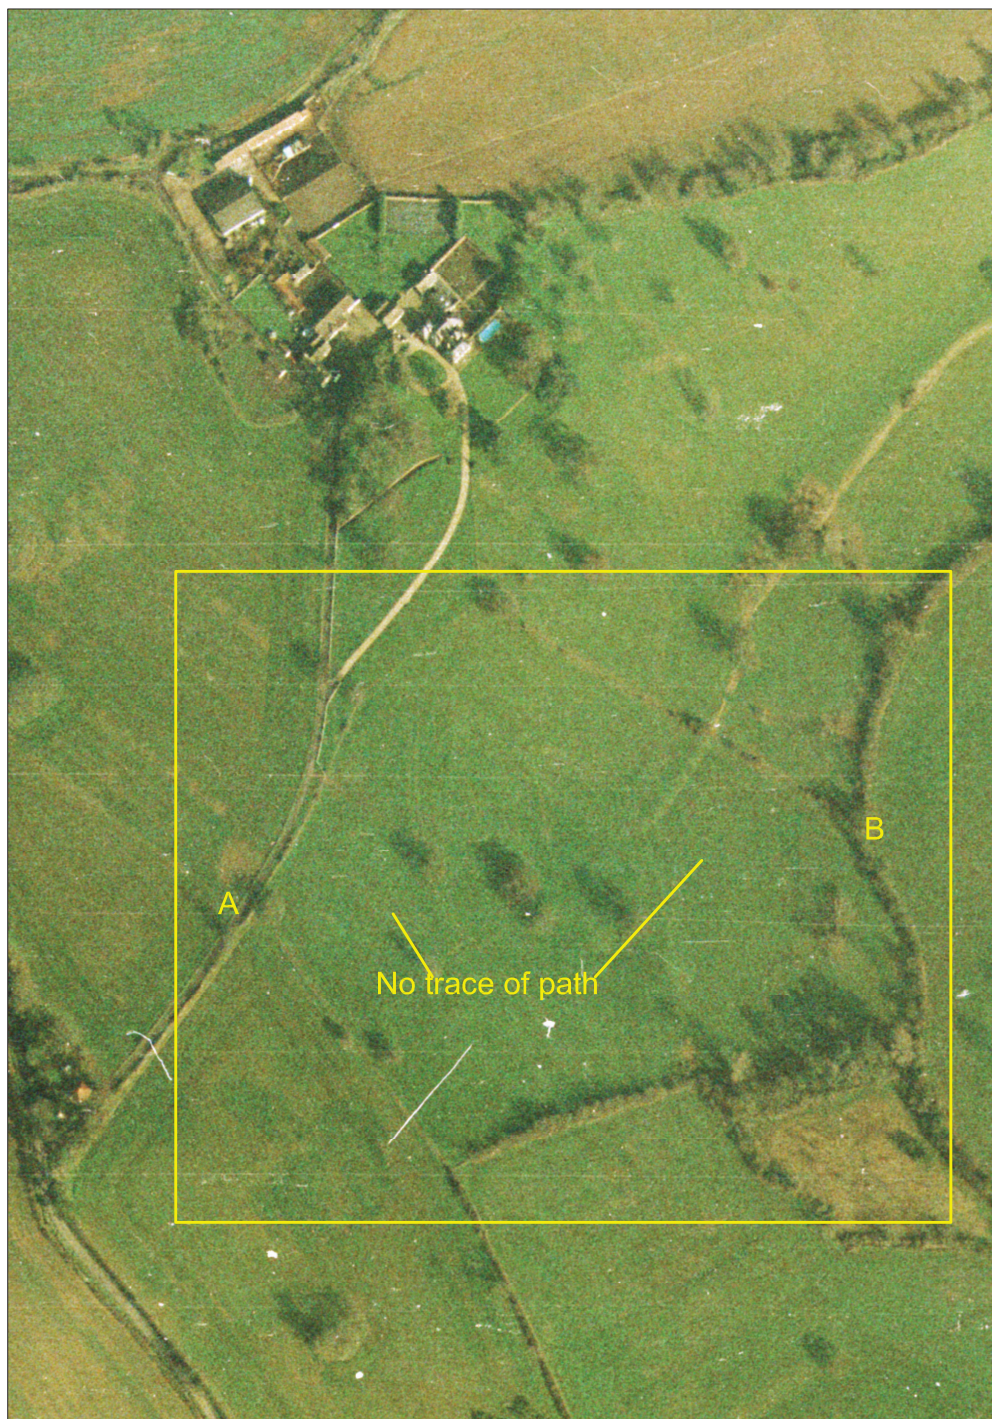
FIGURE 3 1995

Drawing Title | FIGURE 3
HOLT 71 on 9th March 1995
No trace of any path is visible between A and B
White marks and lines are dirt or scratches on the photo negative.

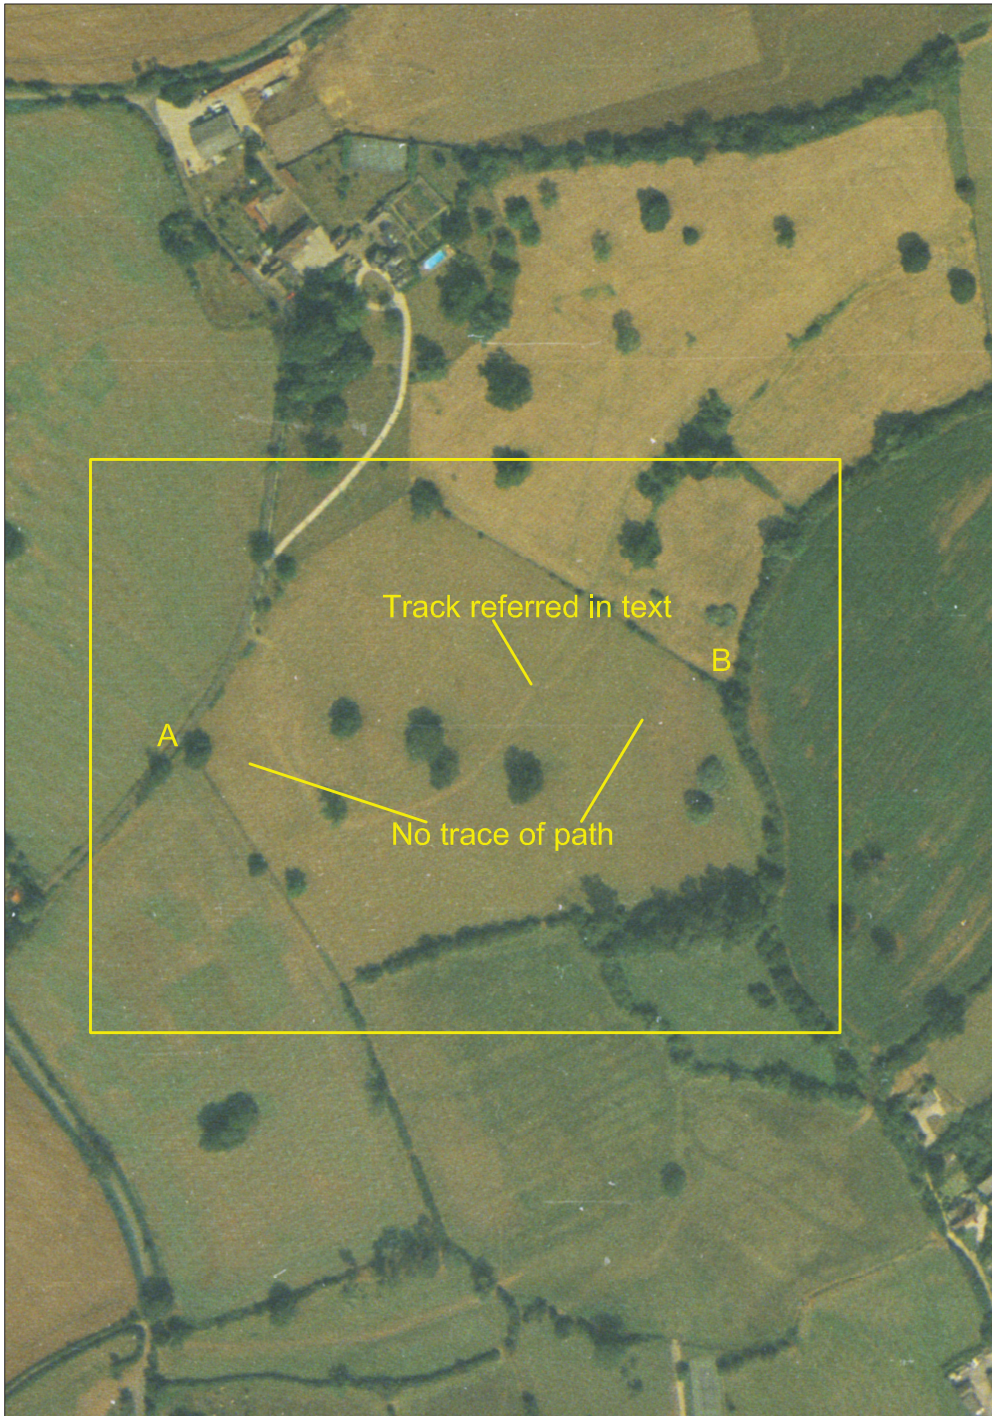
FIGURE 4 1996

Drawing Title | FIGURE 4
HOLT 71 on 4th August 1996
No trace of any path is visible between A and B

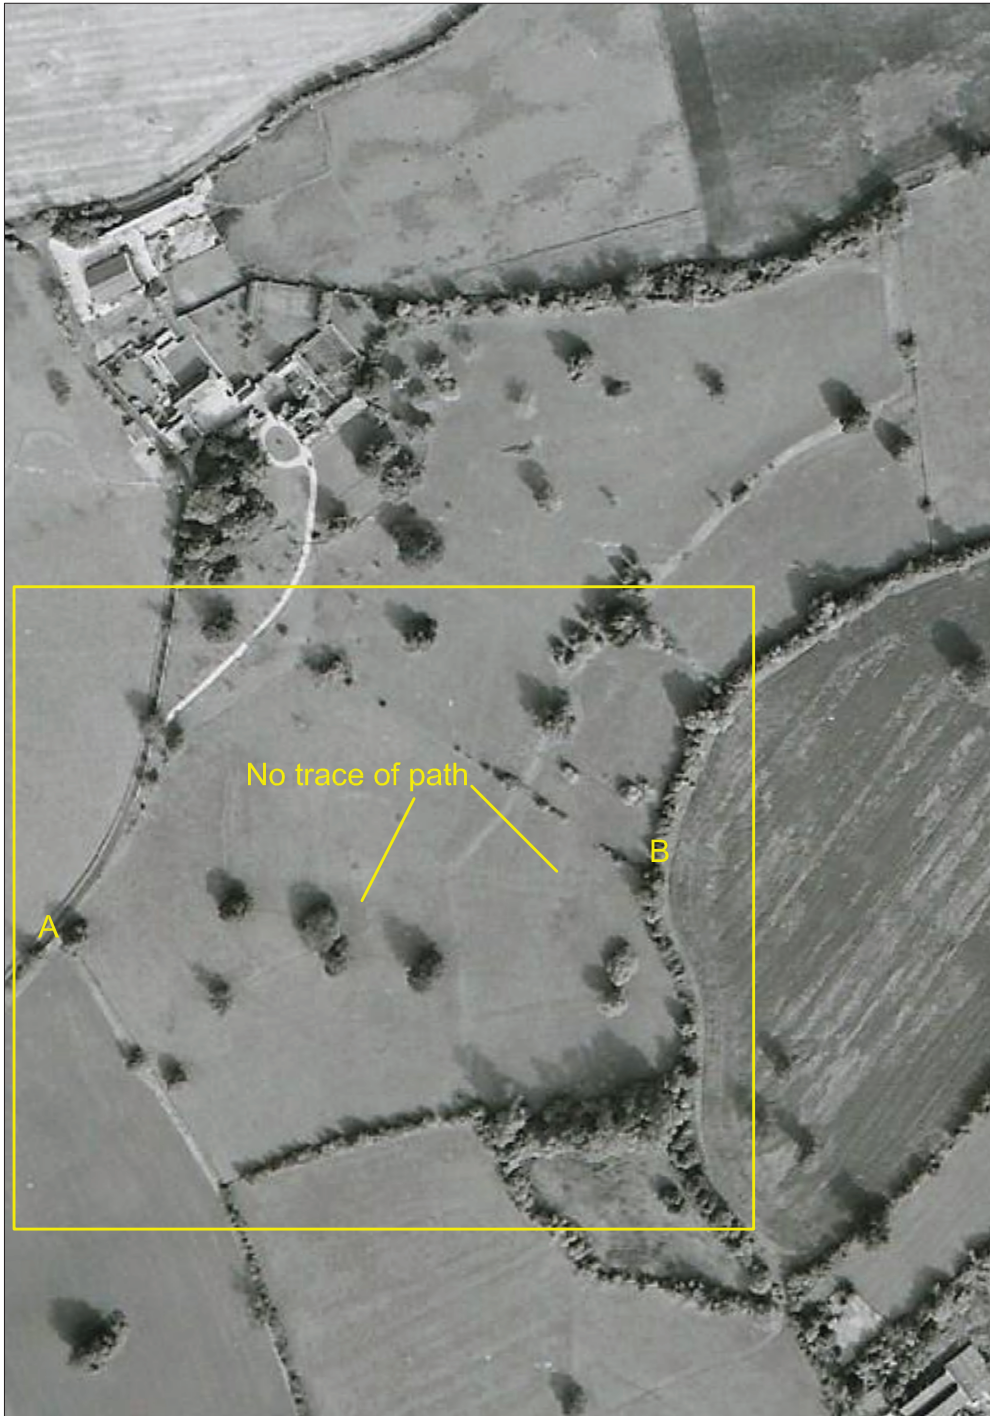
FIGURE 5 1998

- 5.4.4 In 1998, the site is laid to grass. The quality of these photographs is very high indeed.
- 5.4.5 There are several very slightly upstanding features in the field which show the position of former boundaries and agricultural processes, which most likely date back to the Medieval or Post Medieval periods and continue into modern times.
- 5.4.6 There is no trace at all of any continuous indented or worn feature between A and B. this would most definitely have been visible on these photographs if it were present, which it is not.
- 5.4.7 I conclude that a path or track was not likely to be present in 1998 between A and B.

Drawing Title FIGURE 5
HOLT 71 on 17th September 1998
No trace of any path is visible between A and B

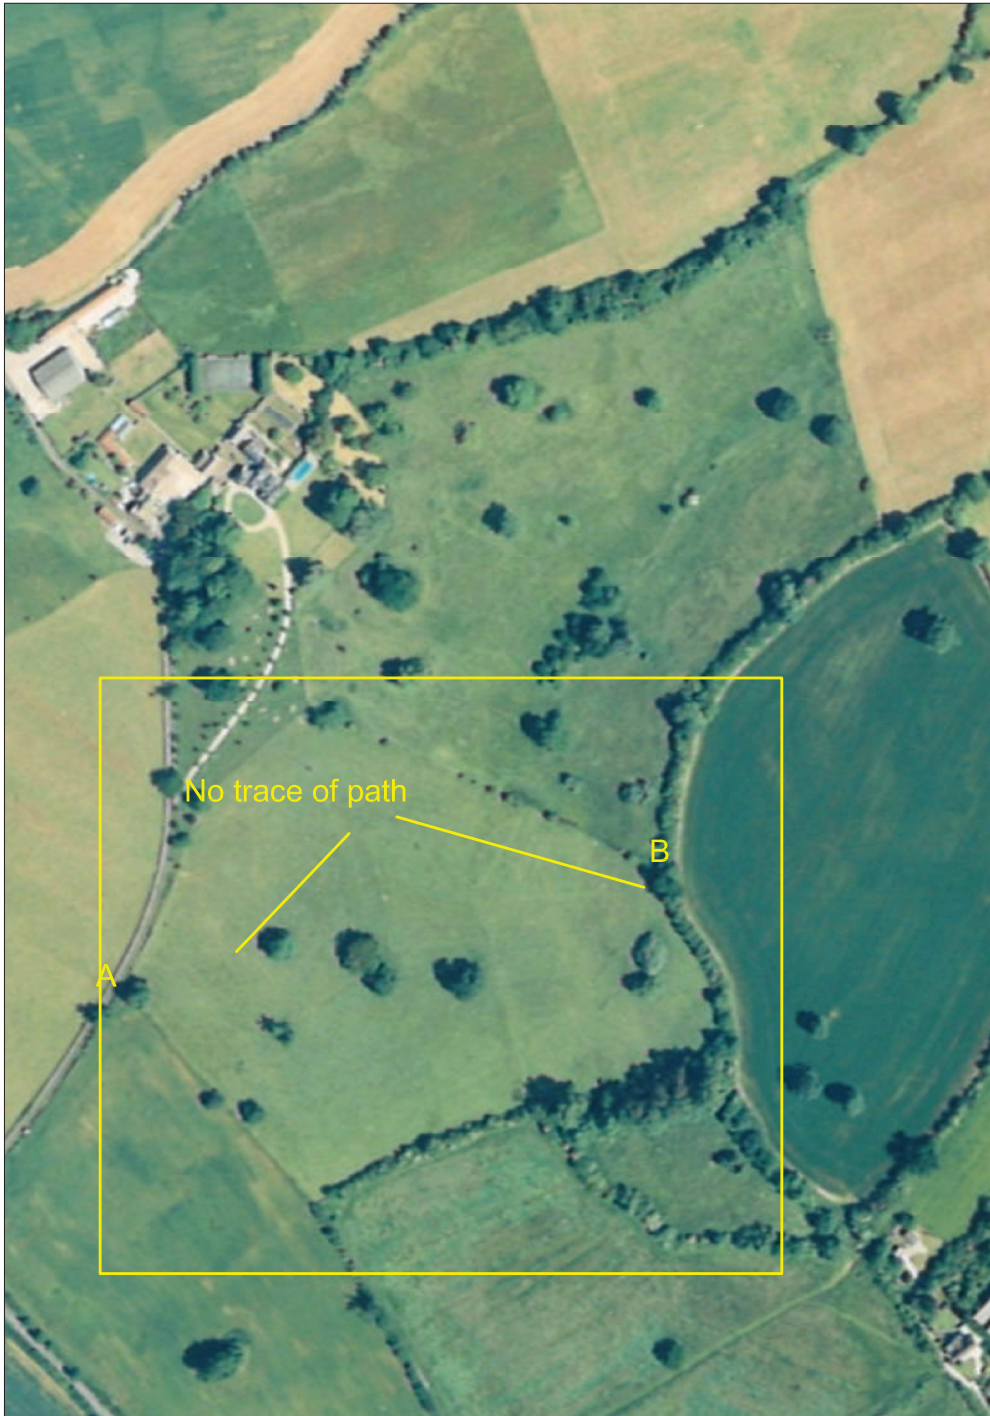
FIGURE 7 2001

Drawing Title | FIGURE 7
HOLT 71 on 20th June 2001
No trace of path between A and B

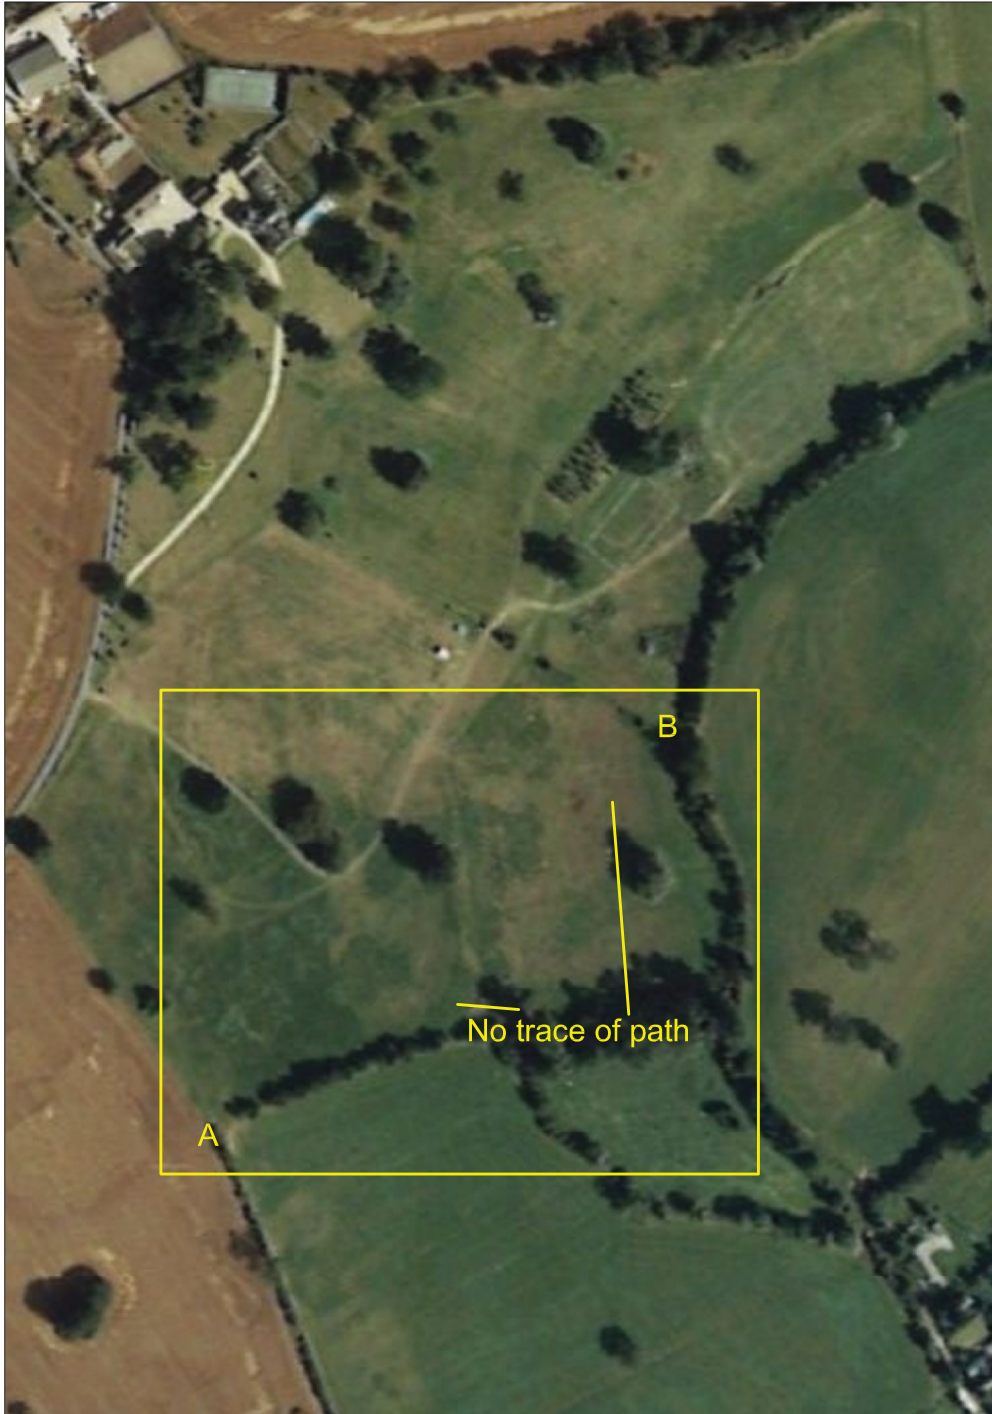
FIGURE 2 1991

Drawing Title | FIGURE 2
HOLT 72 on 19th August 1991
No trace of any path is visible between A and B

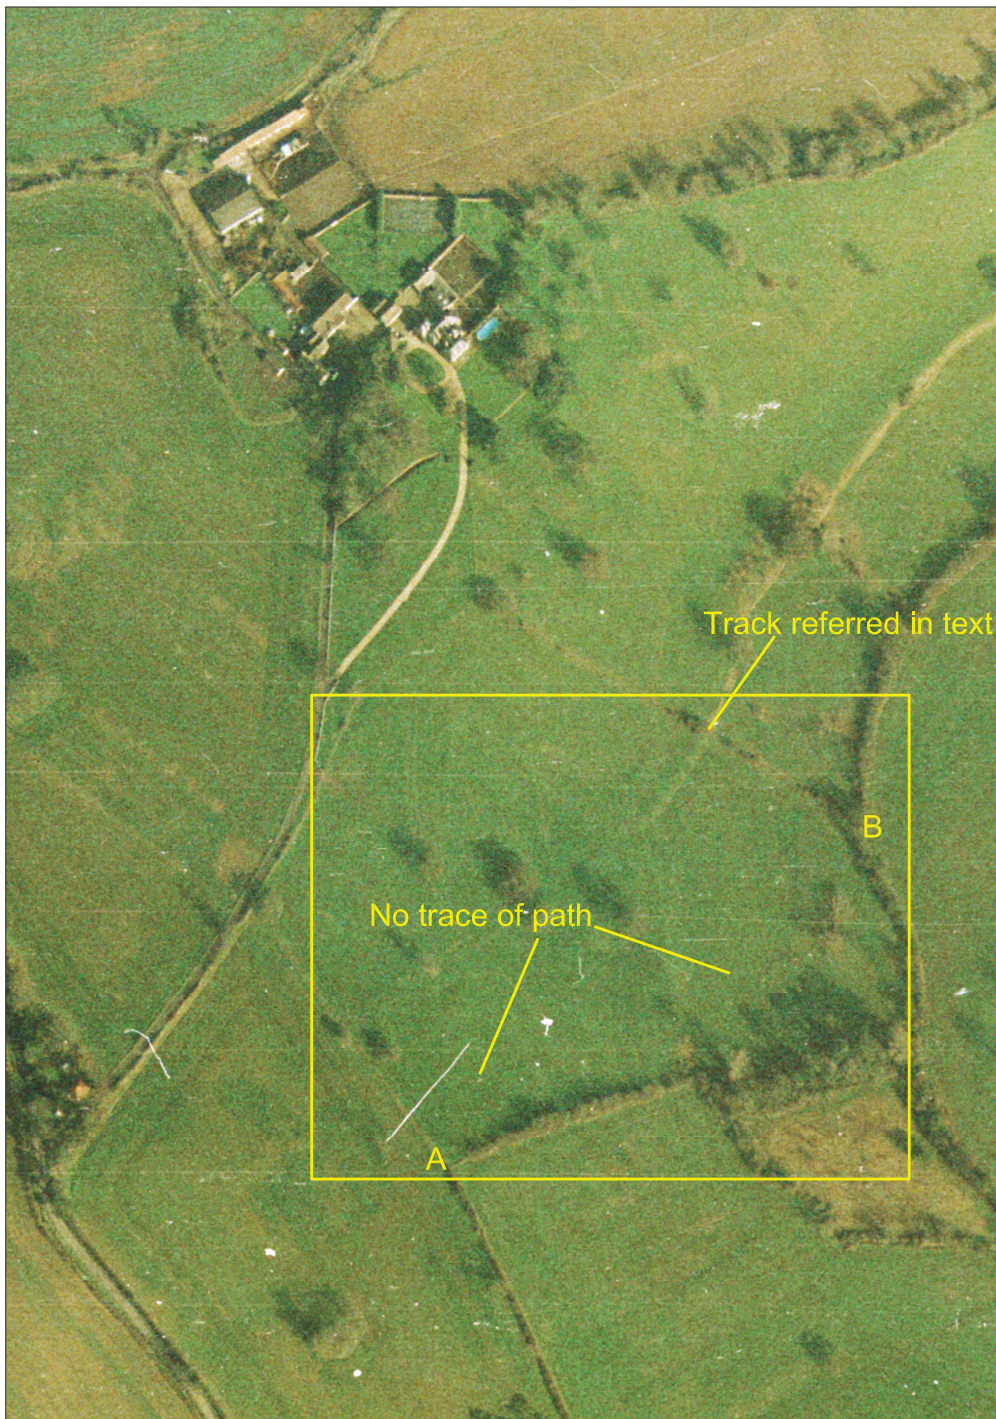
FIGURE 3 1995

- 5.2.1 In 1995 The Site is laid to grass. The quality of this photograph is not good, but it does show a light toned feature where access has been gained to The Site from a point north east of B over the boundary. This light toned feature does not connect with A and does not continue far to the south west.
- 5.2.2 There is a slight line along part of A – B at its north western end and this is likely to be rough vegetation rather than a worn track.
- 5.2.3 I conclude that a path or track was not likely to have been present in 1995 between A and B.

Drawing Title | FIGURE 3
HOLT 72 on 9th March 1995
No trace of any path is visible between A and B
White marks and lines are dirt or scratches on the photo
negative.
Client | Mr P Harris of Holt Manor
Project | Holt Manor, HOLT 72
Drawing No | APS 213 09 01 HOLT 72
Drawing status | FINAL 29 10 2013
Date | 29th October 2013
Drawn | CC

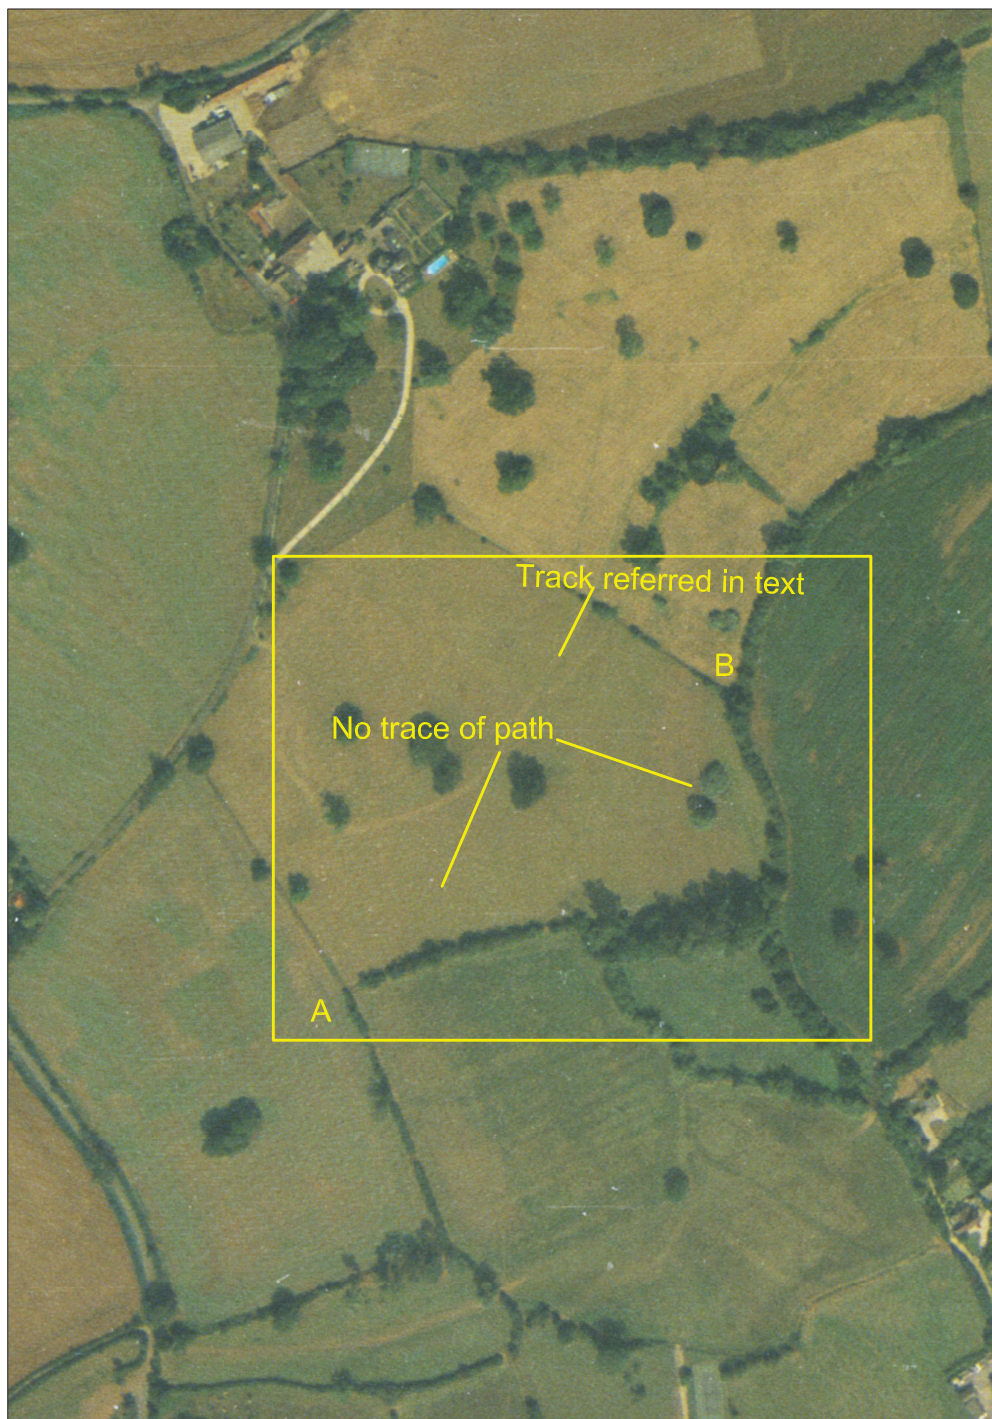
FIGURE 4 1996

Drawing Title | FIGURE 4
HOLT 72 on 4th August 1996
No trace of any path is visible between A and B

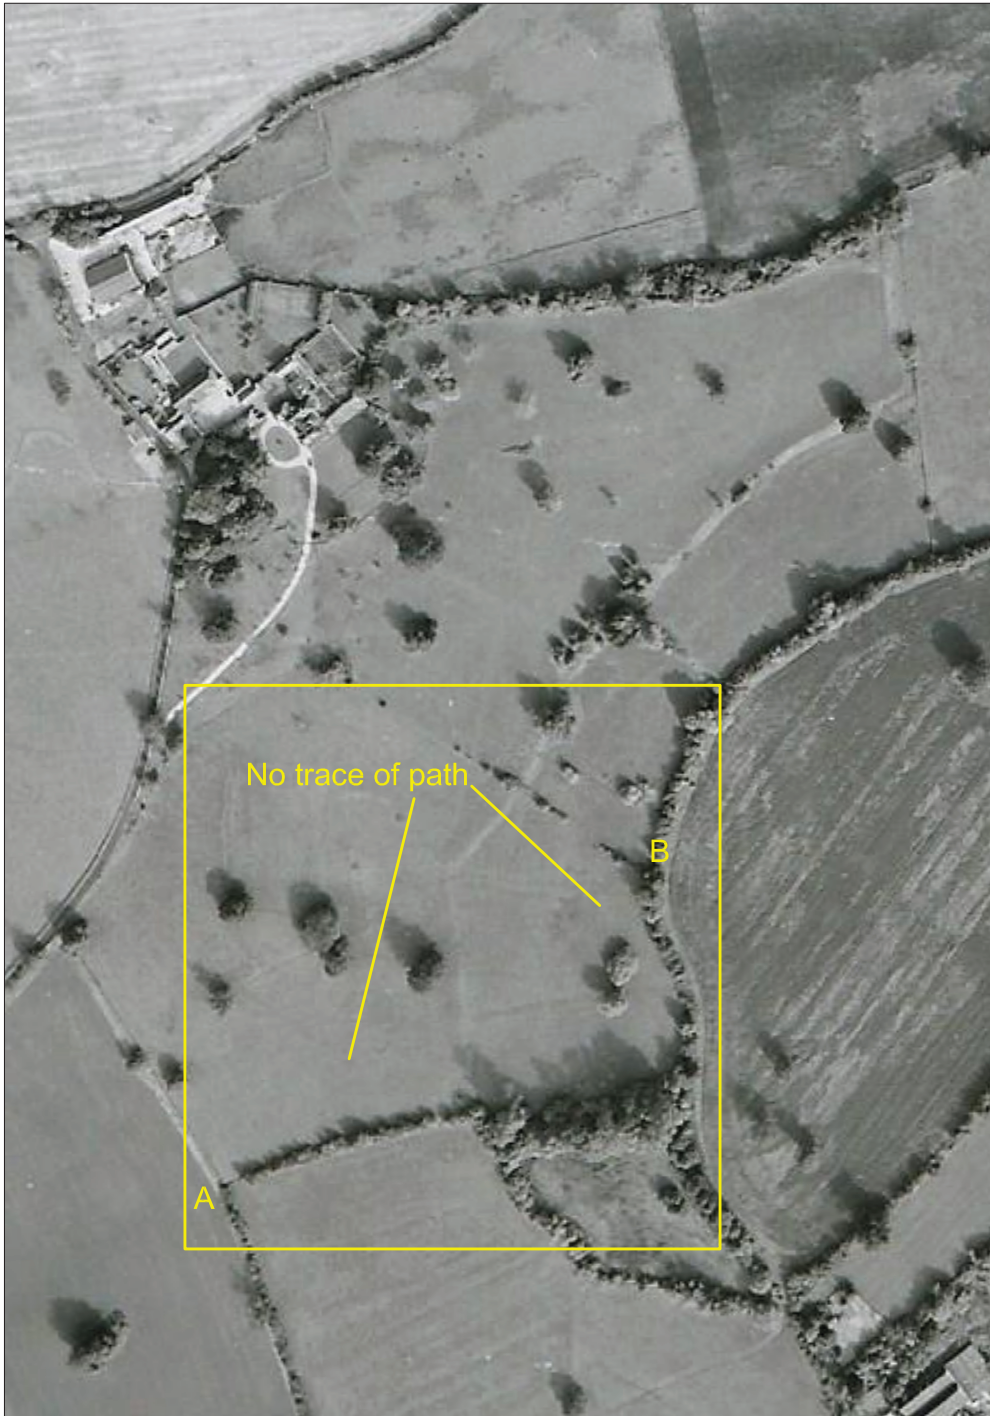
FIGURE 5 1998

Drawing Title FIGURE 5
HOLT 72 on 17th September 1998
No trace of any path is visible between A and B

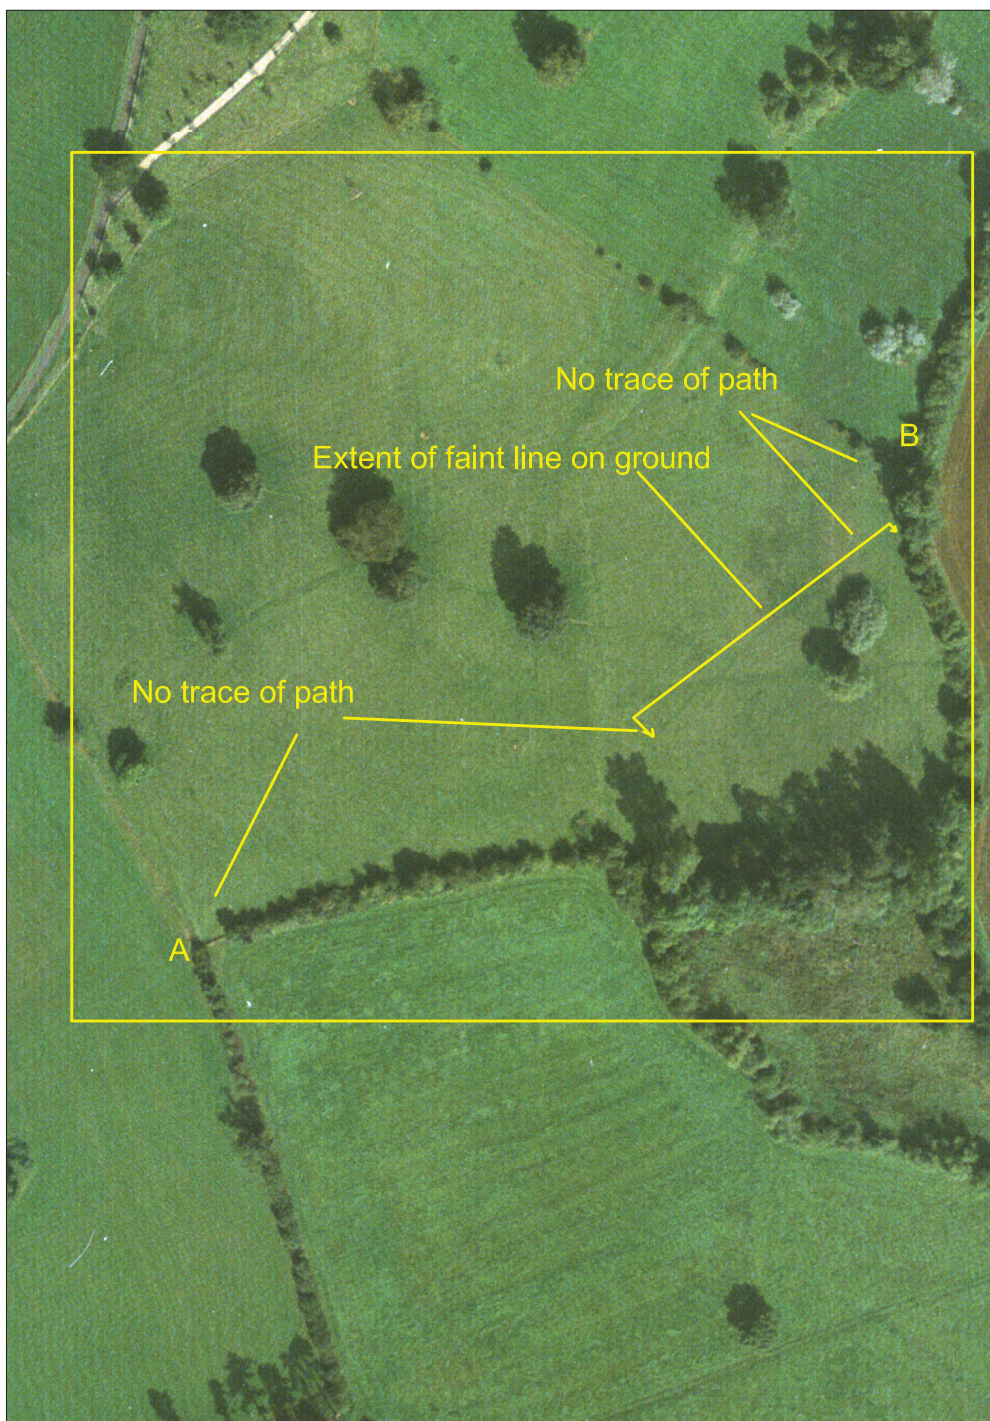
FIGURE 6 1999

- 5.6.1 In 1999, The Site is laid to grass. The quality of these photographs allows me to see the site clearly.
- 5.6.2 For the first time within the Statutory Period, a slight line is visible in the grass along part of the alleged route. It is not worn to substrate and does not connect A and B. It does not begin at B and its extent is marked precisely on Figure 6.
- 5.6.3 The line does not indicate pedestrian access between A and B as it does not connect the two points and there is no traces of it at or beyond the access points A and B.
- 5.6.4 A track connecting A and B is not visible in 1999, although a very slight line is visible in part of this area of the field.

Drawing Title | FIGURE 6
HOLT 72 on 4th September 1999
Only part of the alleged route shows a line which is not
between A and B and is not continuous

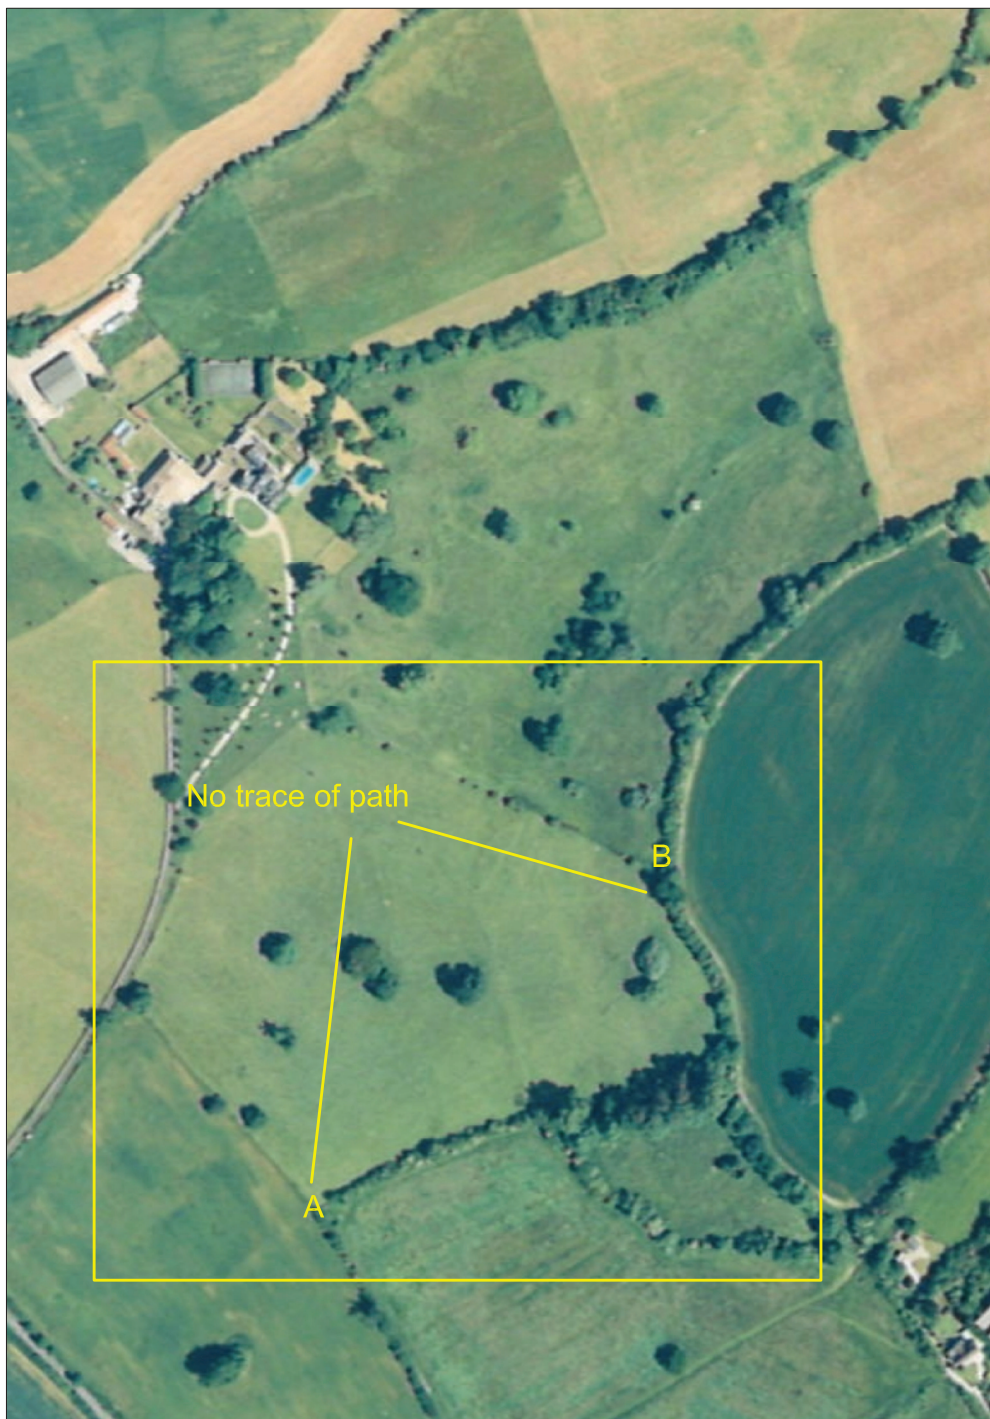
FIGURE 7 2001

- 5.7.4 I conclude that no path or track was present in 2001 between A and B.
- 5.7.5 This is in accordance with an observation on page 8 of Ms Madgwick's report that the most worn route, visible in 2006 and 2008, was not visible in 2001. I understand that the photograph referred by Ms Madgwick (page 8 ref to a photo on page 6) is that of the kissing gate at the top of the page not the aerial photograph dated 2001 which is also displayed at page 6 of her report.

Drawing Title | FIGURE 7
HOLT 72 on 20th June 2001
No trace of path between A and B

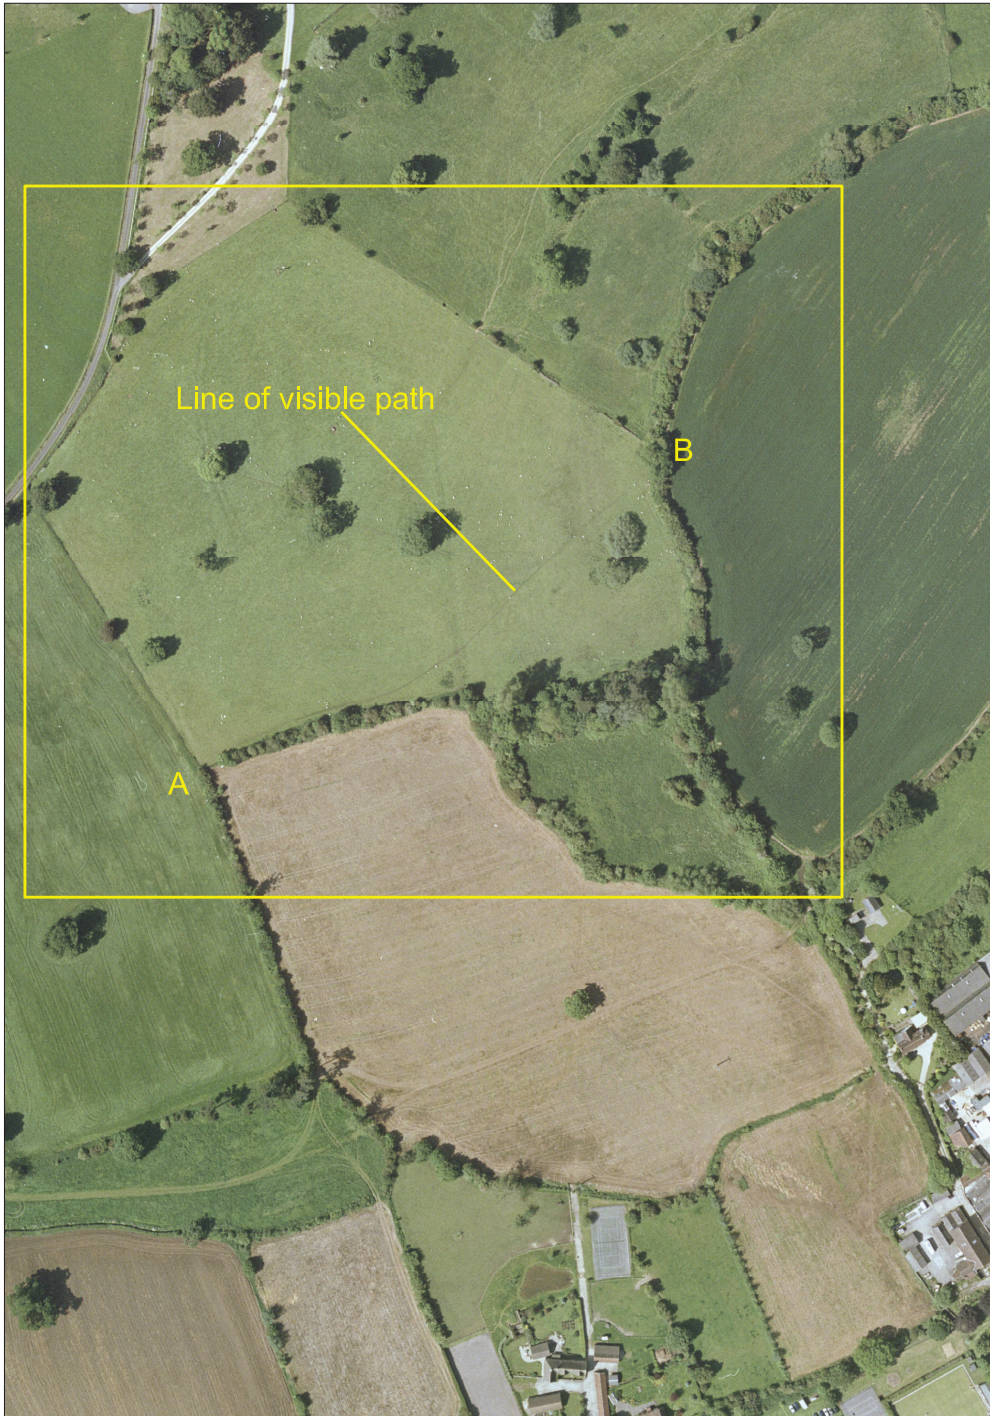
FIGURE 8 2002

5.8.1 In 2002 The Site is again laid to cultivated grass. The position of a track between A and B is clearly visible as a worn line. This is the first time this track or path has been visible as a line, which indicates pedestrian access along the route. The Site contains numerous small white dots which could be grazing sheep.

Drawing Title | FIGURE 8
HOLT 72 on 1st June 2002
Worn line of path visible for the first time fully and between
points A and B

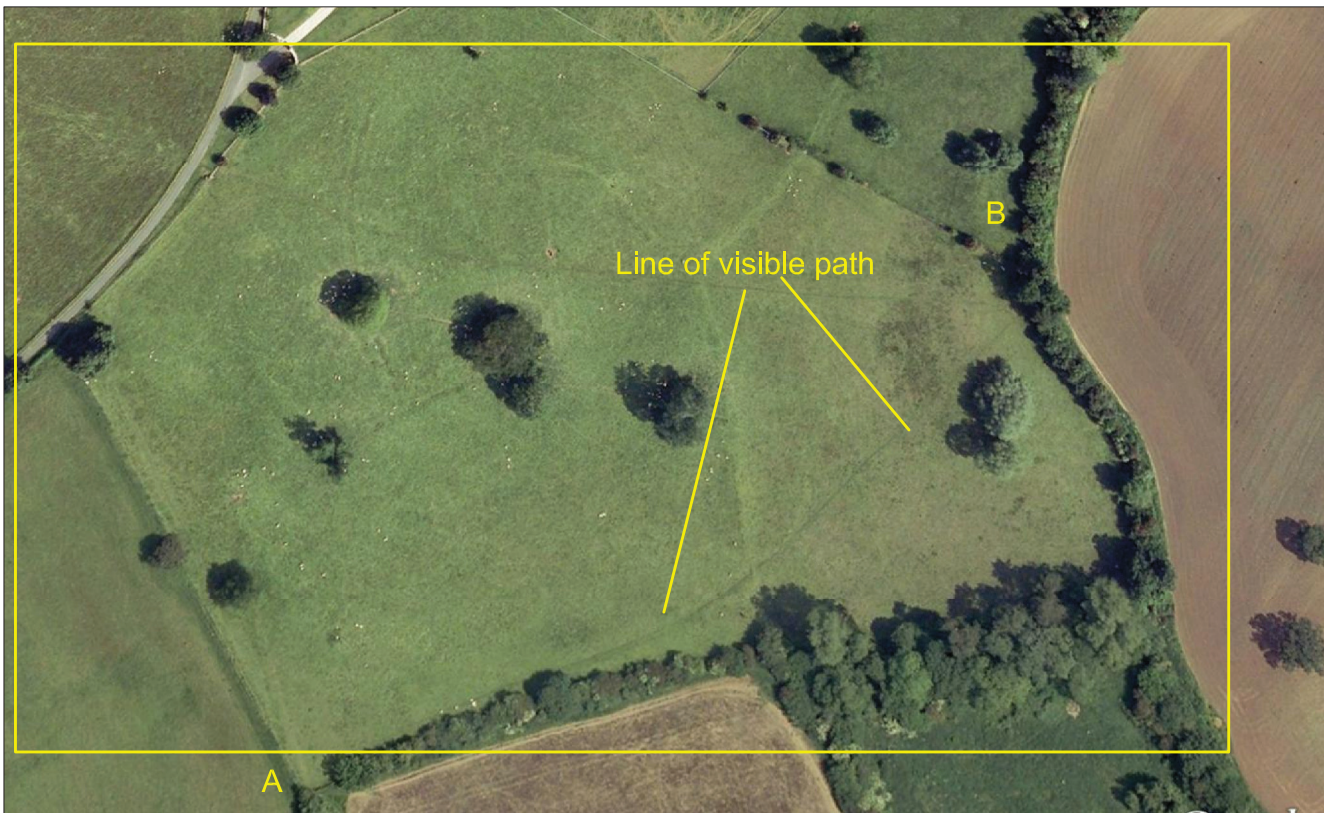
FIGURE 9 2006

- 5.9.1 In 2006, linear and vestigial features on The Site show once again, indicating areas of access and former land use.
- 5.9.2 In common with 2002, the alleged path or track is again clearly visible as a worn line on the ground between A and B.
- 5.9.3 The Site contains numerous grazing sheep.
- 5.9.4 I conclude that a path or track is present in 2006 between A and B on the same line as it was first observed in 2002.

Drawing Title	FIGURE 9 HOLT 72 on 8th June 2006 Worn line of path visible
Client	Mr P Harris of Holt Manor
Project	Holt Manor, HOLT 72
Drawing No	APS 213 09 01 HOLT 72
Drawing status	FINAL 29 10 2013
Date	29th October 2013
Drawn	CC

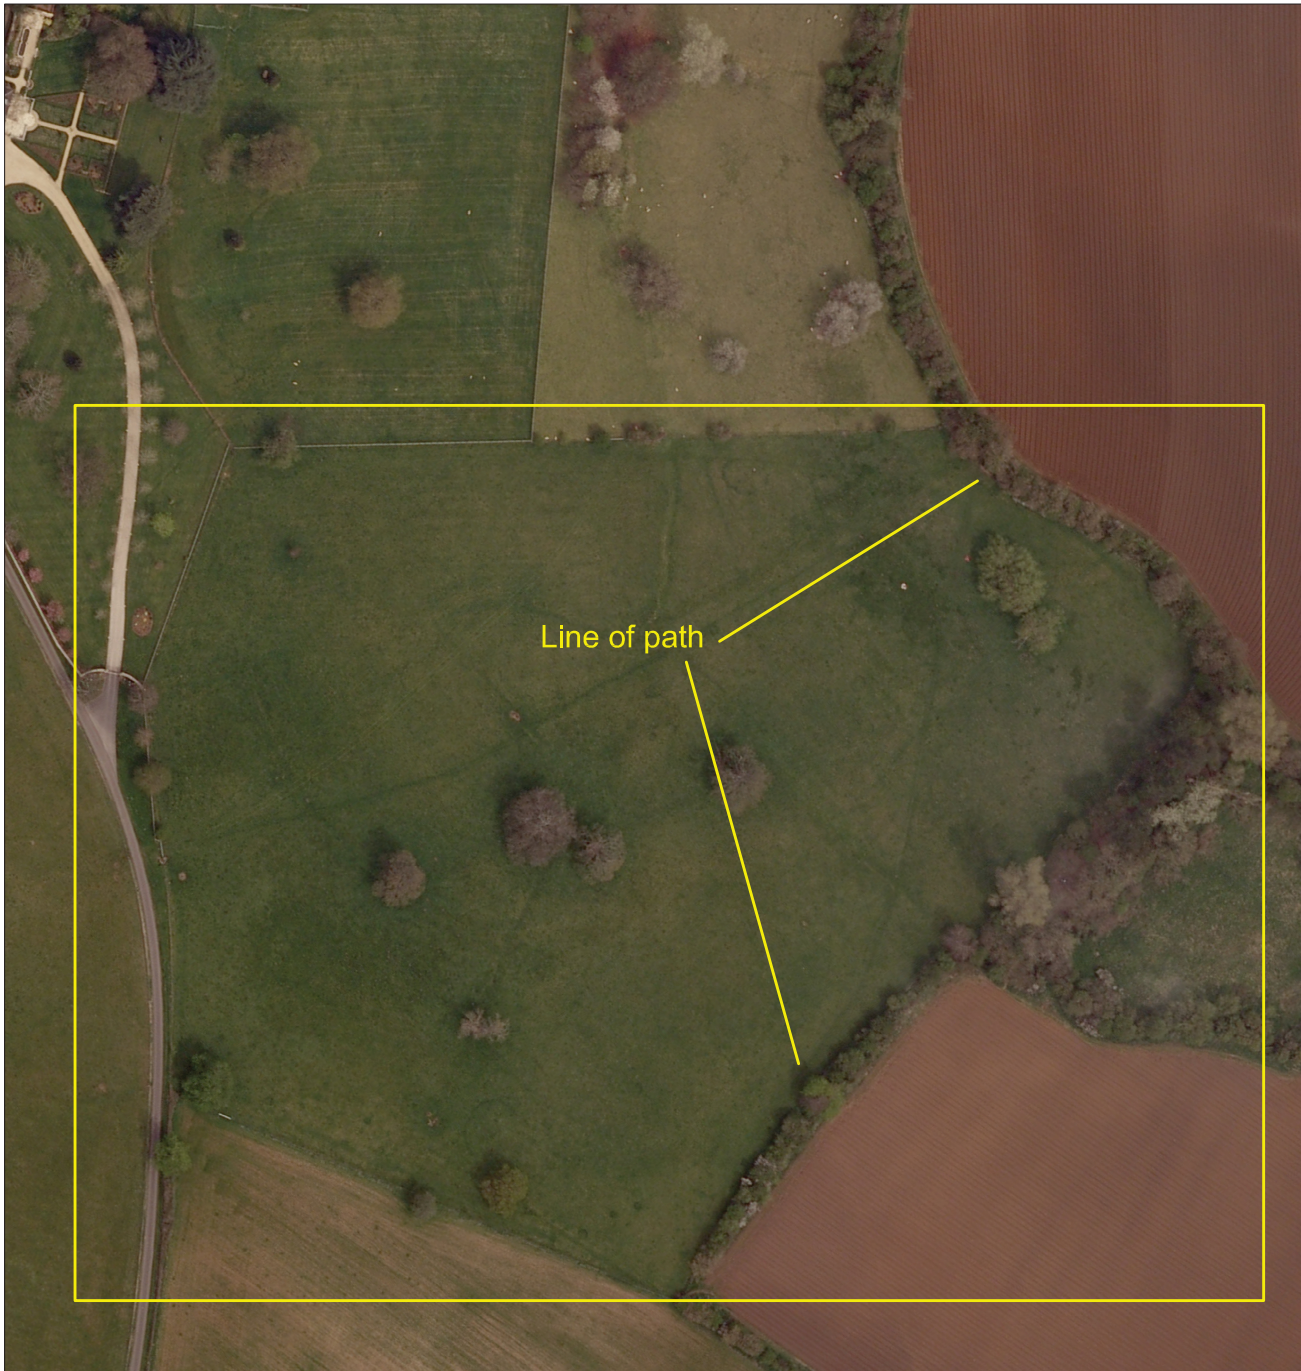
FIGURE 10 2008

- 5.10.1 In 2008, linear and vestigial features on The Site show once again, indicating areas of access and former land use as previously described.
- 5.10.2 In common with 2002 and 2006, the alleged path or track is again visible as a darker toned line on the ground between A and B. It is not worn to substrate as previously seen, so may not be so well used at this time as in 2002 and 2006.
- 5.10.3 I conclude that a path or track is present in 2008 between A and B on the same line as it was first observed in 2002 and 2006. The track, in common with other linear and curvilinear features, is not so apparent in 2008 as in 2002 and 2006, but is nonetheless visible.

Drawing Title | FIGURE 10
HOLT 72 on 26th April 2008
Faint unworn line of path visible
