## **Salisbury Night Audit Report**

### **Introduction and background**

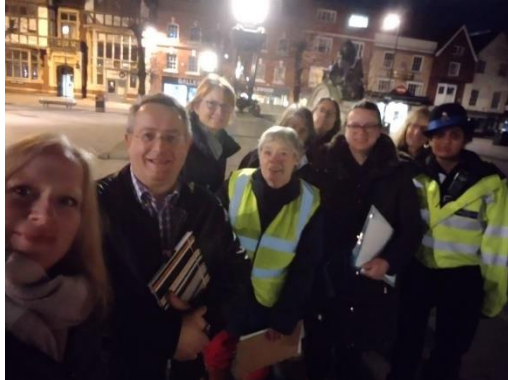
Every streetlight that was not operating (or in some cases was obscured by foliage) was reported on the MyWilts reporting system within a few days of each of the audits. Two non-working streetlights were on the bypass and we were advised by the Councillor present on the night that these were the responsibility of The Highways Agency, so they were reported on their website reporting system. As can be seen from the list in Appendix 2, this

amounted to some 40 non-functioning streetlights.

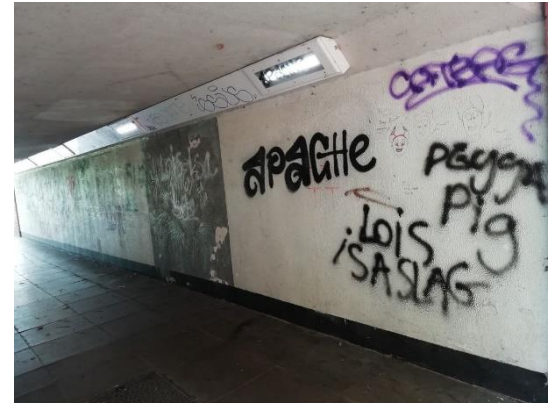
### **St Paul's roundabout 5 tunnels**

We were pleasantly surprised by how well lit these tunnels were. We could find no lights out and there was no flooding or litter to be seen. However we did note significant graffiti in the tunnels and this has also been the subject of recent social media posts, so we have reported this.
