B3105 Woolley Green – Site Assessment

> > Document Reference – WC-WG-SA-R001-REV A 24th April 2107

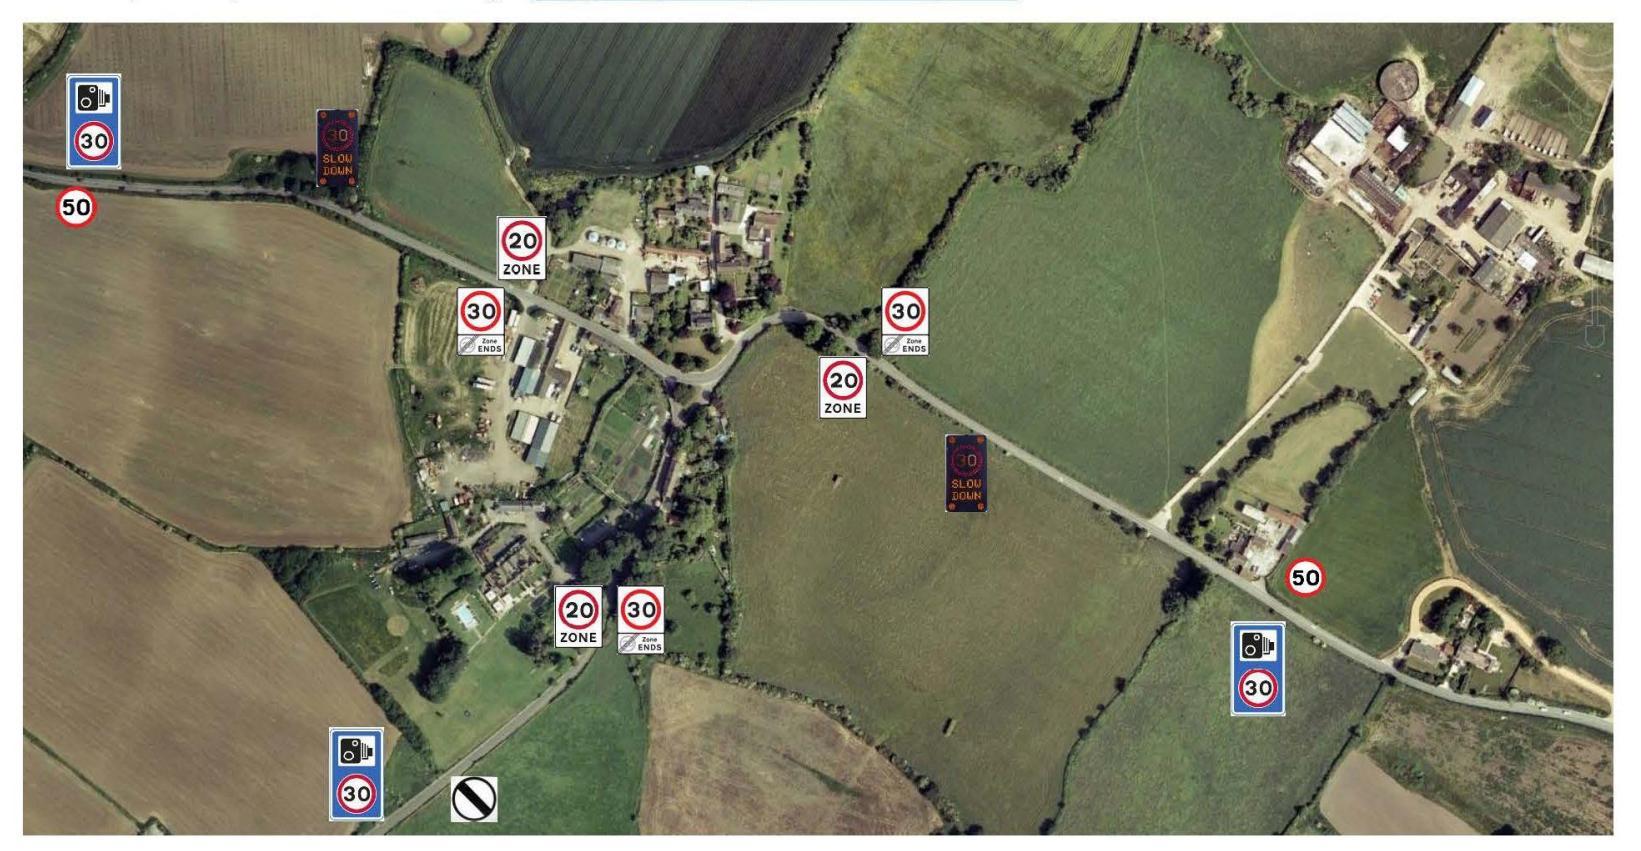
Option 1: Reduced speed limit

Reduced speed limit, slow down indication signs (http://sidsigns.co.uk/slow-down-sid-signs.htm)
