Special Inspection Report

Project: Bank Street Melksham,

Prepared by: J Haines Date: 12th May 2004

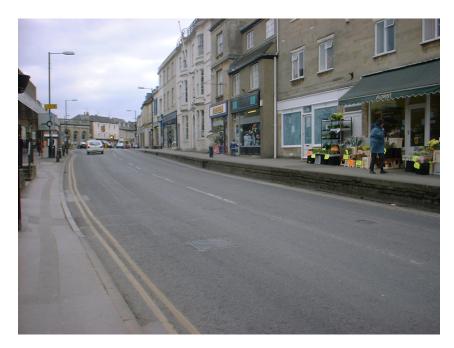
The existing pavement consists of cast in situ concrete slabs supported off a random rubble stone wall to the front face. It is believed that there are no construction records available from when the slabs were installed.
