REPORT OUTLINE FOR AREA PLANNING COMMITTEES**Report No.**

Date of Meeting	04 September 2019
Application Number	19/02713/LBC
Site Address	Merchant House 34 High Street Royal Wootton Bassett SN4 7AF
Proposal	Replacement of UPVC windows, replacement of damaged lintels and rebuilding of front wall above windows
Applicant	Mr Johnathan Bourne on behalf of Royal Wotton Bassett Town Council
Town/Parish Council	ROYAL WOOTTON BASSETT
Electoral Division	Wootton Bassett South– Cllr Hurst
Grid Ref	406728 182586
Type of application	Listed Building Consent
Case Officer	Caroline Ridgwell

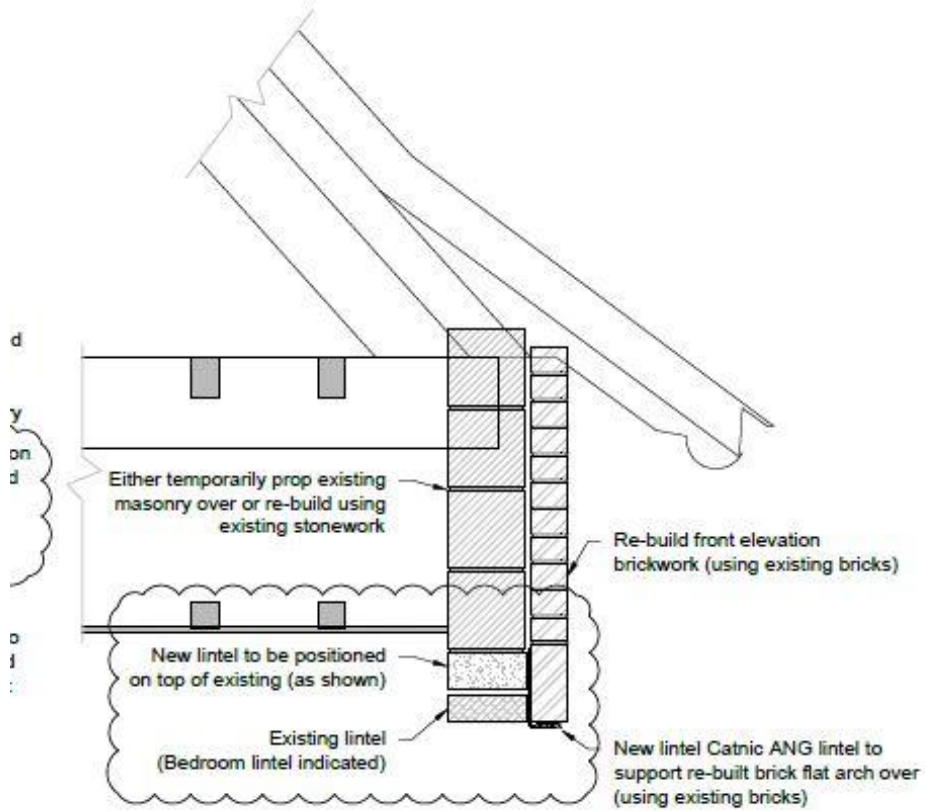
1-1 Section 1-1
Scale: 1:20

SDS strengthening proposals 22.05.19

lintol on each of the first floor windows on the front elevation, and addition of a steel catnic lintol 'L' lintol to reinforce the brick arch to the windows. This lintol would be visible externally on the underside of the brick arch/window reveal. The proposals for the lintol are an amendment to the originally submitted scheme which suggested removal of the existing timber lintol to be replaced with either a timber or a pre-stressed concrete lintol with catnic lintol.

Should it be agreed that the lintols do require strengthening in some way, there is a less intrusive and more subtle method than the one proposed. An alternative solution has been put forward which adheres to the conservation approach that the least intrusive solution is most acceptable for a heritage asset. The more conservative solution would be to strengthen the lintols so that they are adequate to carry the required loading. The applicants proposals appear to be based on requirements for a new building and would be far more intrusive. A catnic lintol is not a traditional detail, it is found on new buildings.

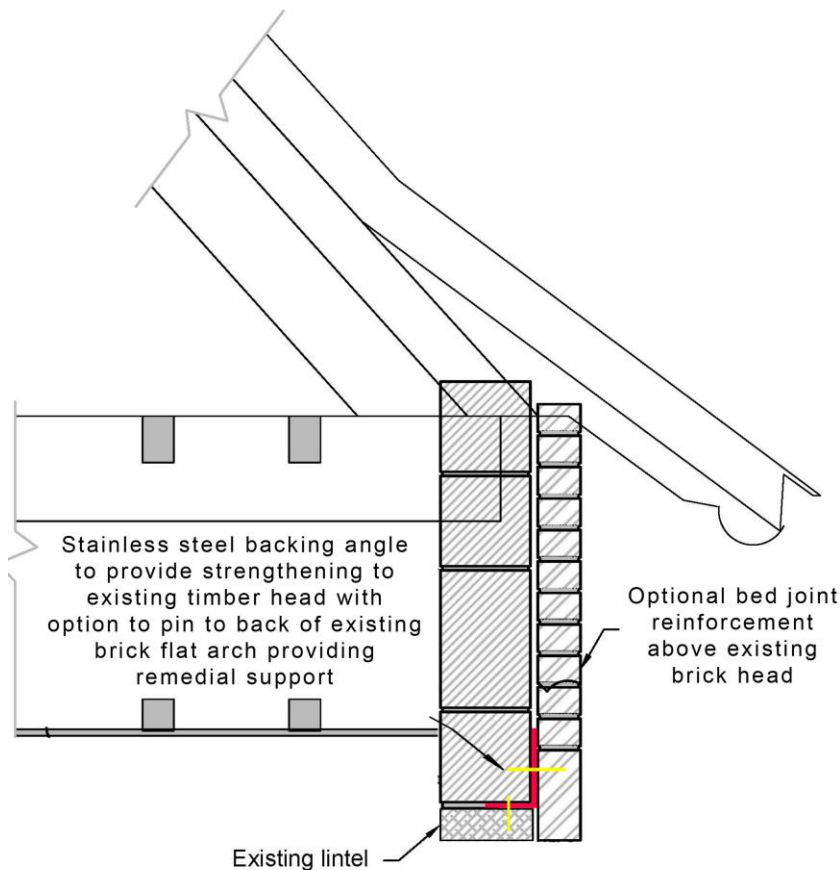
Merchants House, Wooton Bassett

Option for strengthening to existing first floor window head
