## Diversion of Baydon 2 & 11

## APPENDIX A

### Specification as discussed with Stephen Leonard 08.11.13

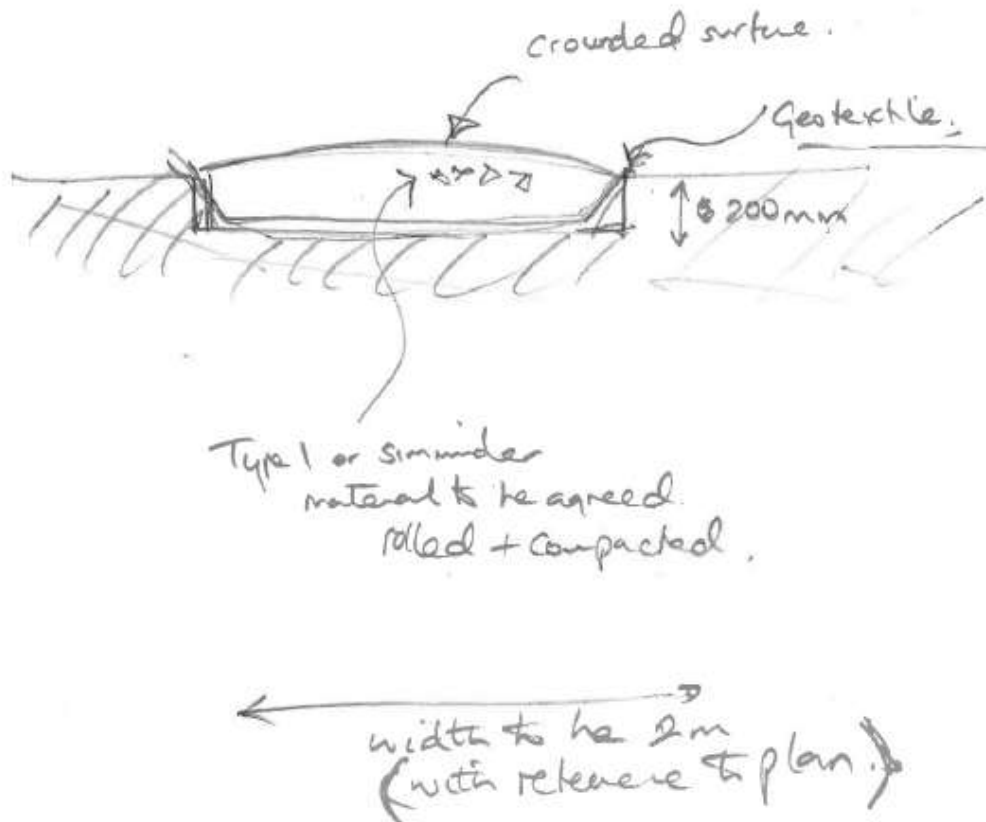
Surface Spec

Depth of surface material to be at least 200 mm laid over a geotextile membrane and compacted as necessary.

Surface to be laid level with surrounding grass to promote ease of maintenance and to have a cambered surface to promote good drainage and to prevent pooling of water.

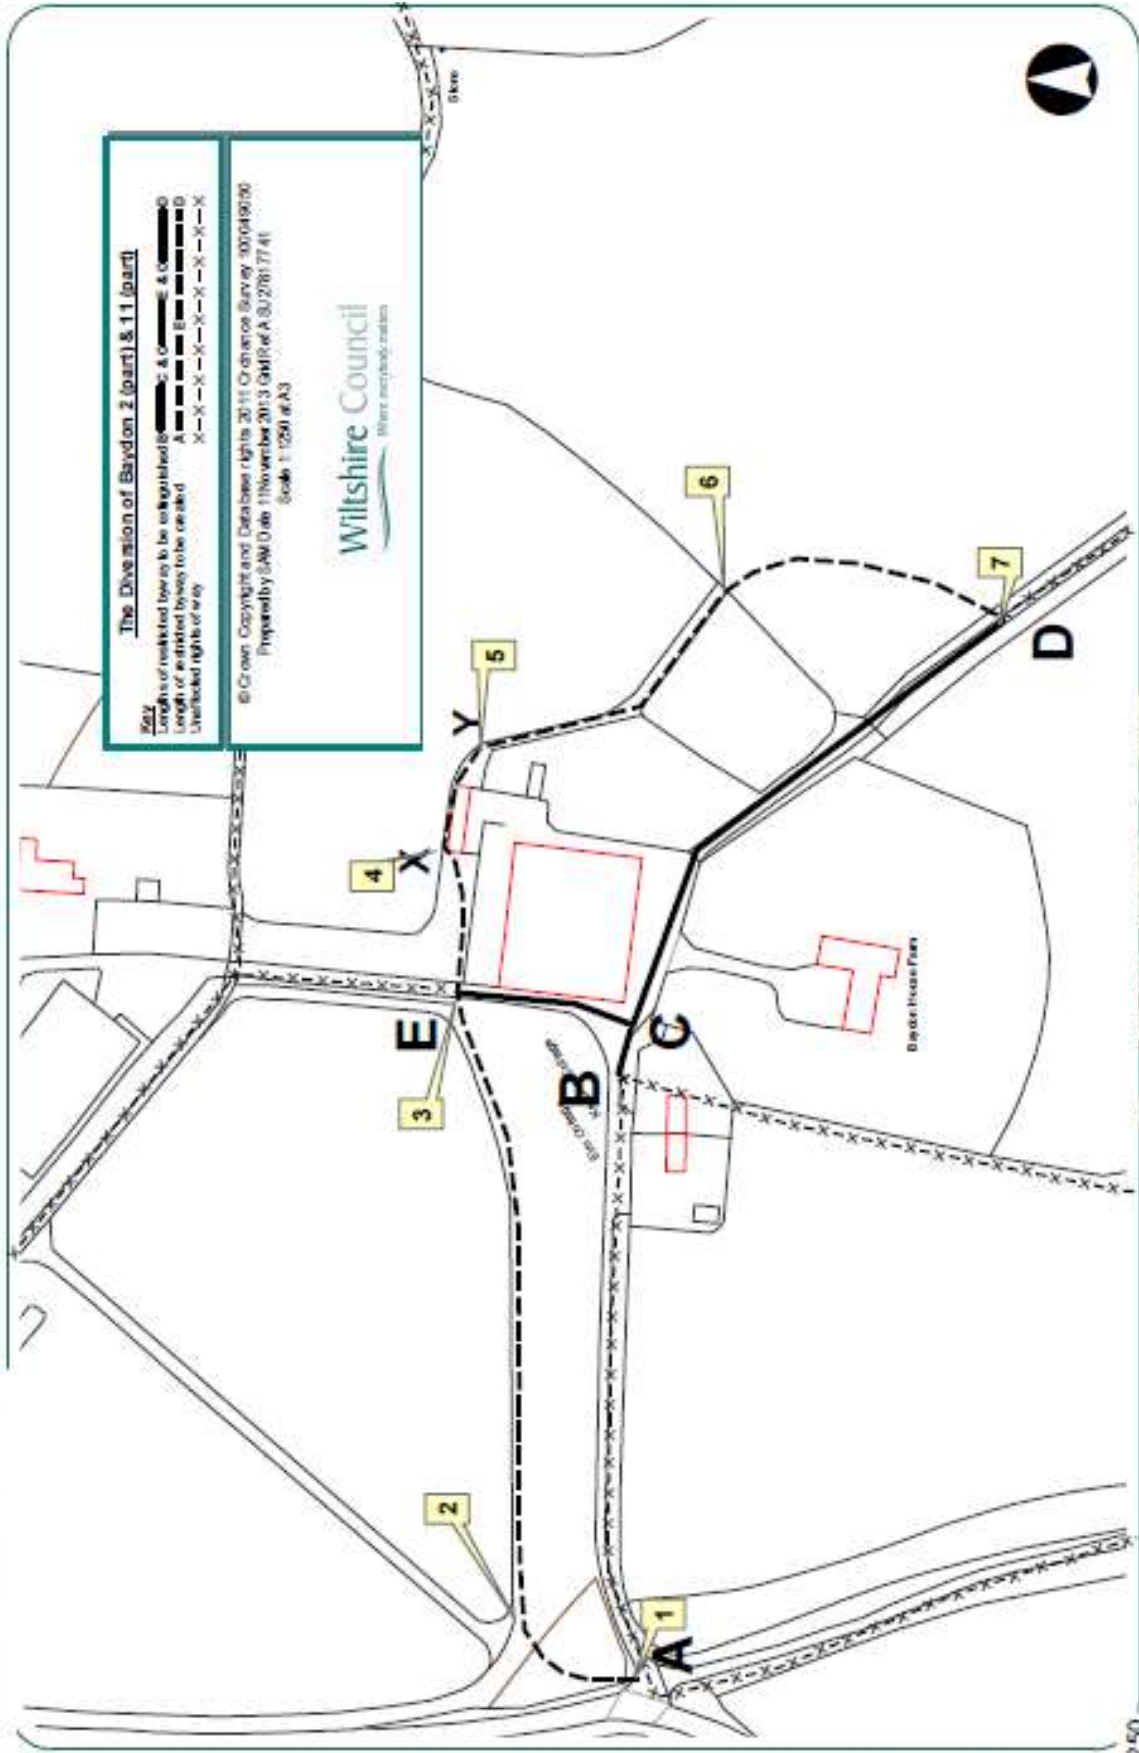
**Division of Baydon 2 and 11 (part)  
at Baydon House Farm**

### **With reference to numbered plan:**

- Point 1 - 2    Width to be at least 4.1 metres.  
Route to avoid cross camber fall and to minimise gradient.  
Trees to be transplanted from route and low branches removed as appropriate (12 to 15 feet)  
Surfaced section to lie within total width and ideally on eastern side of route  
Metal fencing to be relocated as appropriate

- Point 2 - 3    Width at least 4.1 metres  
Surfaced section to be either central or on southern side of route
- Point 3 - 4    Increase width to at least 4.1 metres  
Realign fencing and remove any tree growth  
Route between points 3 and 4 not to have right angles or sharp bends  
transplant trees as discussed. Large eucalyptus to be retained

- Point 4 - 5    Width at least 2.6 metres to be maximised wherever possible  
Surfacing to extend to total width for section between points 4 and 5  
Relocate fence lines to maximise width.  
Erect fencing around pole stay

- Point 5 - 6    Increase width to at least 4.1 metres  
Cut back coniferous tree growth to a height of at least 12 feet  
Cut back all other tree growth as appropriate to facilitate use of full width.  
Remove self seeded and dying growth  
Surfaced section may return to a width of at least 2 metres

- Point 6 – 7    Remove low branches affecting path  
Full width of 4.1 metres to be available  
2 wide surfaced section not have loose material on (this section susceptible to water run off)  
Entrance/egress to/from new section to be wide and inviting from existing path no. 2  
Gradient to be minimised where bank removed  
Small trees to be removed at point 7 to enable clear wide access that will not be susceptible to becoming 'grown in'  
Blend new surface in with existing
