City of Salisbury Conservation Area Appraisal and Management Plan

Final draft May 2012

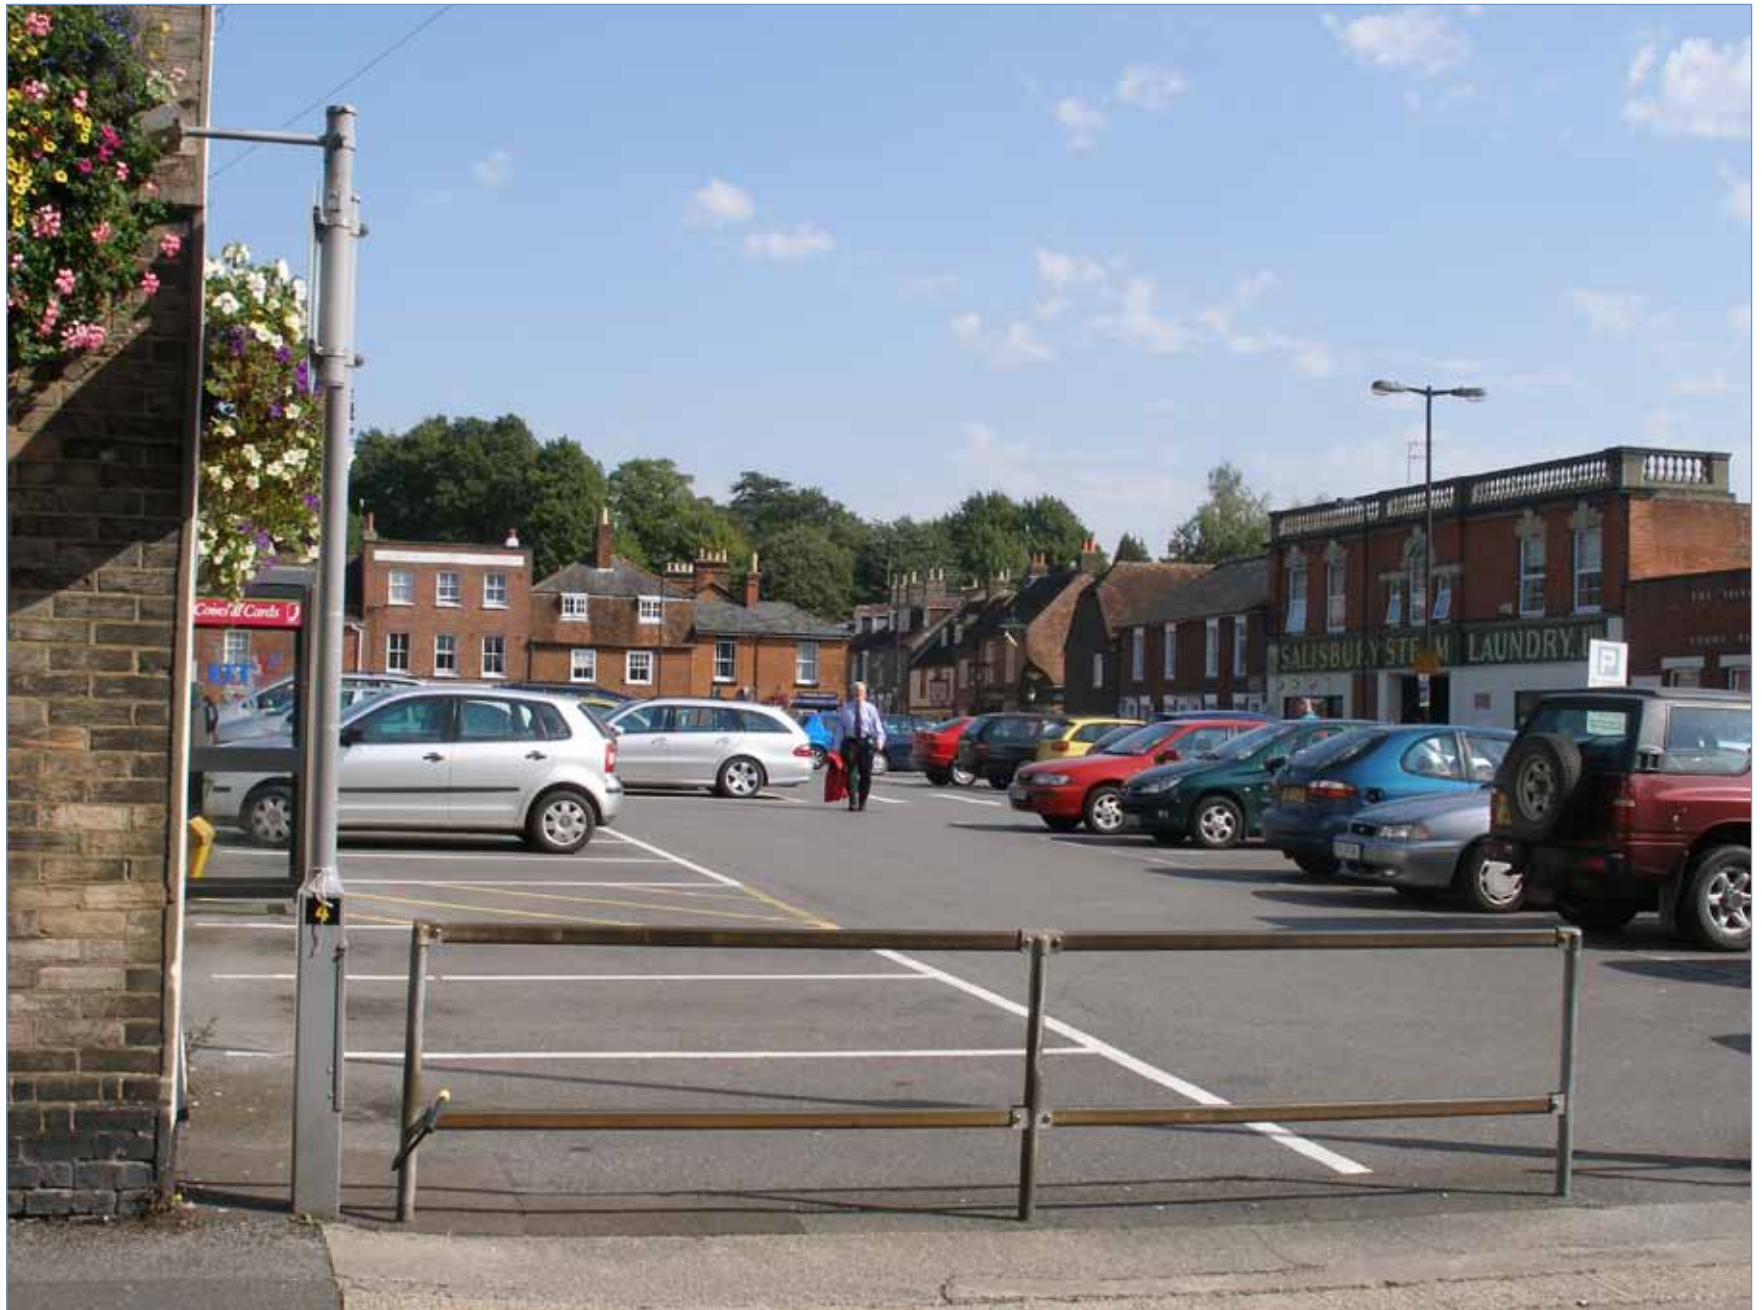
Fig 9,
Parson's Chequer

Parson's Chequer (Figure 9)

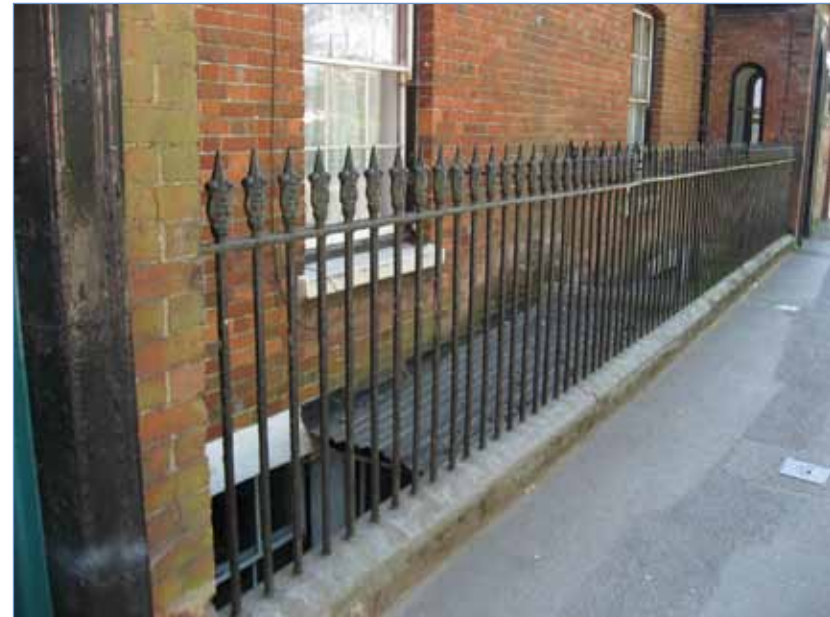
Fig 84
Cast iron
railings

7.272 The predominant material is red brick with natural slate roofs, although many of the roofs have been replaced with concrete tiles.

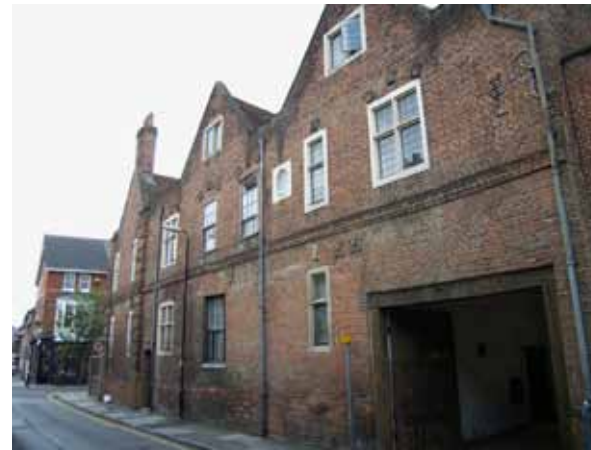
Fig 150
Northern end
of St Edmund's,
Church Street

- 10.9 Mathematical tiles were a device for covering and remodelling earlier facades, in most cases timber framing. They were attached either by hanging them from battens directly nailed to the timber frame, or a later system of cross battens placed in front of the frame, or attached to softwood boarding nailed to the timber frame. Some were bedded and nailed directly into a mortar applied to the facades but these invariably failed.
- 10.10 The tiles were pointed in to give the impression of high quality gauged brickwork. They can be identified by a timber fillet to the edge of the window, or on corners where this is not present, the tile slip can clearly be seen. They can also take on an uneven appearance; not physically possible for a normal brick unless there is a failure in the wall (Figure 153).

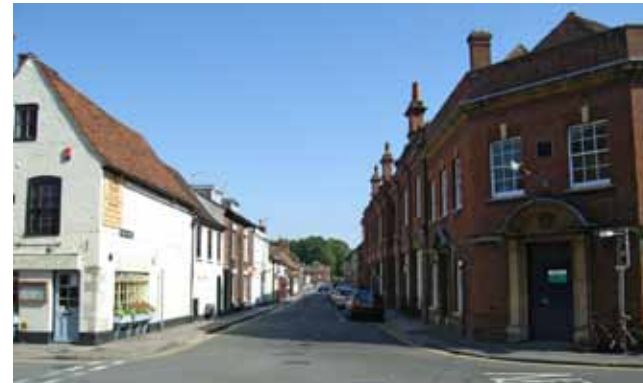
Fig 167

- 13.4 The care and repair of mathematical tiles is an issue throughout the historic core. A number of the houses finished in this material are showing signs of failure. These relatively rare architectural fragments are a key part of the evolution of the city and a characteristic which has helped shape the townscape into the diverse mix of styles and forms seen on many of the streets in the city.

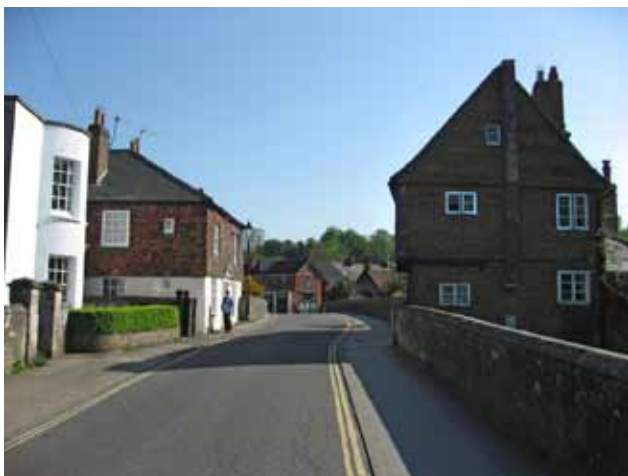
Fig 173

- 18.15 It should be noted that the corner shop (No. 1 Harnham Road) with its original shopfront and fenestration (Figure 173) closes the view south across the bridge.
- 18.16 The terraces have mostly lost their original windows, with only some retaining their timber framed sliding sashes and timber four panel doors. However, their projecting square stone bays to the ground floor (some painted) form a strong rhythm and set the terraces apart from other indifferently designed examples from the period (Figure 174).
- 18.17 This is an important gateway to the city and the quality of its townscape should be protected.
