City of Salisbury Conservation Area Appraisal and Management Plan

Final draft May 2012

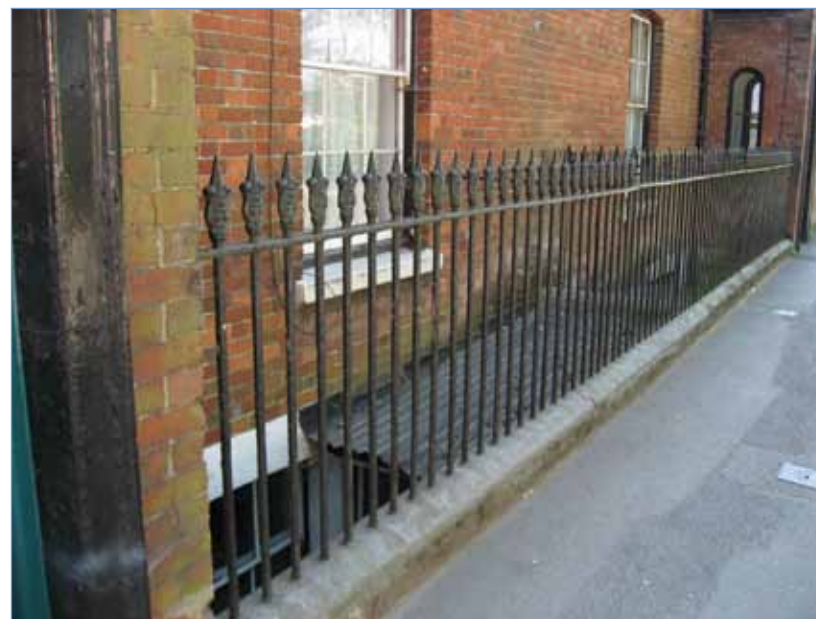
Fig 84
Cast iron
railings

7.272 The predominant material is red brick with natural slate roofs, although many of the roofs have been replaced with concrete tiles.

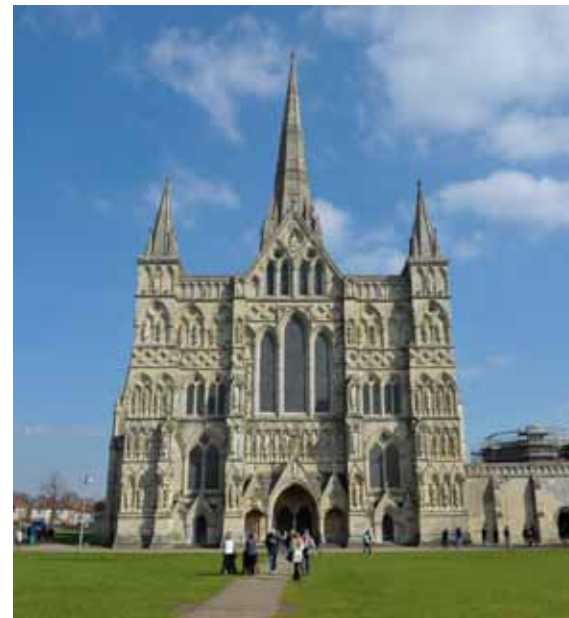
Fig 149
Salisbury Cathedral

- 10.5 Hurdcott and Chilmark stone is also found in the city and particularly evident in the walls of The Close. These stones have similar characteristics and weather to a soft grey colour.

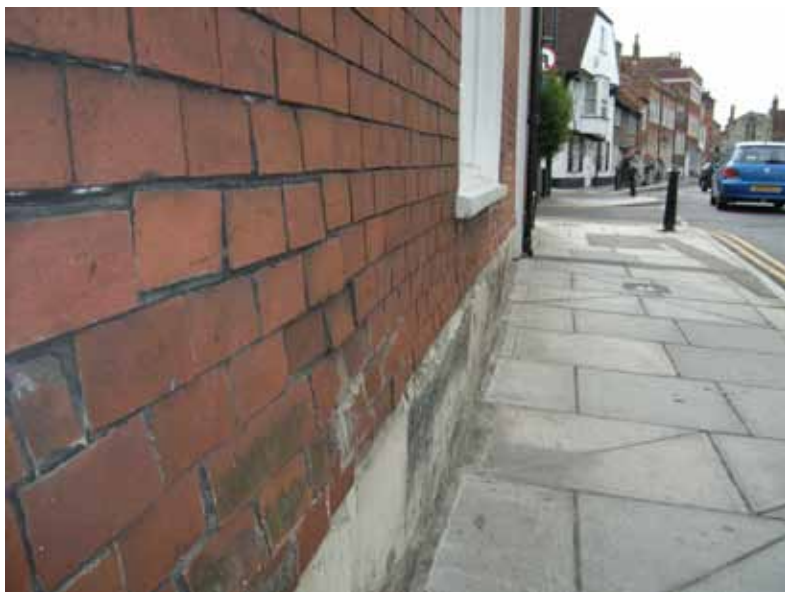
Fig 153

- 10.9 Mathematical tiles were a device for covering and remodelling earlier facades, in most cases timber framing. They were attached either by hanging them from battens directly nailed to the timber frame, or a later system of cross battens placed in front of the frame, or attached to softwood boarding nailed to the timber frame. Some were bedded and nailed directly into a mortar applied to the facades but these invariably failed.
- 10.10 The tiles were pointed in to give the impression of high quality gauged brickwork. They can be identified by a timber fillet to the edge of the window, or on corners where this is not present, the tile slip can clearly be seen. They can also take on an uneven appearance; not physically possible for a normal brick unless there is a failure in the wall (Figure 153).
