Report subject: Operational development comprising material alterations to the landform and the construction of a bund on land at the rear of Bourne View, Allington.

Report to: Northern Area Committee.

Date: 2nd November 2006.

Author: Stephen Hawkins, Principal Planning Officer (Enforcement)

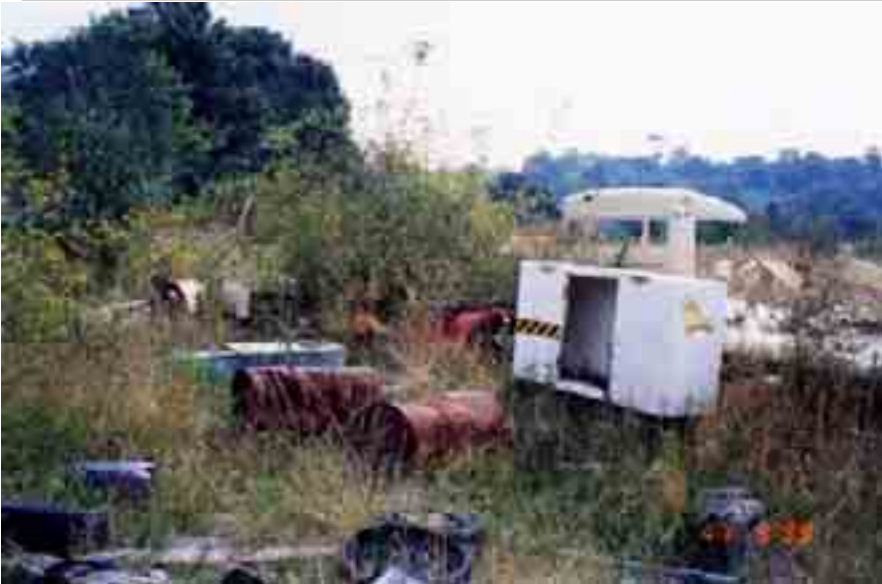
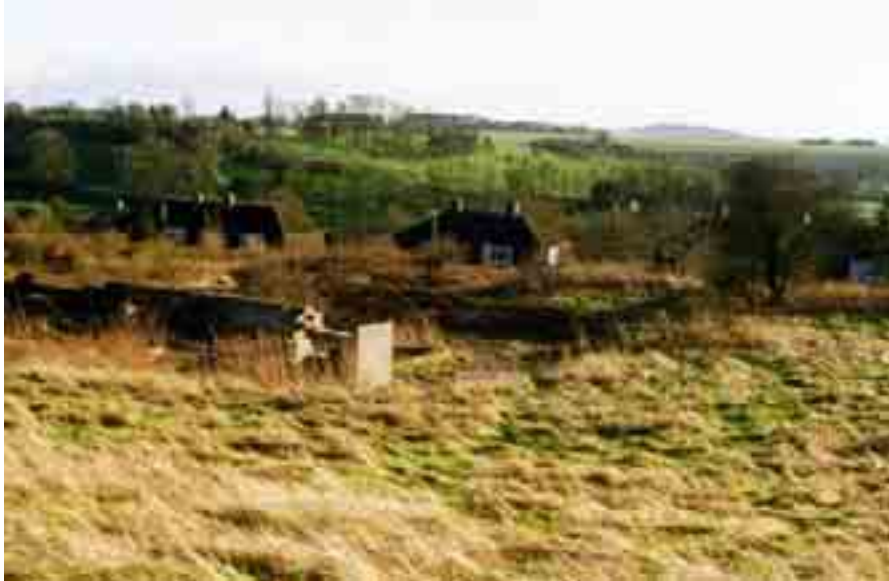
I would like to reiterate that on my possession of the land in Nov 1999, after I had cleared the ground from Cars, Milk Floats and household rubbish and at the time the Planning Application was made there was a bund in existence. This you can see clearly in the picture on the right which was taken from the Northern most boundary of my land.

The picture to the left shows the view from the same position as the picture taken on 11/9/99 and to the right, the land to the rear of the council houses as of Today and before planting.

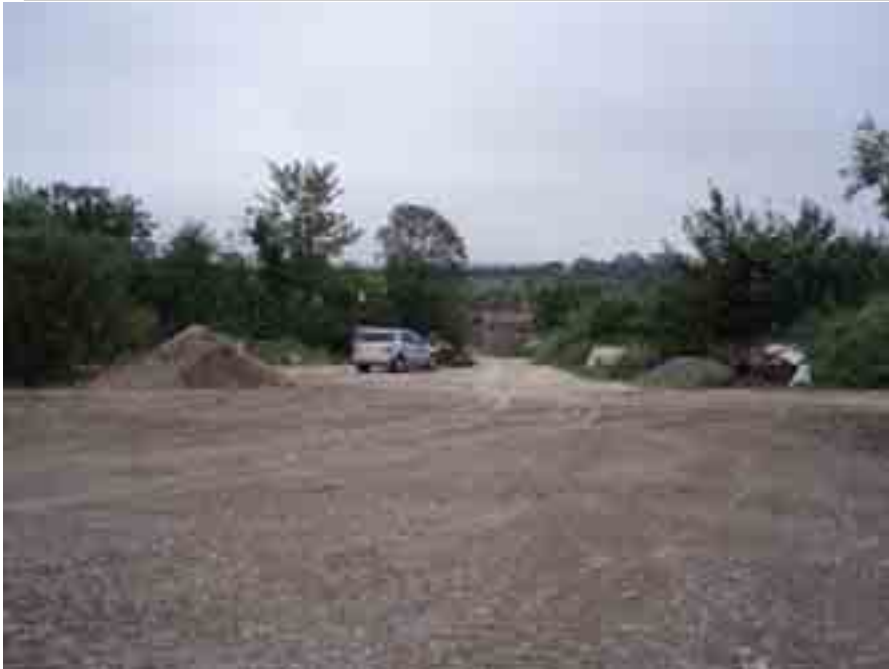
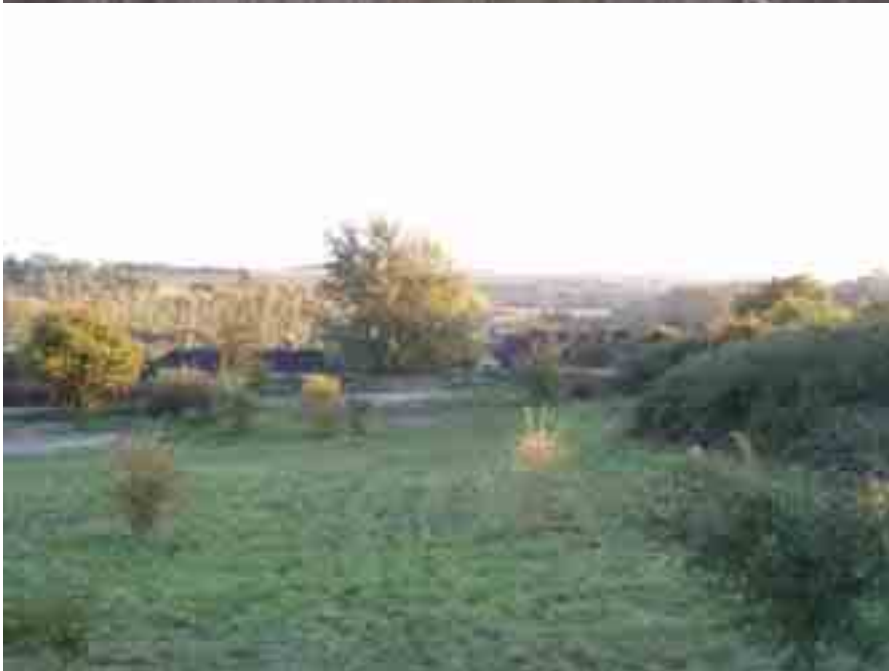
You will see from the before and after pictures that the height of the replaced bund is not much different than how it was in the Winter of 1999. It will of course settle and I expect during the winter it will drop around 150-300mm. It is certainly not 1.5-2.0m in height anywhere along its length.
